June 26, 2018

Project No. 1895029

**RE: VT ROUTE 12 SLOPE STABILITY – STABILIZATION ALTERNATIVES AND FINAL DESIGN  
BETHEL, VERMONT**

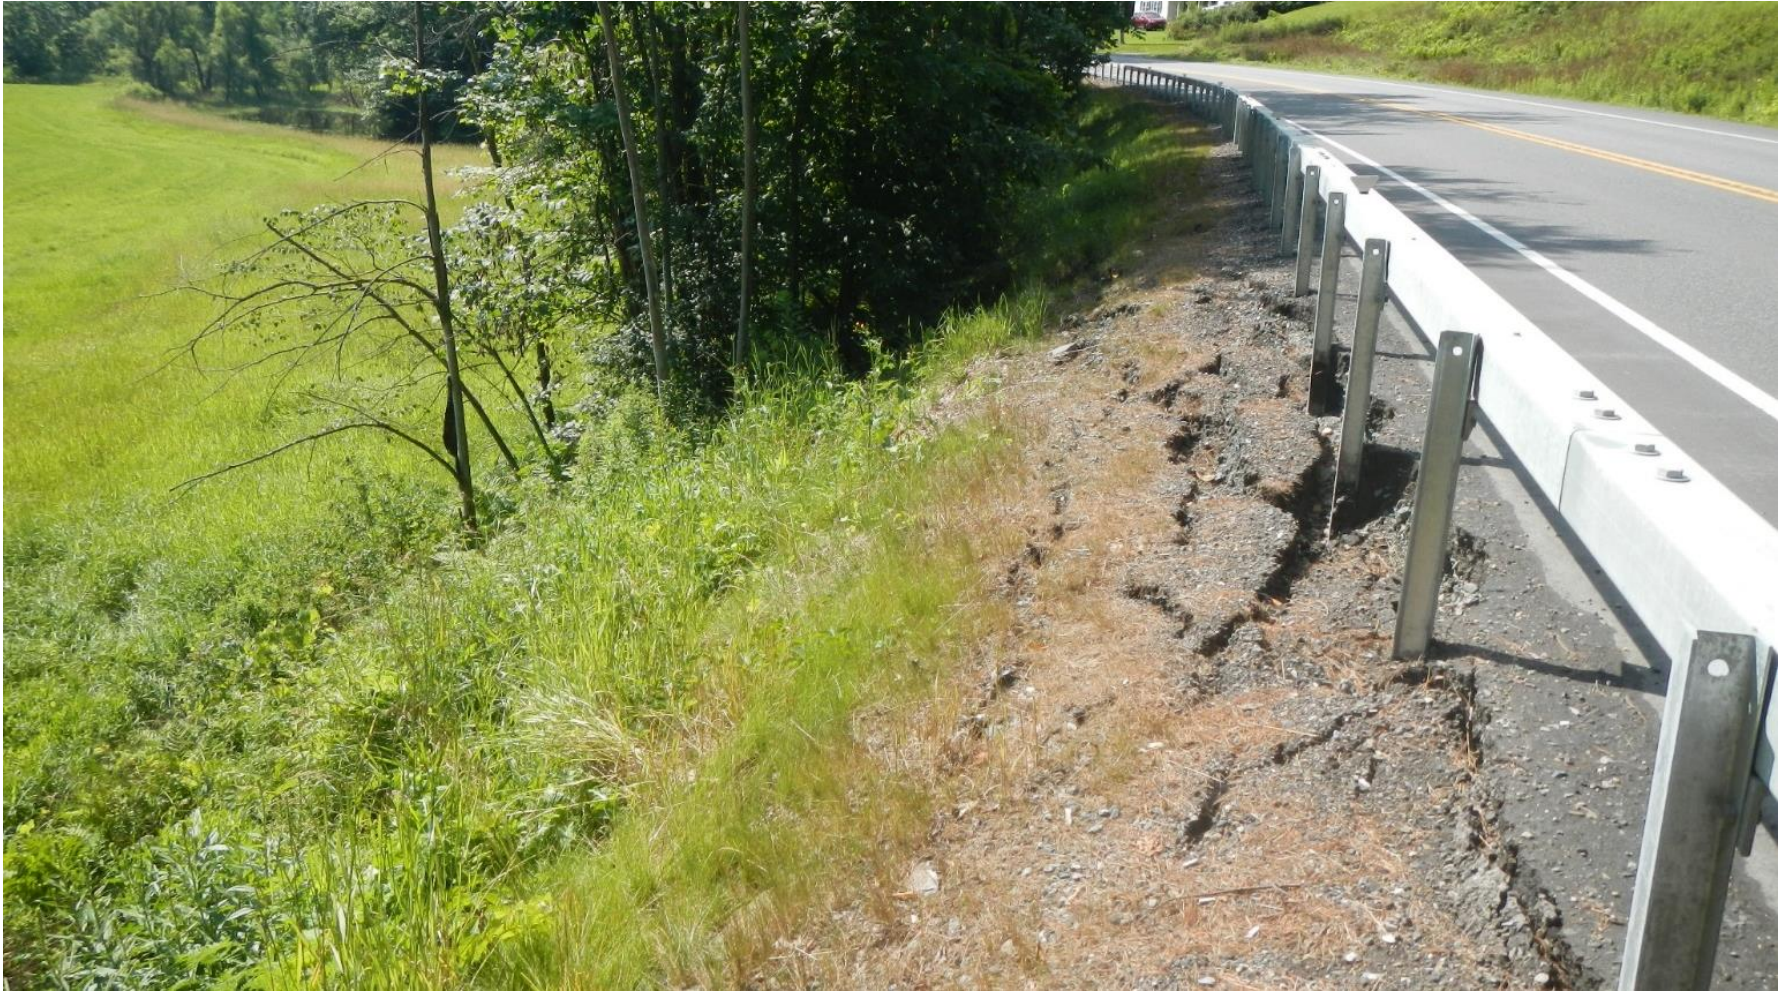
**Figure 1: MM 2.9 Existing Conditions**

At MM 2.9, information from the site visit indicated the stone fill extended approximately 1/3 of the slope height (approximately 10-feet down the slope). The grade of the slope was measured to be approximately 1.2H:1V. A tension crack was noted along the guardrail posts and a surficial failure was observed along the upper portion of the slope. Grassy vegetation was noted past the stone fill, but no mature trees were seen in this section of the slope, as seen in Figure 1. The toe of this slope generally transitions to a level meadow. The lateral limits of the slope instability were measured to be approximately 75 feet and span from Sta. 1+40 to Sta. 2+15.

A 2H:1V regrade with granular borrow is recommended at this site, as seen in Figure 27. This typical should begin around Station 1+40 and extend to approximately Station 2+15, using VTrans' initial survey stationing. The upper portion of this regrade should begin at an offset of 17 feet from centerline and transition down slope on a 2H:1V grade. The slope should be re-graded using Granular Borrow (Item 203.32). We recommend the existing slope surface be benched, according to VTrans Standard Drawing B-5 to facilitate compaction and provide a stronger interface layer. A 6 inch layer of topsoil and seed should be added to the slope to re-establish vegetation. A 6-inch underdrain should be installed along the toe of the slope, as detailed in Figure 26.

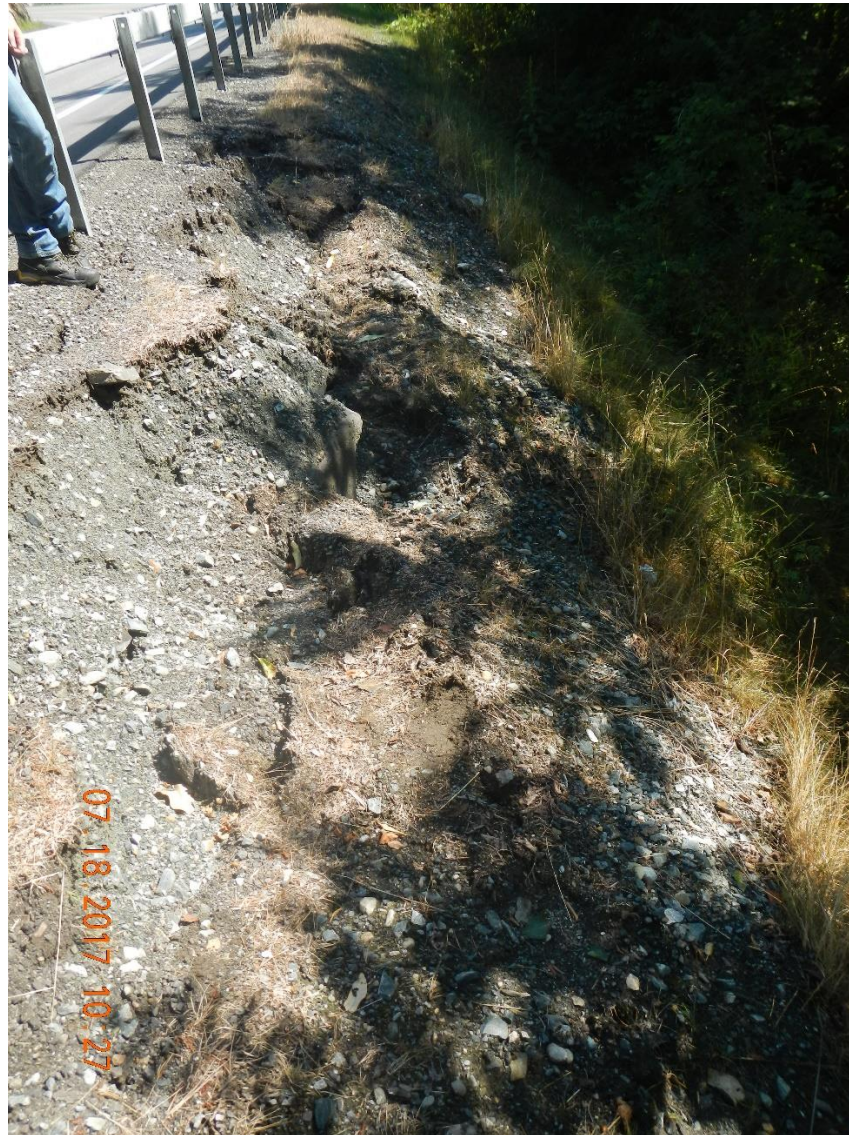
**Figure 2: MM 6.0 Existing Conditions**

At MM 6.0, information from the site visit indicated the stone fill extended approximately 6-feet down the slope from the crest. The grade of the slope was measured to be approximately 1.15H:1V with portions as steep as a 1H:1V. A tension crack was noted just outside the guardrail posts in the shoulder material and a surficial failure was noted along the upper portion of the slope, as seen in Figure 2. Grassy vegetation was noted past the stone fill to the approximate bottom of the failure surface. A 3-foot by 3-foot box culvert was noted at the toe of the slope, as seen in Figure 3, with a stream flowing parallel to the roadway. Two delineator posts were found on either side of the roadway at this embankment, and it was later confirmed by Jack Holding of VTTrans on April 4, 2018 that these posts marked the approximate limits of a 15-inch reinforced concrete pipe (RCP). The lateral limits of the slope instability were measured to be approximately 150 feet and span from Sta. 0+60 to Sta. 2+10.

A 1.5H:1V regrade with Type II stone fill is recommended at this site, as seen in Figure 28. This typical should begin around Station 0+60 and extend to approximately Station 2+10, using VTrans' initial survey stationing. The upper portion of this regrade should begin at an offset of 19 feet from centerline and transition down slope on a 1.5H:1V grade. Three (3) feet of Type II stone fill should be placed along the upper 13 feet (measured vertically from the top of the slope), followed by a 5 foot layer of Type II stone fill to the toe of slope. An additional 4-foot berm (measured horizontally) of Type II stone fill should be added along the bottom 9 feet of the slope to increase the counterweight along the toe of the slope. There is a 3' x 3' box culvert that currently outlets onto the existing slope as well as a 15-inch reinforced concrete pipe (RCP) culvert that outlets near the toe of slope. VTrans found the 15-inch RCP culvert is plugged with sediment about 18 feet in from the inlet. We recommend this pipe be flushed prior to construction of the regrade at this site. VTrans has performed a hydraulic analysis of both culverts and found they are both suitable candidates for extensions. We have shown these extensions on the typical sections. Golder understands that VTrans will perform the final design and detailing of these culvert extensions.

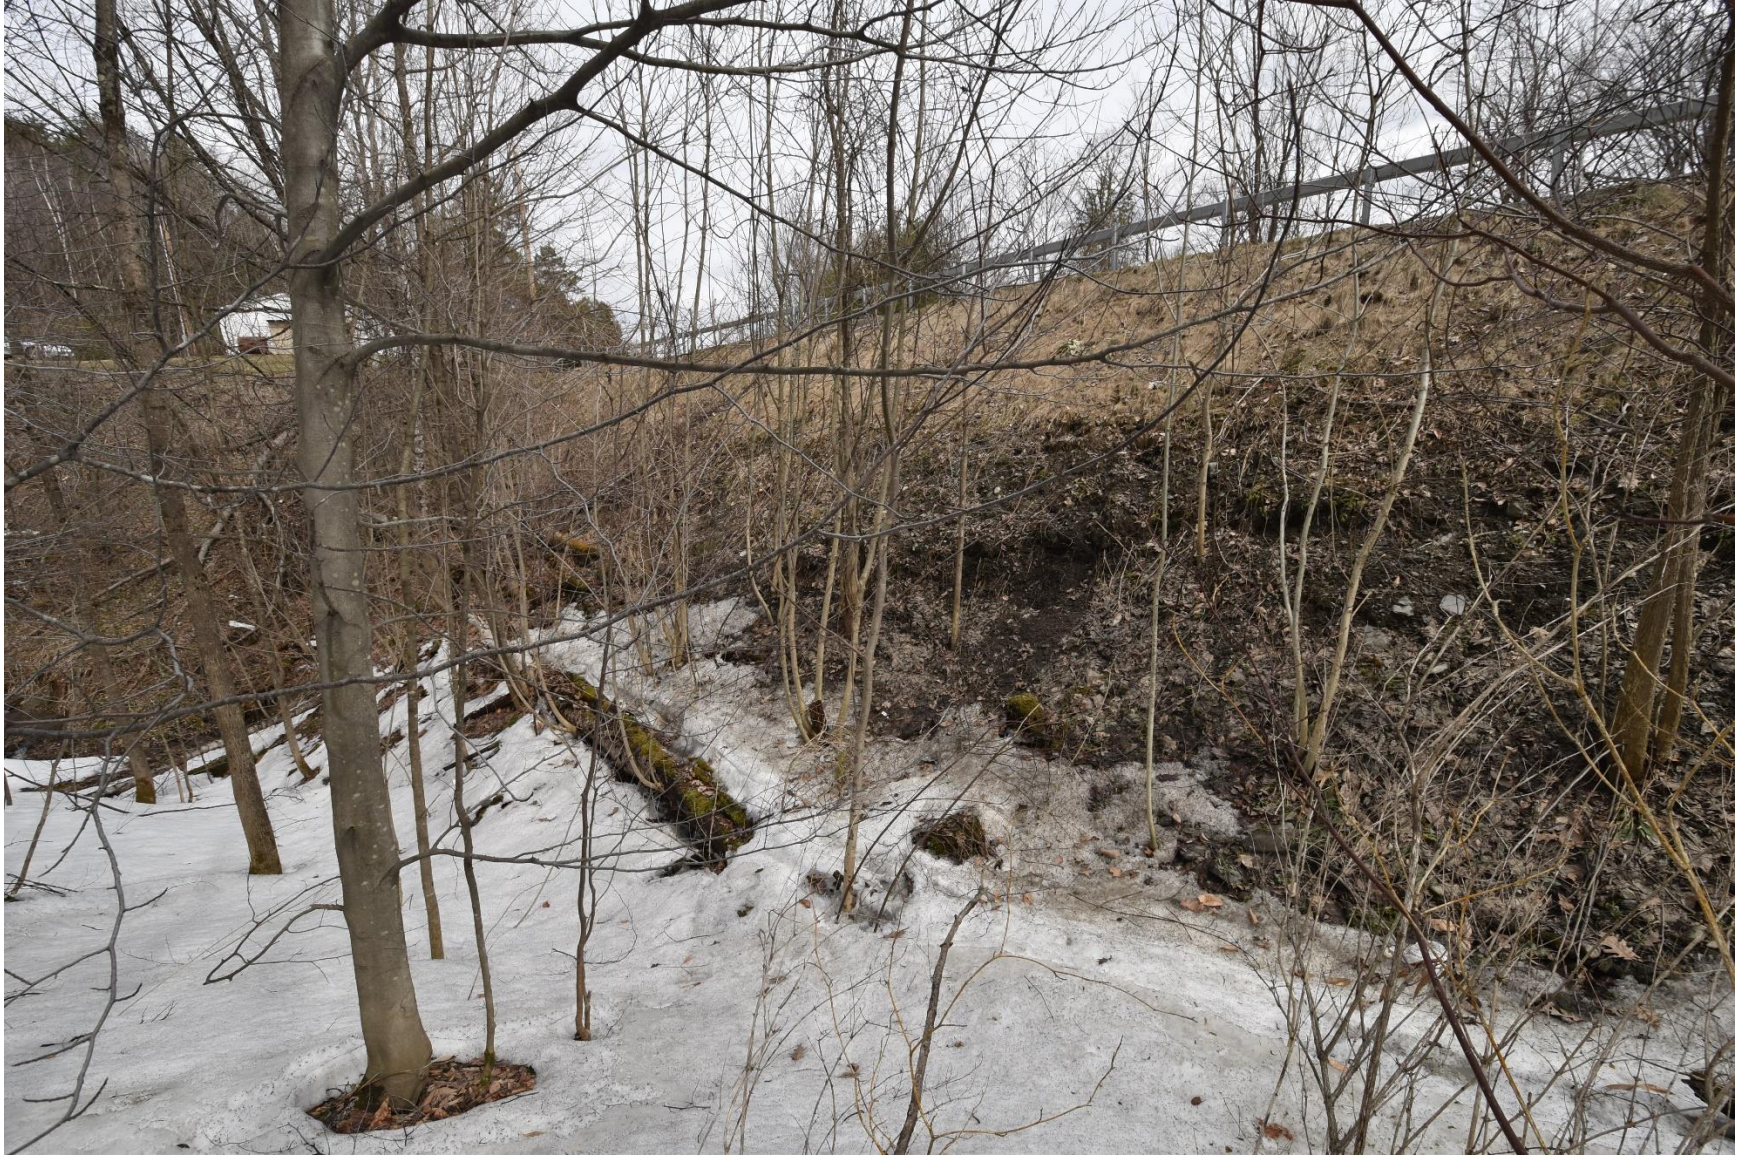
Figure 4: MM 6.28 Surficial Failure at Toe of Slope

At MM 6.28, the ground was generally snow covered during our February 2018 site visit. Information from the survey indicated the lateral limits of the slope instability are approximately 140 feet which was used in the alternatives analysis. During a subsequent site visit performed on April 12, 2018, Golder noted a small surficial failure near the toe of the slope, as seen in Figure 4, but no cracking was evident adjacent to the guardrail posts. The slope was measured to be graded to approximately a 1.3H:1V and was heavily vegetated except for the small surficial failure near the toe of the slope. The lateral limits of the surficial failure were measured to be approximately 50 feet and span from Sta. 116+00 to Sta. 116+50 (using the datum from the survey provided on April 18, 2018). The April 18, 2018 survey datum was used as that survey picked up more detail along the toe of the slope; however, this corresponds to Sta. 5+29 to Sta. 5+79 using the original survey stationing.

After a review of the existing slope conditions and a discussion with VTrans, we recommend only a spot treatment of stone fill at this site to address some minor soil sloughing along a lower section of a portion of this slope. A 2-foot thick layer of Type II stone fill is recommended along the bottom portion of the slope (from El. 492 to the ditch line) between Sta. 116+00 and Sta. 116+50, using the latest VTrans survey data, to reinforce the slope against further surficial failures. This corresponds to Sta. 5+29 to Sta. 5+79 using the original survey stationing; however, that stationing does not provide as much detail at the toe of the slope. The slope should be cleared of any debris and brush and excavated to the limits shown on Figure 28, lined with a geotextile, and then armored with Type II stone fill to match the existing slope grade. Golder understands that VTrans recognizes that the global factor of safety of this slope will be less than 1.3 after the repair has been completed but has accepted the nominal risk associated with this condition. Golder recommends that the area foreman continue to monitor this section of roadway for pavement distress including longitudinal cracking and deformations (settlement).

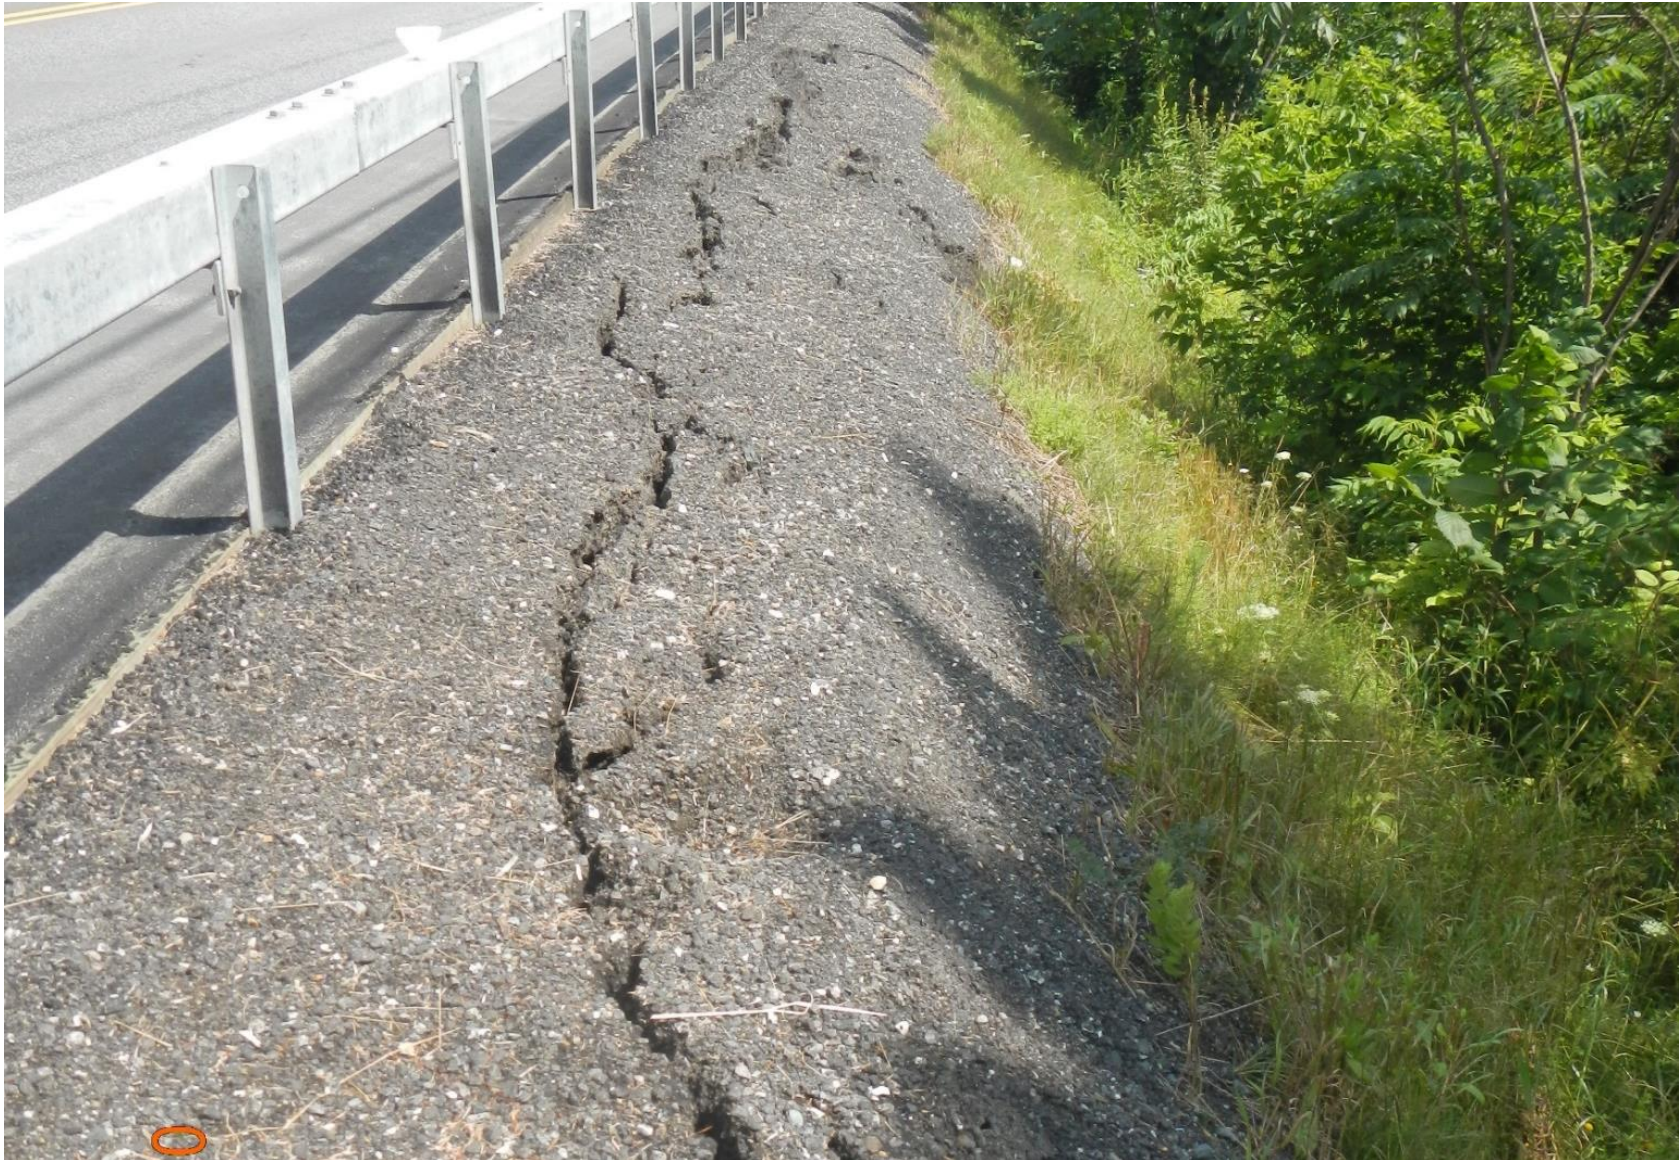
Figure 5: MM 6.35 Existing Conditions

At MM 6.35, information from the site visit indicated the stone fill extended approximately ¼ of the slope height (approximately 12-feet down the slope) and the slope has a current grade of around 1.15H:1V at its steepest section. A crescent shaped tension crack was noted parallel to the guardrail posts, approximately 60 feet long, and a surficial failure was noted around the upper portion of the slope, as seen in Figure 5. Grassy vegetation and small underbrush was noted past the stone fill to the bottom of the slope. Remnants of an 18-inch RCP were noted at

the toe of the slope with water still flowing around the exposed rebar. It was later confirmed by Michelle Redmond on May 3, 2018 that at 73 feet in from the inlet, the culvert invert is fully deteriorated and water is flowing on the embankment soil. The lateral limits of the slope instability were measured to be approximately 150 feet and span from Sta. 0+90 to Sta. 2+40.

A 2H:1V regrade with granular borrow is recommended at this site, as seen in Figure 29. This typical should begin around Station 0+90 and extend to approximately Station 2+40, using VTrans' initial survey stationing. The upper portion of this regrade should begin at an offset of 17 feet from centerline and transition down slope on a 2H:1V grade. The slope should be re-graded using Granular Borrow (Item 203.32). We recommend the slope be benched, according to VTrans Standard Drawing B-5, to facilitate compaction and provide a stronger interface layer. A 6 inch layer of topsoil and seed should be added to the slope to re-establish vegetation. A 6-inch underdrain should be installed along the toe of the slope, as detailed in Figure 29.

At the location of the failed 18-inch RCP around Sta. 1+60, we recommend a new 24-inch pipe be installed using trenchless methods to limit impacts to the pavement structure and the traveling public. The invert of the new pipe should be installed at elevation 502.6 (at the inlet) to be below the existing laterals (6-inch underdrain with an invert elevation (at the inlet) of 507.3 and 15-inch HDPE with an invert elevation (at the inlet) of 503.6). The new pipe should be sloped at ¼" per foot. Pipe material should consist of either centrifugally cast fiberglass reinforced polymer mortar pipe (CCFRPM), reinforced concrete pipe (RCP), corrugated polyethylene pipe (CPEP), or steel pipe. A stone drainage swale at the outlet, lined with a geotextile, is recommended as detailed in Figure 29A. We recommend the failed 18-inch RCP be filled with Controlled Density (Flowable) Fill (Item 541.45) prior to construction of the regrade at this site. As requested by VTrans, Golder will provide special provisions for the trenchless excavation and culvert installation as a separate document to this report.

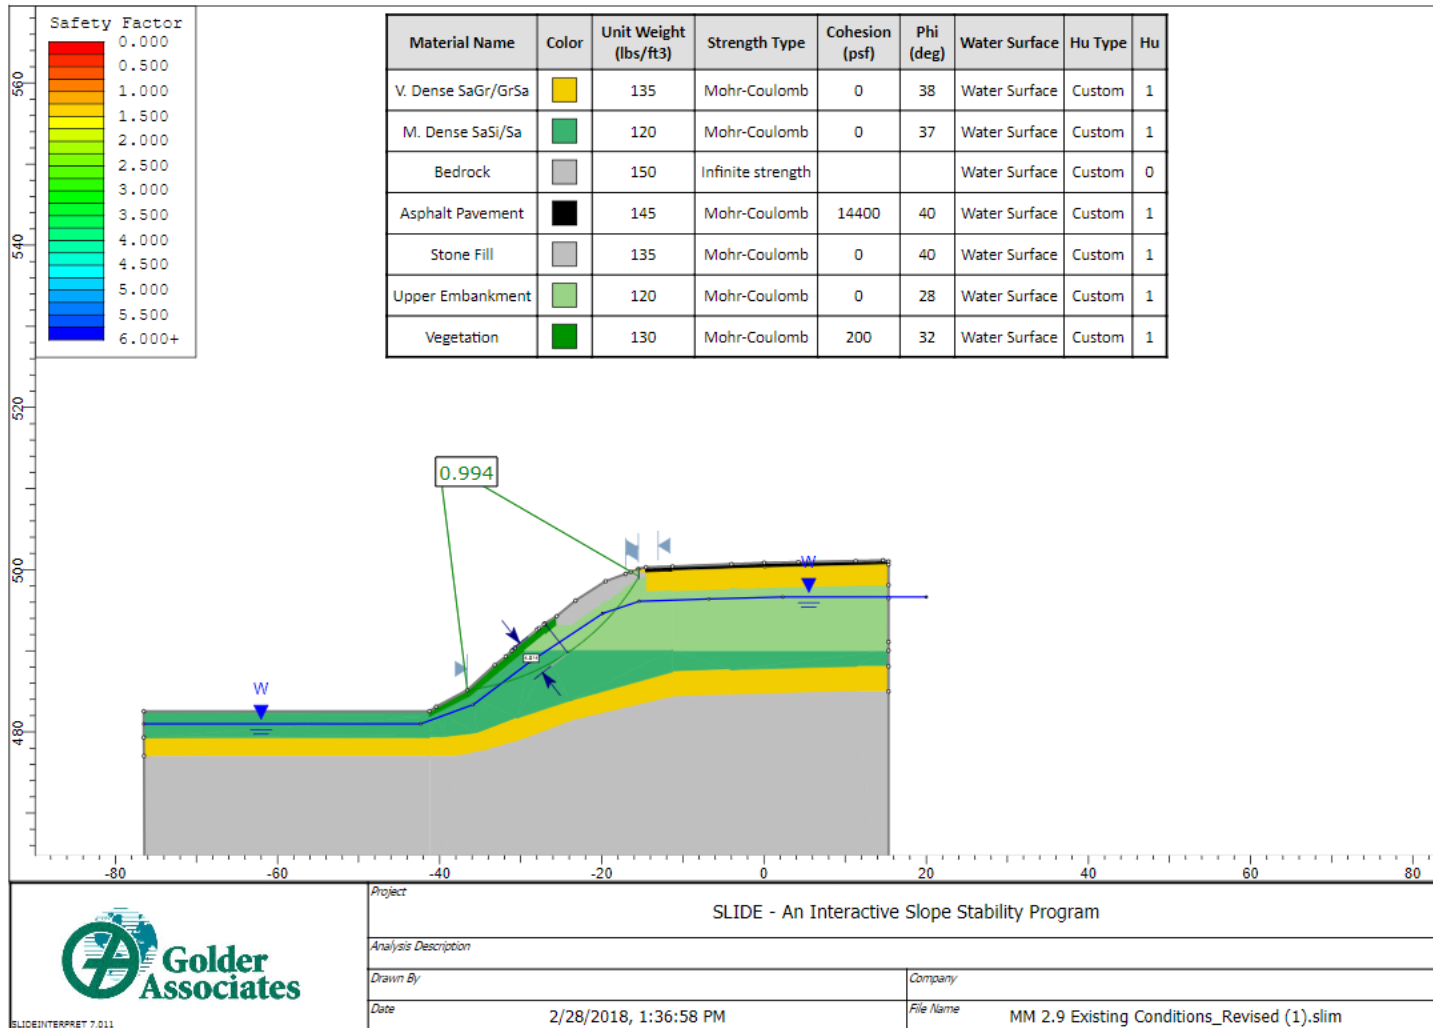
Figure 6: MM 2.9 Initial Conditions

For the existing condition models, the global factor of safety (FS) of close to 1.0 was targeted in order to model imminent failure conditions and refine the soil and groundwater properties used in the analyses (see Figures 6, 11, 16, and 21). A water filled tension crack was modelled at the observed head scarps at MM 2.9, 6.0, and 6.35 to account for the influx of rainwater from the July 2017 storm event and the field conditions observed. Results for the existing conditions models are summarized in Table 1 below.

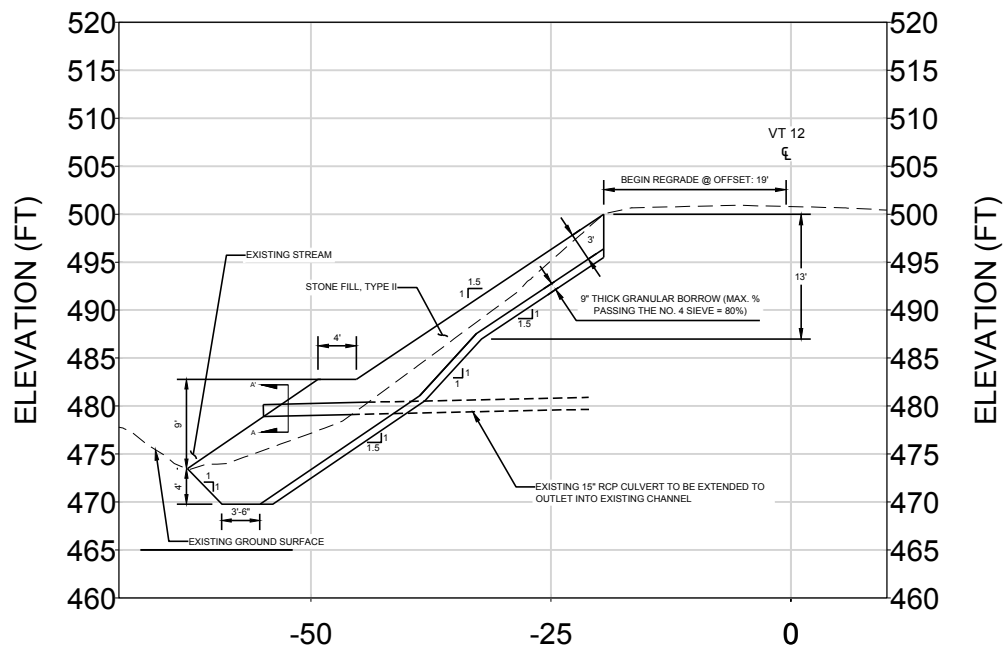
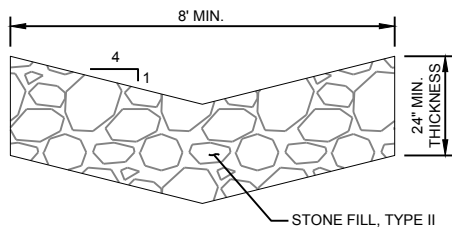
**TYPICAL SECTION - MM 6.0 AT RCP CULVERT CROSSING**

- Existing 15" RCP is plugged with sediment approximately 18 feet in from the inlet and should be flushed prior to the regrade construction at this location.
- Slope excavation and construction shall be performed in segments (maximum 25 feet) along this slope. No excavations shall be left open overnight or on weekends.
