**State of Vermont
Highway Division**

Date: October 9, 2023

Subject: Montpelier – Waterbury IM 089-2(56) Asphalt Core Analysis

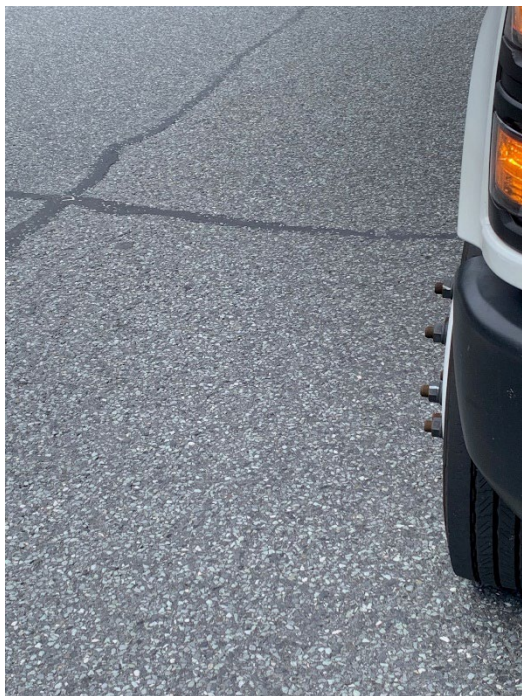
Surface Distresses at MM 52.85, Left Lane; photograph taken in front of drilling rig.

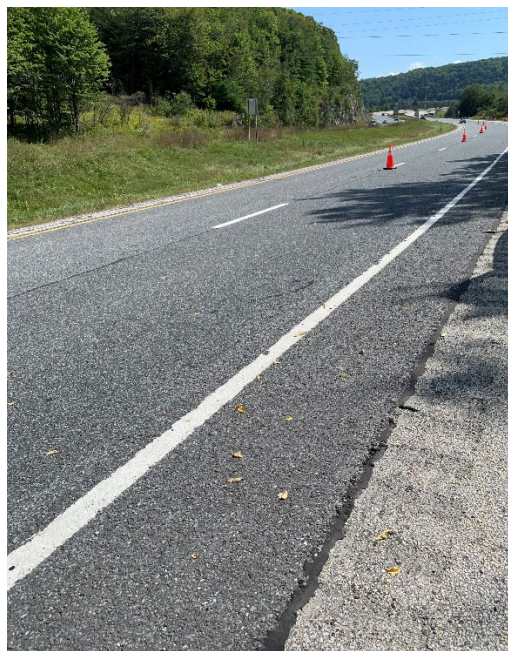
Surface Distresses at MM 52.85, Right Lane

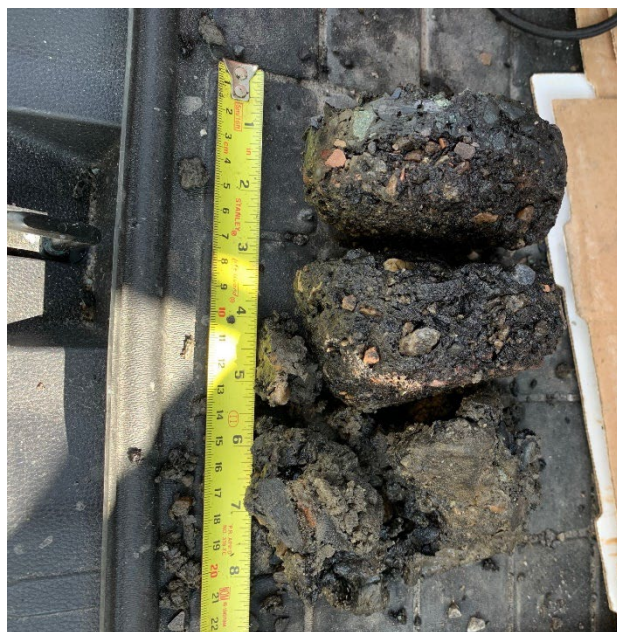
Asphalt core extracted at MM 52.85, Left Lane

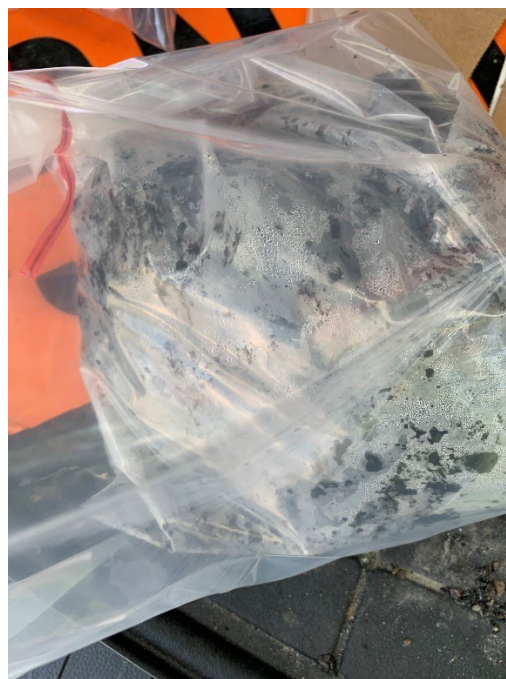
Asphalt core extracted at MM 52.85, Right Lane. The core completely disintegrated when extracted.

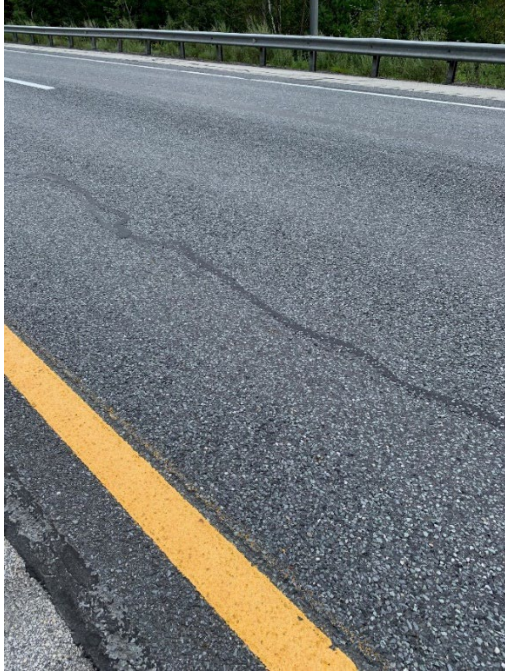
Surface Distresses at MM 54.0, Left Lane

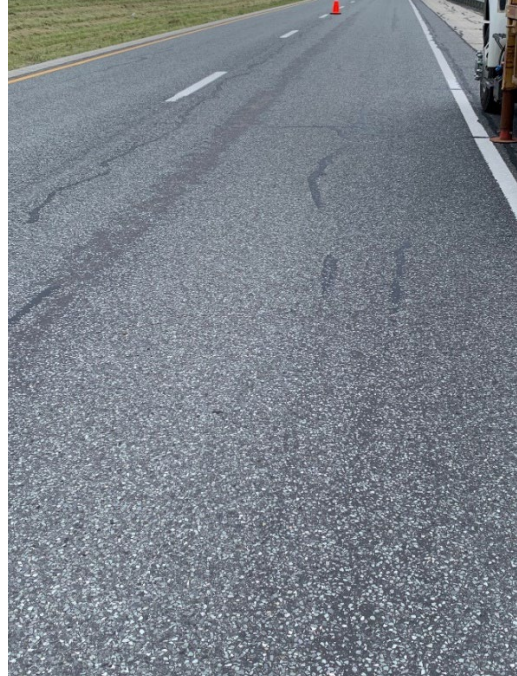
Surface Distresses at MM 54.0, Right Lane

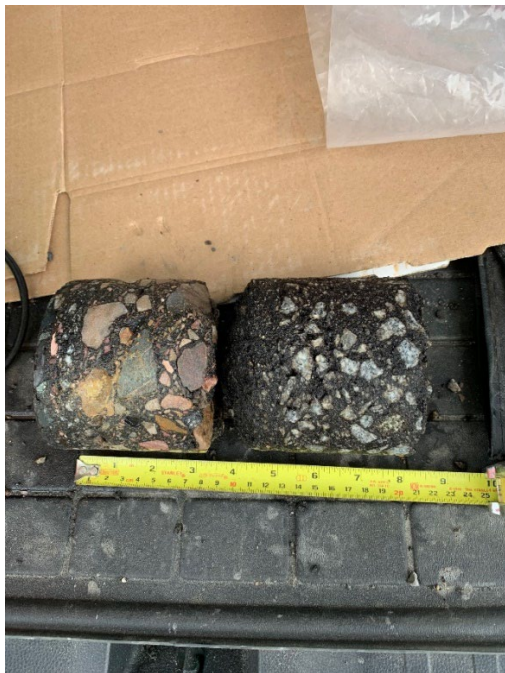
Asphalt core extracted at MM 54.0, Left Lane

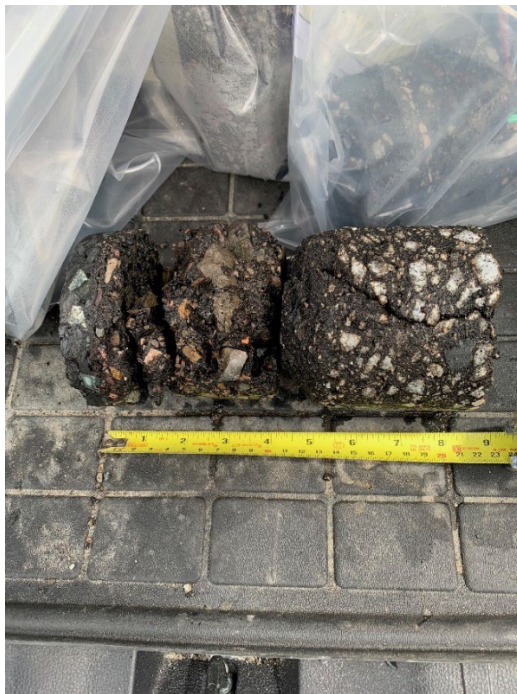
Asphalt core extracted at MM 54.0, Right Lane.

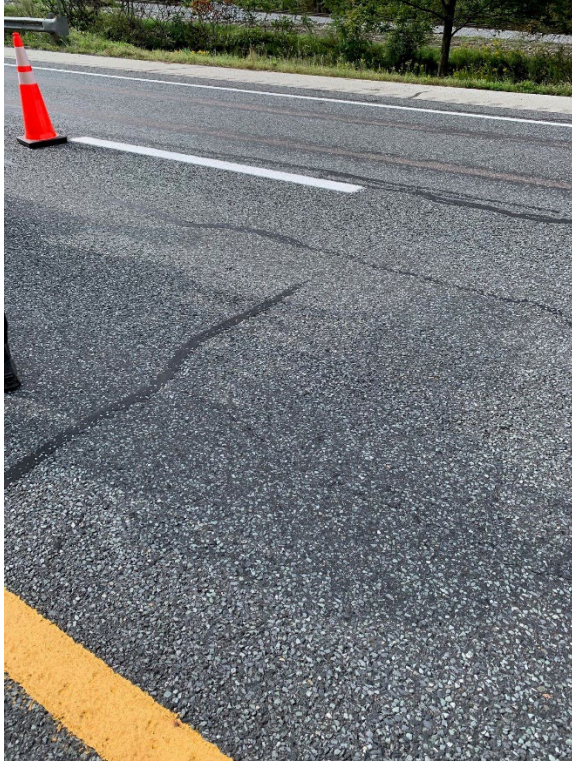
Surface Distresses at MM 55.0, Left Lane

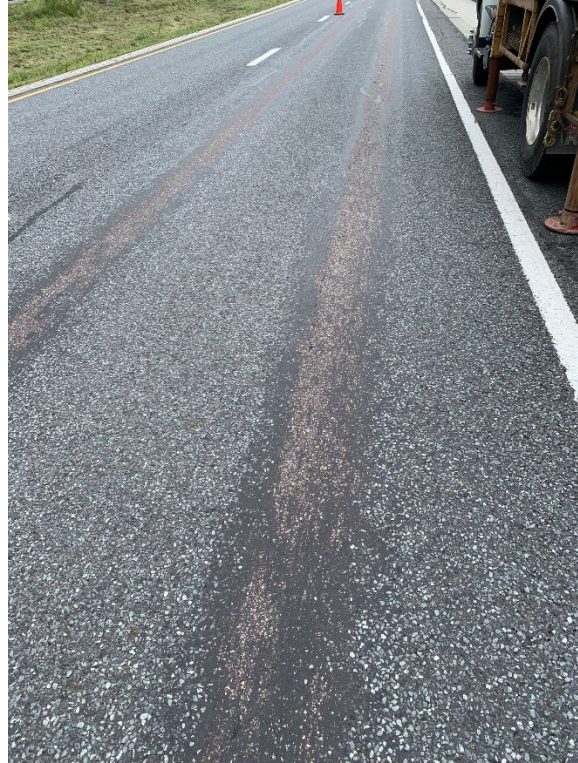
Surface Distresses at MM 55.0, Right Lane

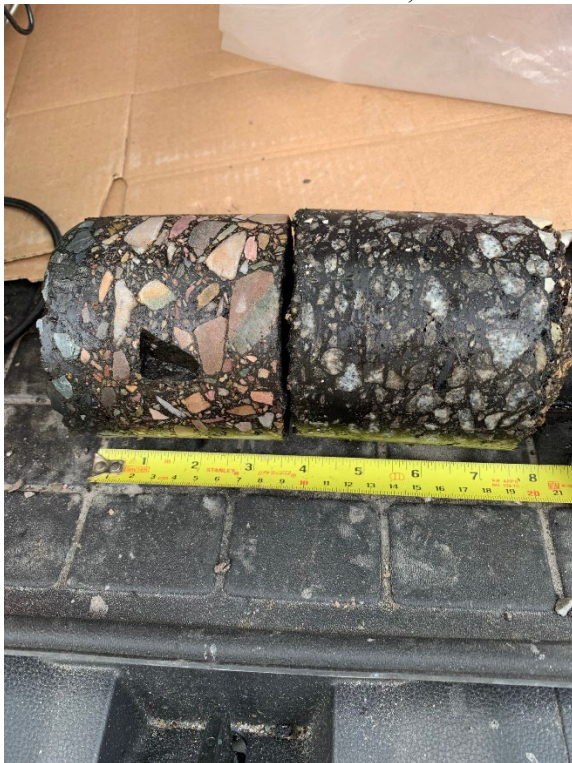
Asphalt core extracted at MM 55.0, Left Lane

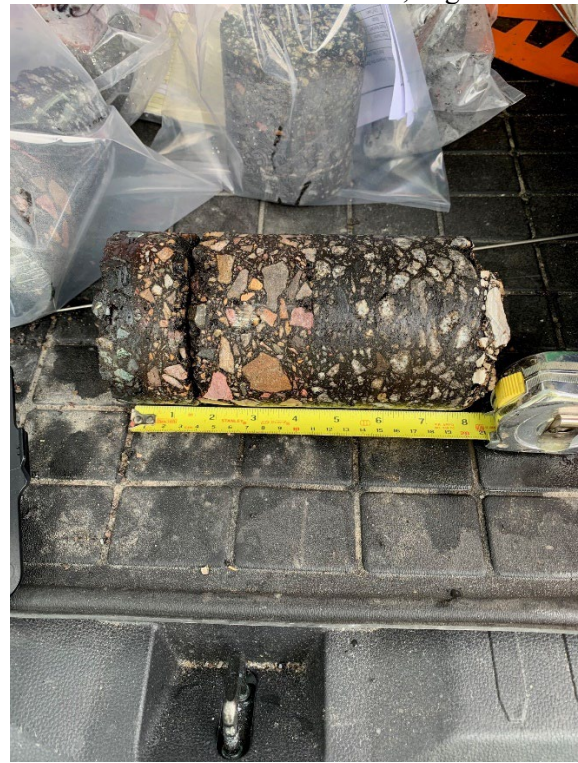
Asphalt core extracted at MM 55.0, Right Lane

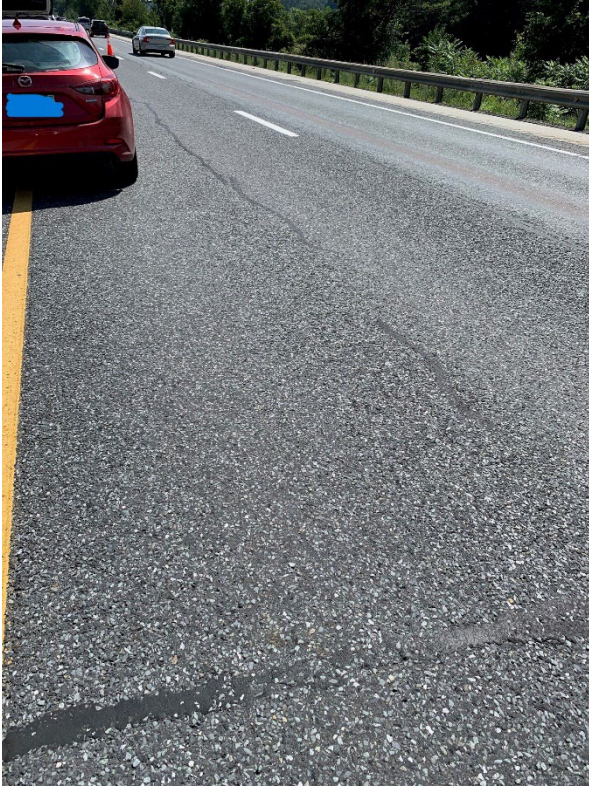
Surface Distresses at MM 56.0, Left Lane

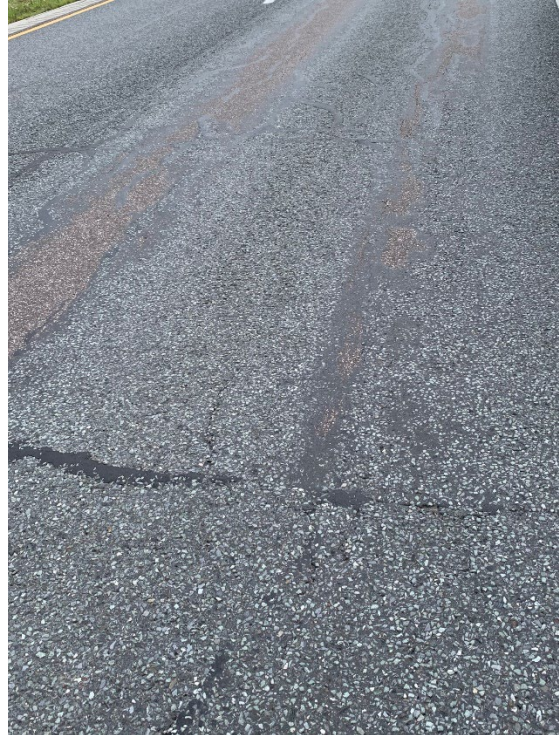
Surface Distresses at MM 56.0, Right Lane.

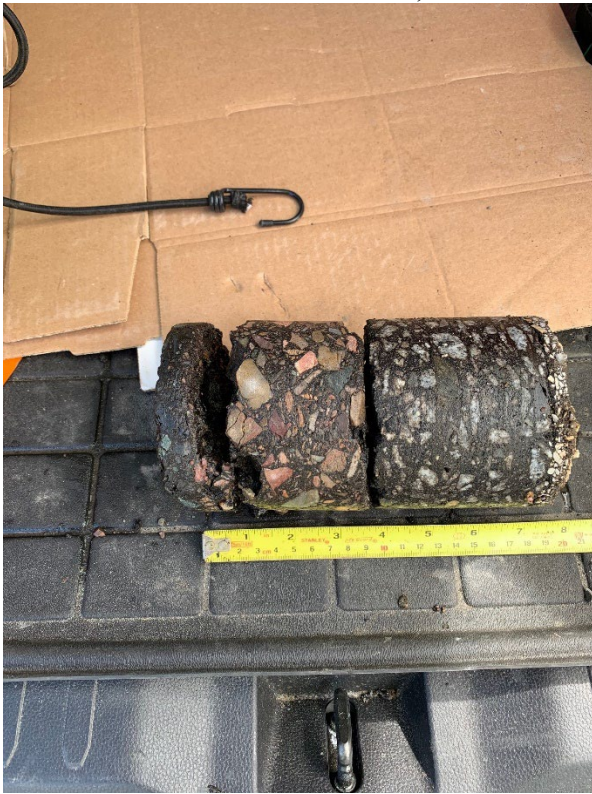
Asphalt core extracted at MM 56.0, Left Lane.

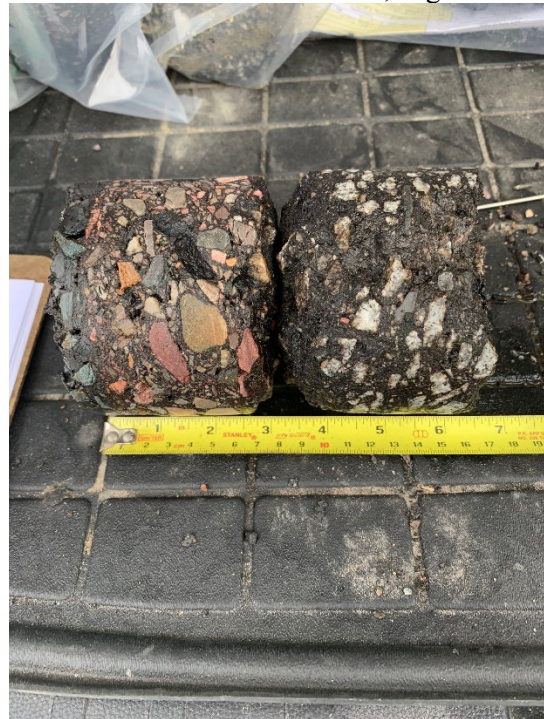
Asphalt core extracted at MM 56.0, Right Lane.

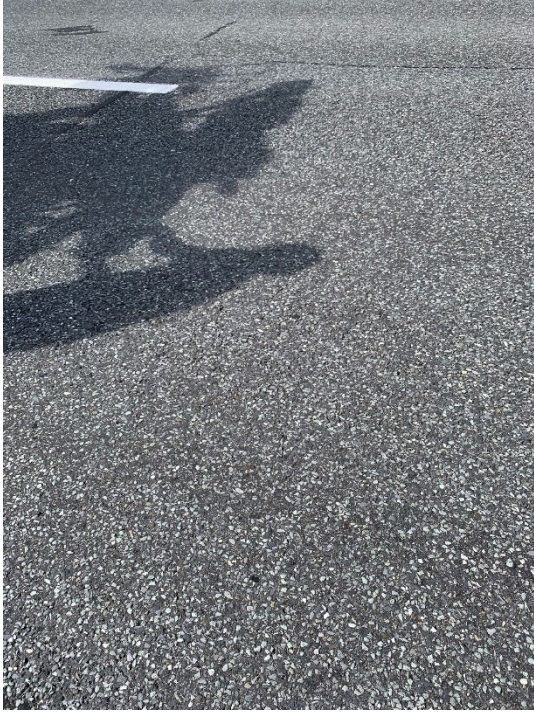
Surface Distresses at MM 57.0, Left Lane

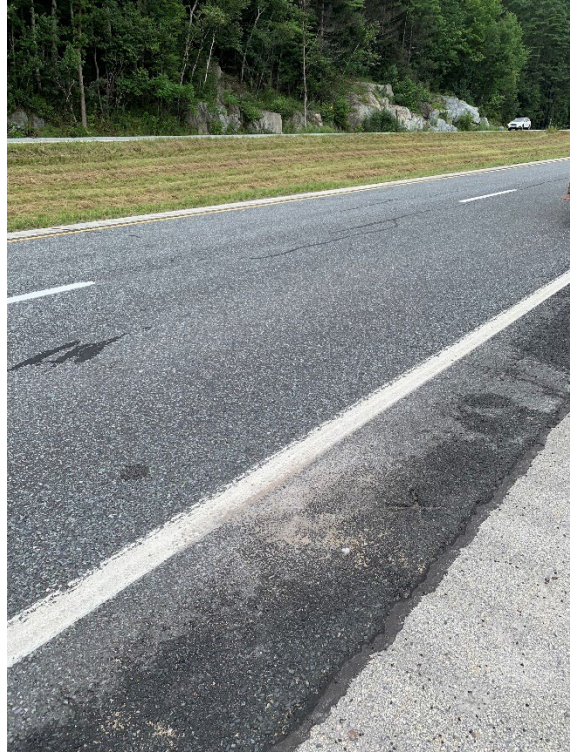
Surface Distresses at MM 57.0, Right Lane

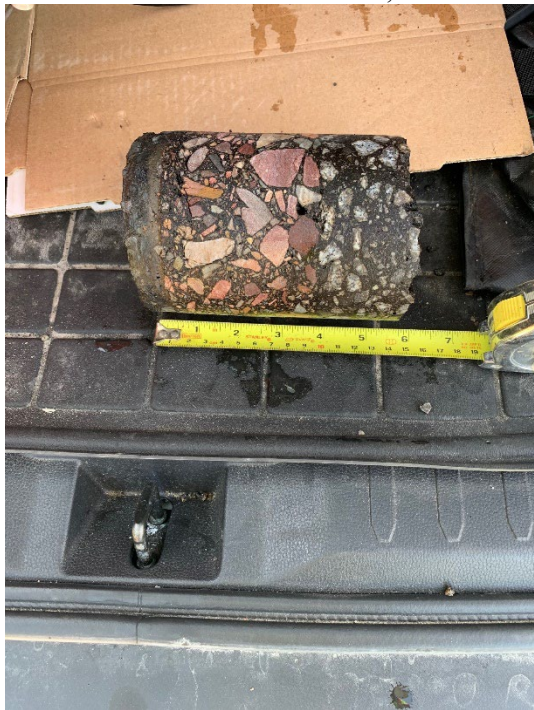
Asphalt core extracted at MM 57.0, Left Lane

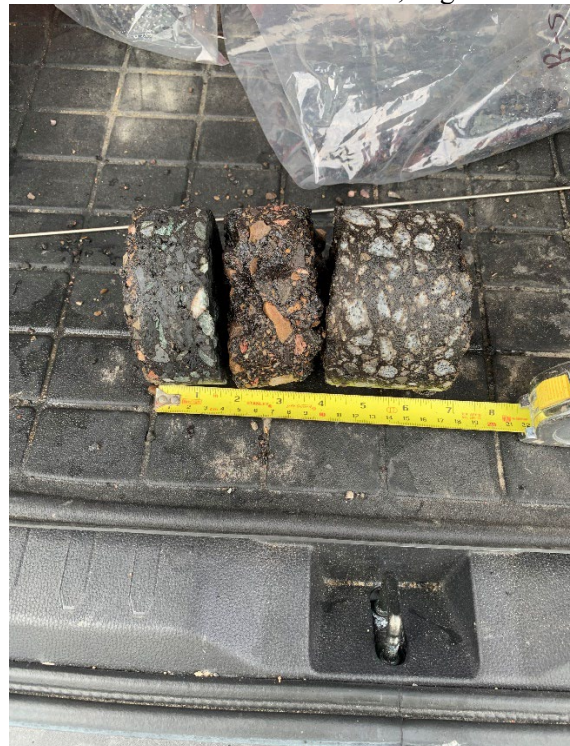
Asphalt core extracted at MM 57.0, Right Lane.

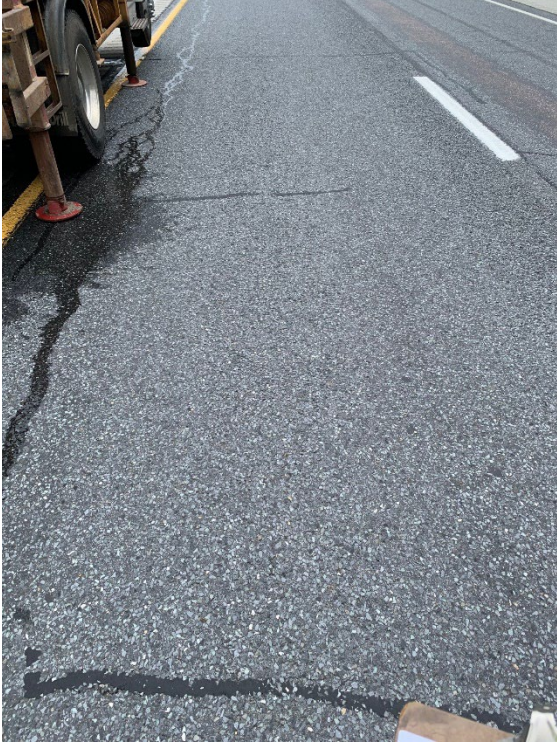
Surface Distresses at MM 58.0, Left Lane

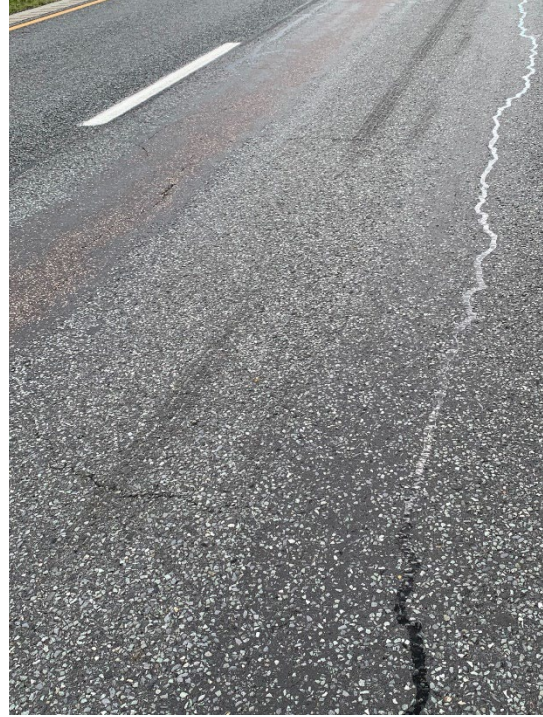
Surface Distresses at MM 58.0, Right Lane

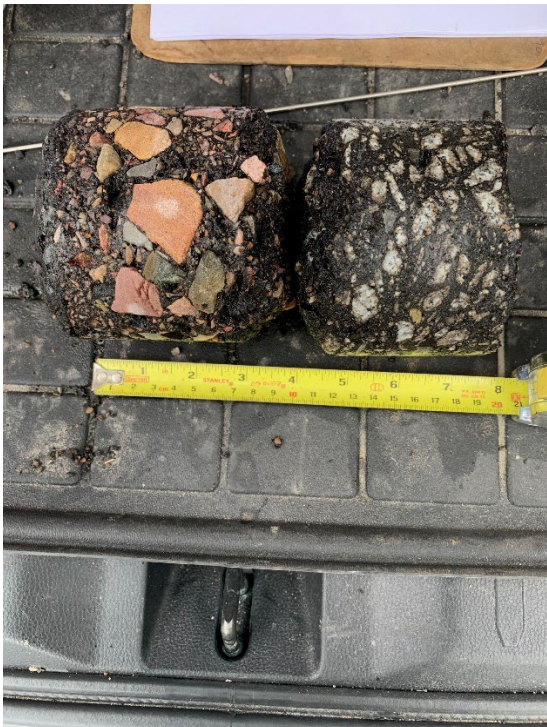
Asphalt core extracted at MM 58.0, Left Lane

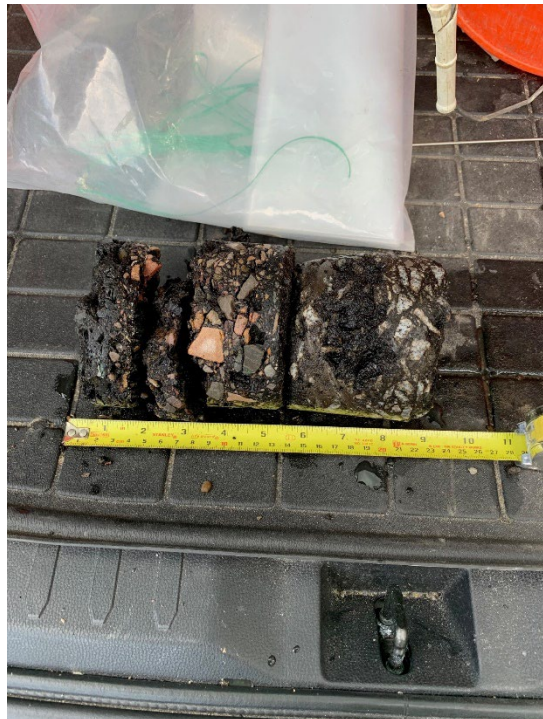
Asphalt core extracted at MM 58.0, Right Lane

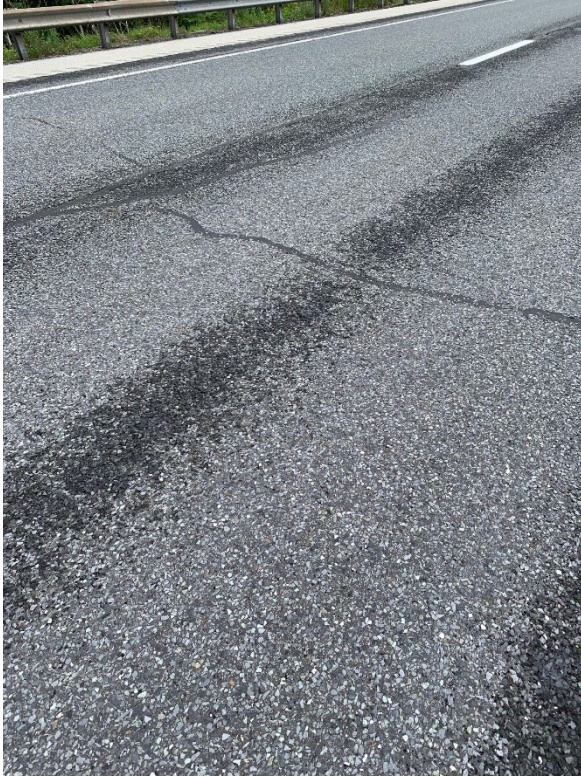
Surface Distresses at MM 59.05, Left Lane

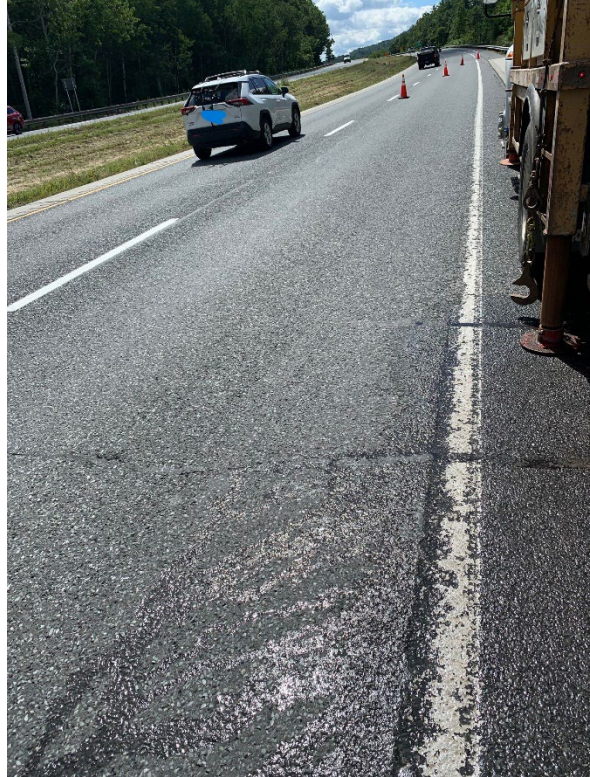
Surface Distresses at MM 59.05, Right Lane

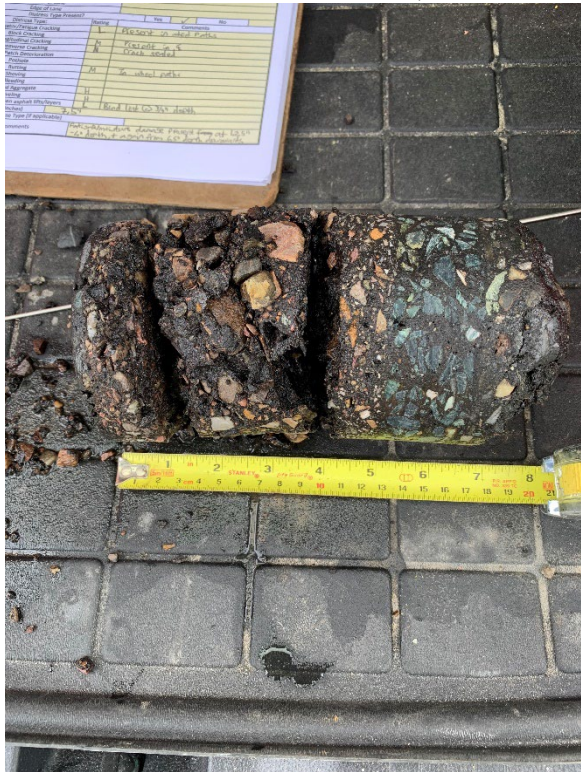
Asphalt core extracted at MM 59.05, Left Lane

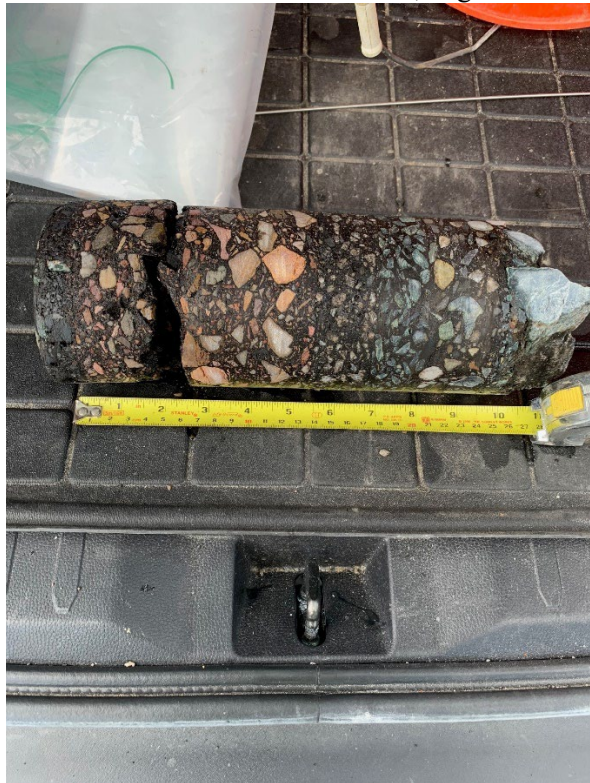
Asphalt core extracted at MM 59.05, Right Lane

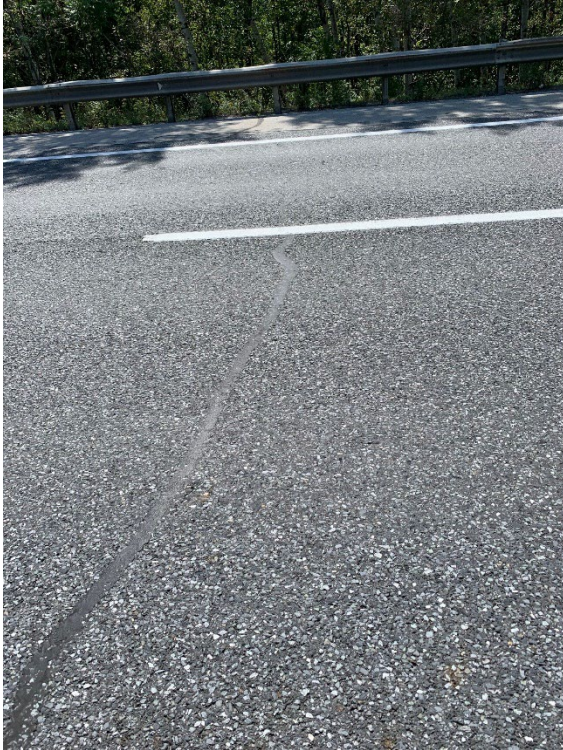
Surface Distresses at MM 60.0, Left Lane

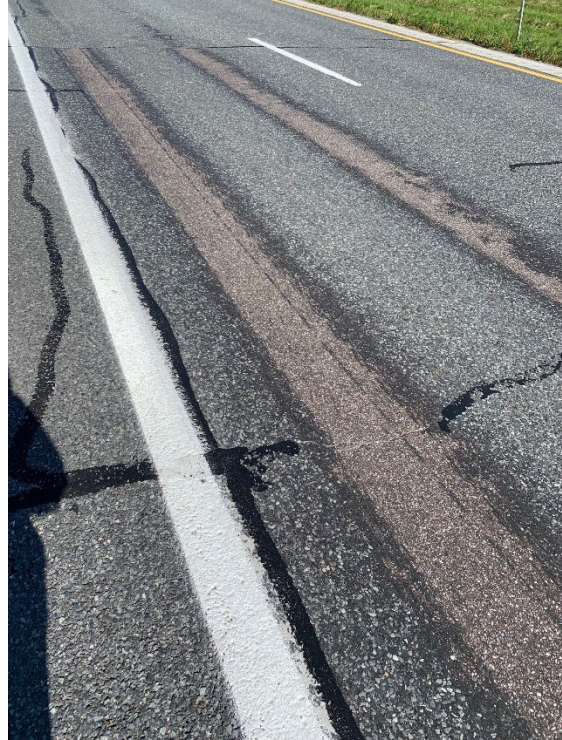
Surface Distresses at MM 60.0, Right Lane

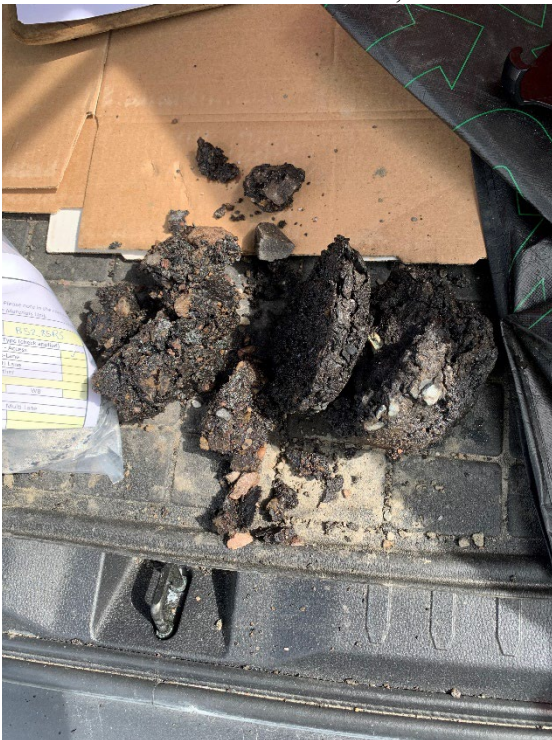
Asphalt core extracted at MM 60.0, Left Lane

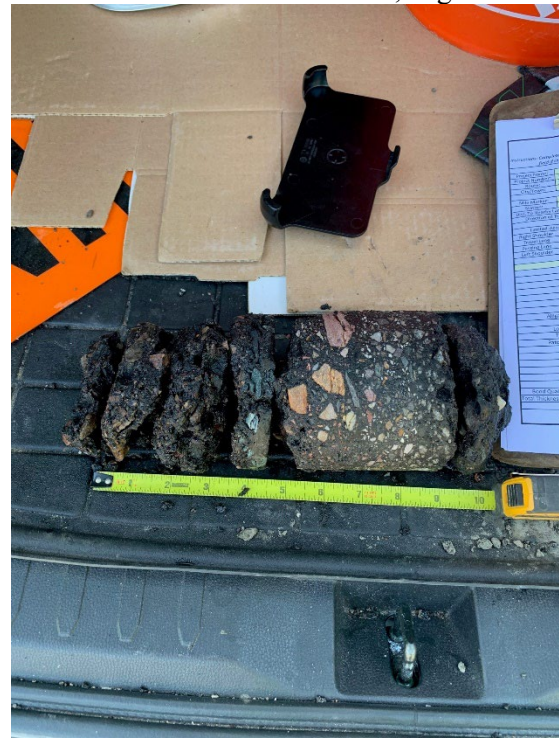
Asphalt core extracted at MM 60.0, Right Lane

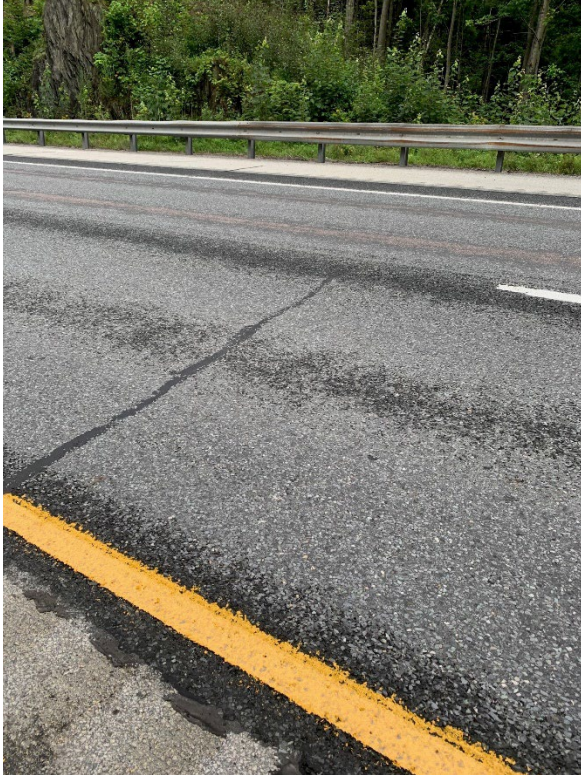
Surface Distresses at MM 61.0, Left Lane

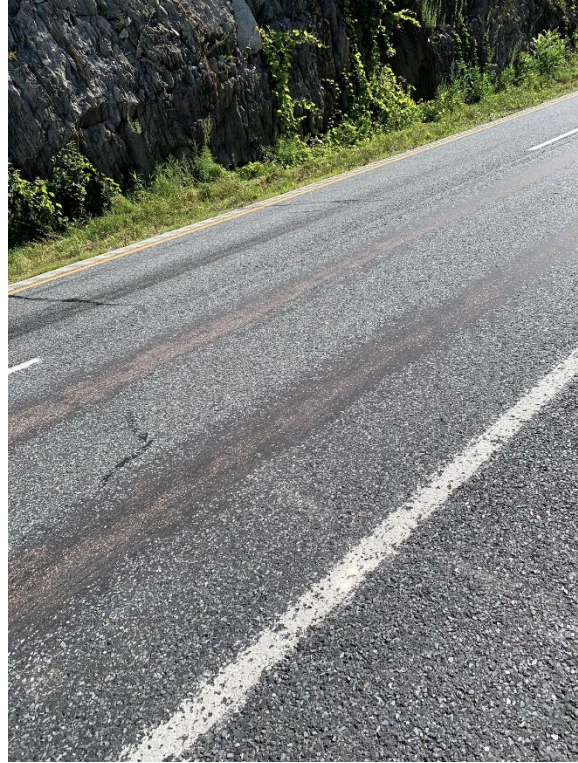
Surface Distresses at MM 61.0, Right Lane

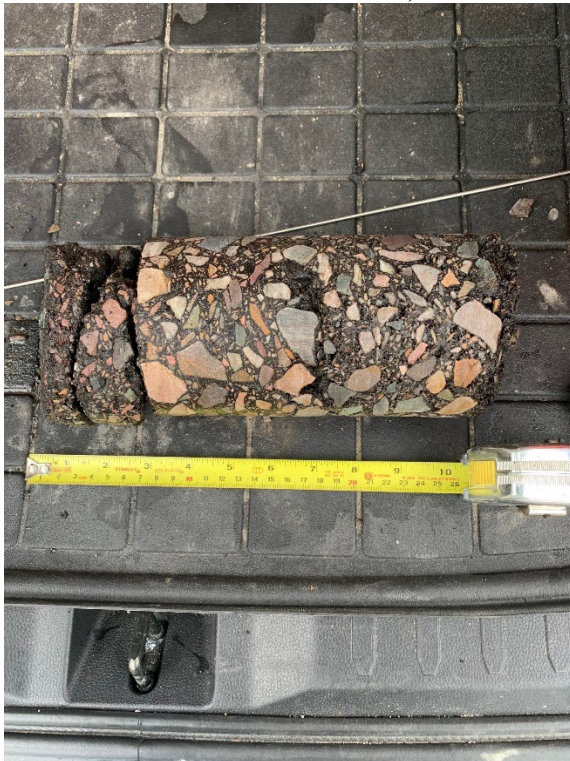
Asphalt core extracted at MM 61.0, Left Lane

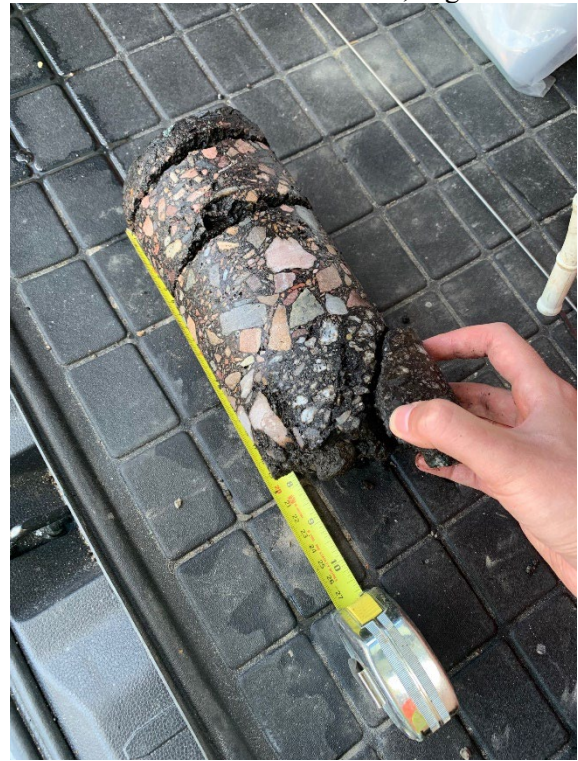
Asphalt core extracted at MM 61.0, Right Lane

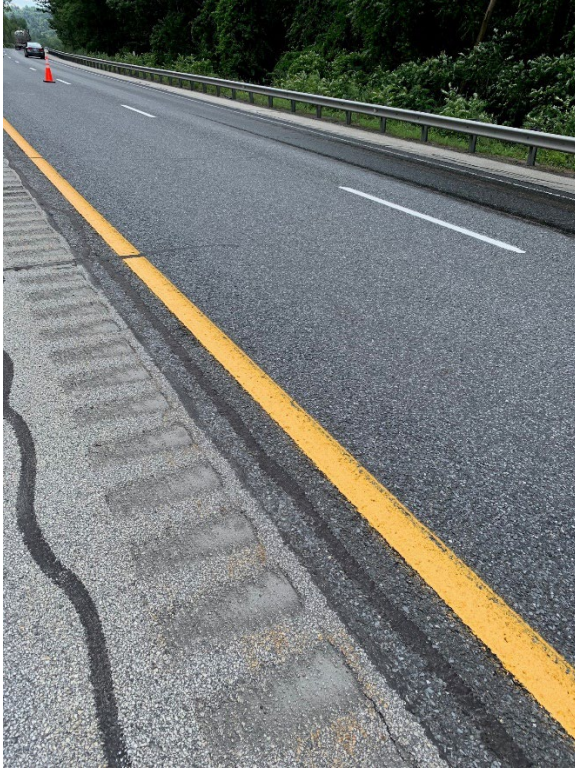
Surface Distresses at MM 62.0, Left Lane

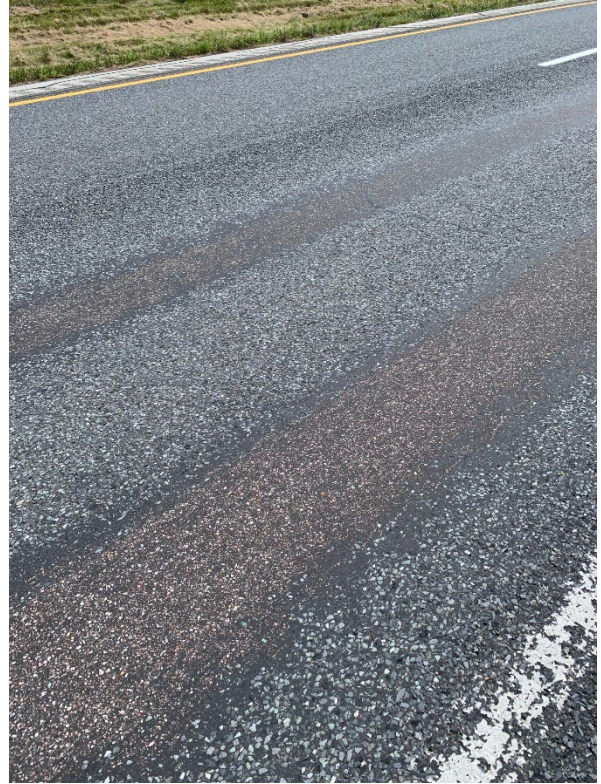
Surface Distresses at MM 62.0, Right Lane

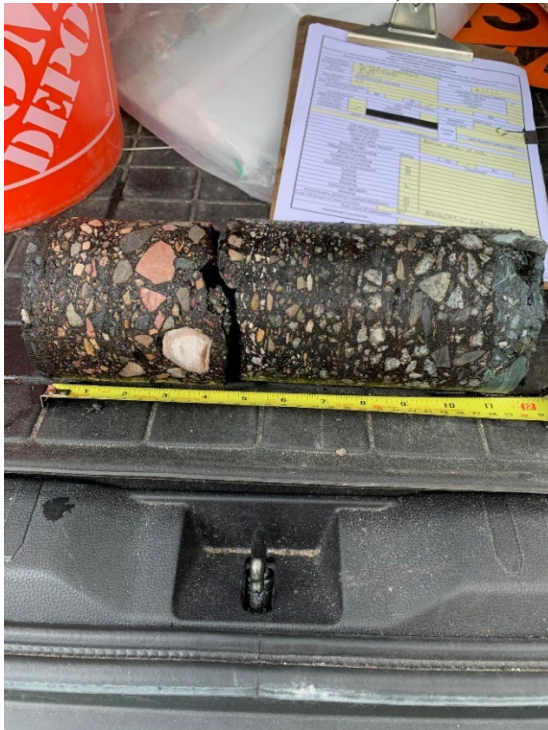
Asphalt core extracted at MM 62.0, Left Lane

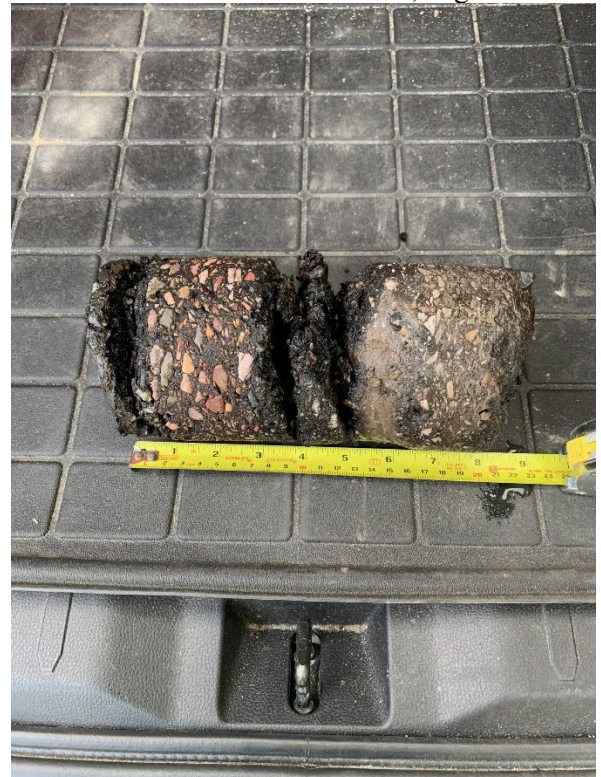
Asphalt core extracted at MM 62.0, Right Lane

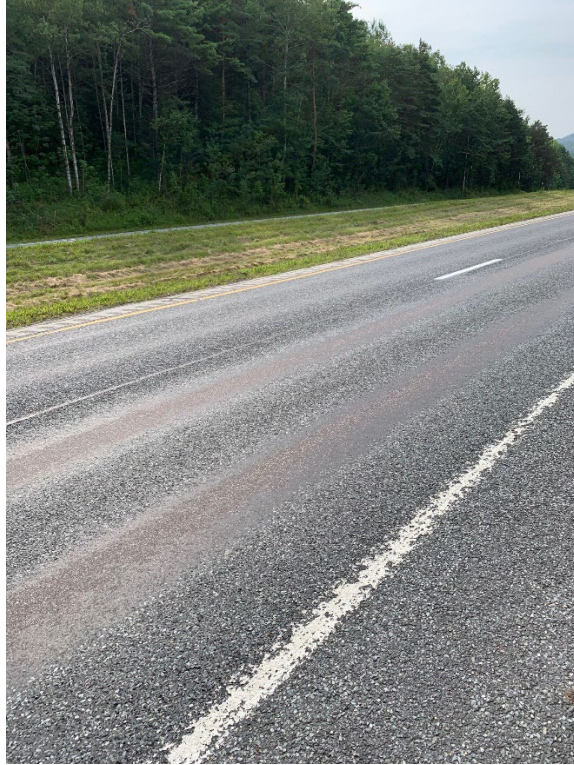
Surface Distresses at MM 63.0

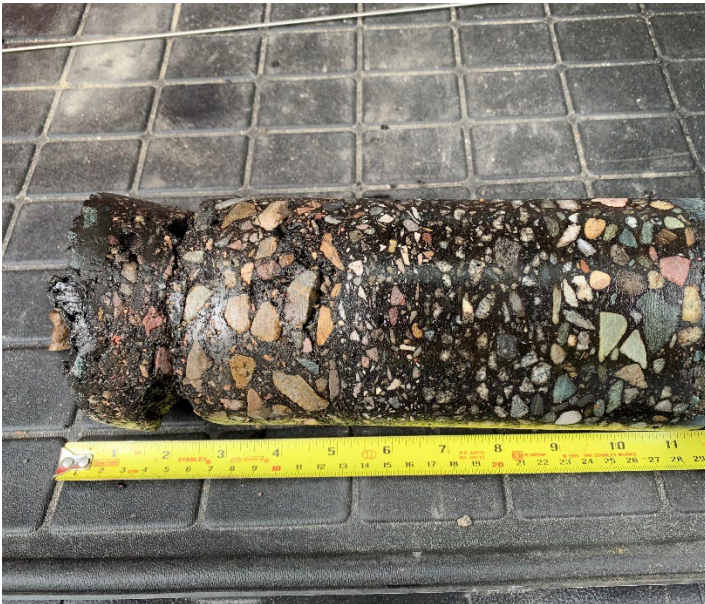
Asphalt core extracted at MM 63.0, Left Lane

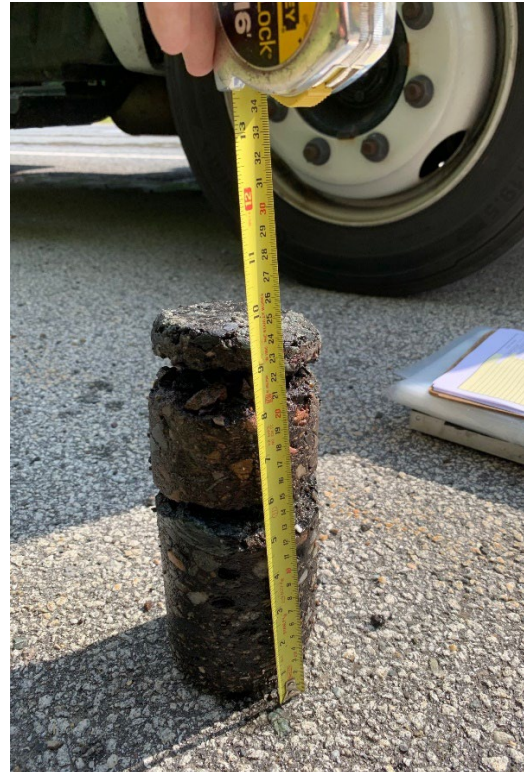
Asphalt core extracted at MM 63.0, Right Lane
