27 January 2025
Internal Project No. 24-09

Subject: Concept Development Report
Phase 3 Rockfall Mitigation Design
I-91 Southbound, Mile Marker 92.55
Fairlee, Vermont

CONCEPTUAL PHASE 3 ROCK SLOPE MITIGATION
FAIRLEE ROCK SLOPE I-91 SB MM 92.55
VTRANS IM 091-2(97)

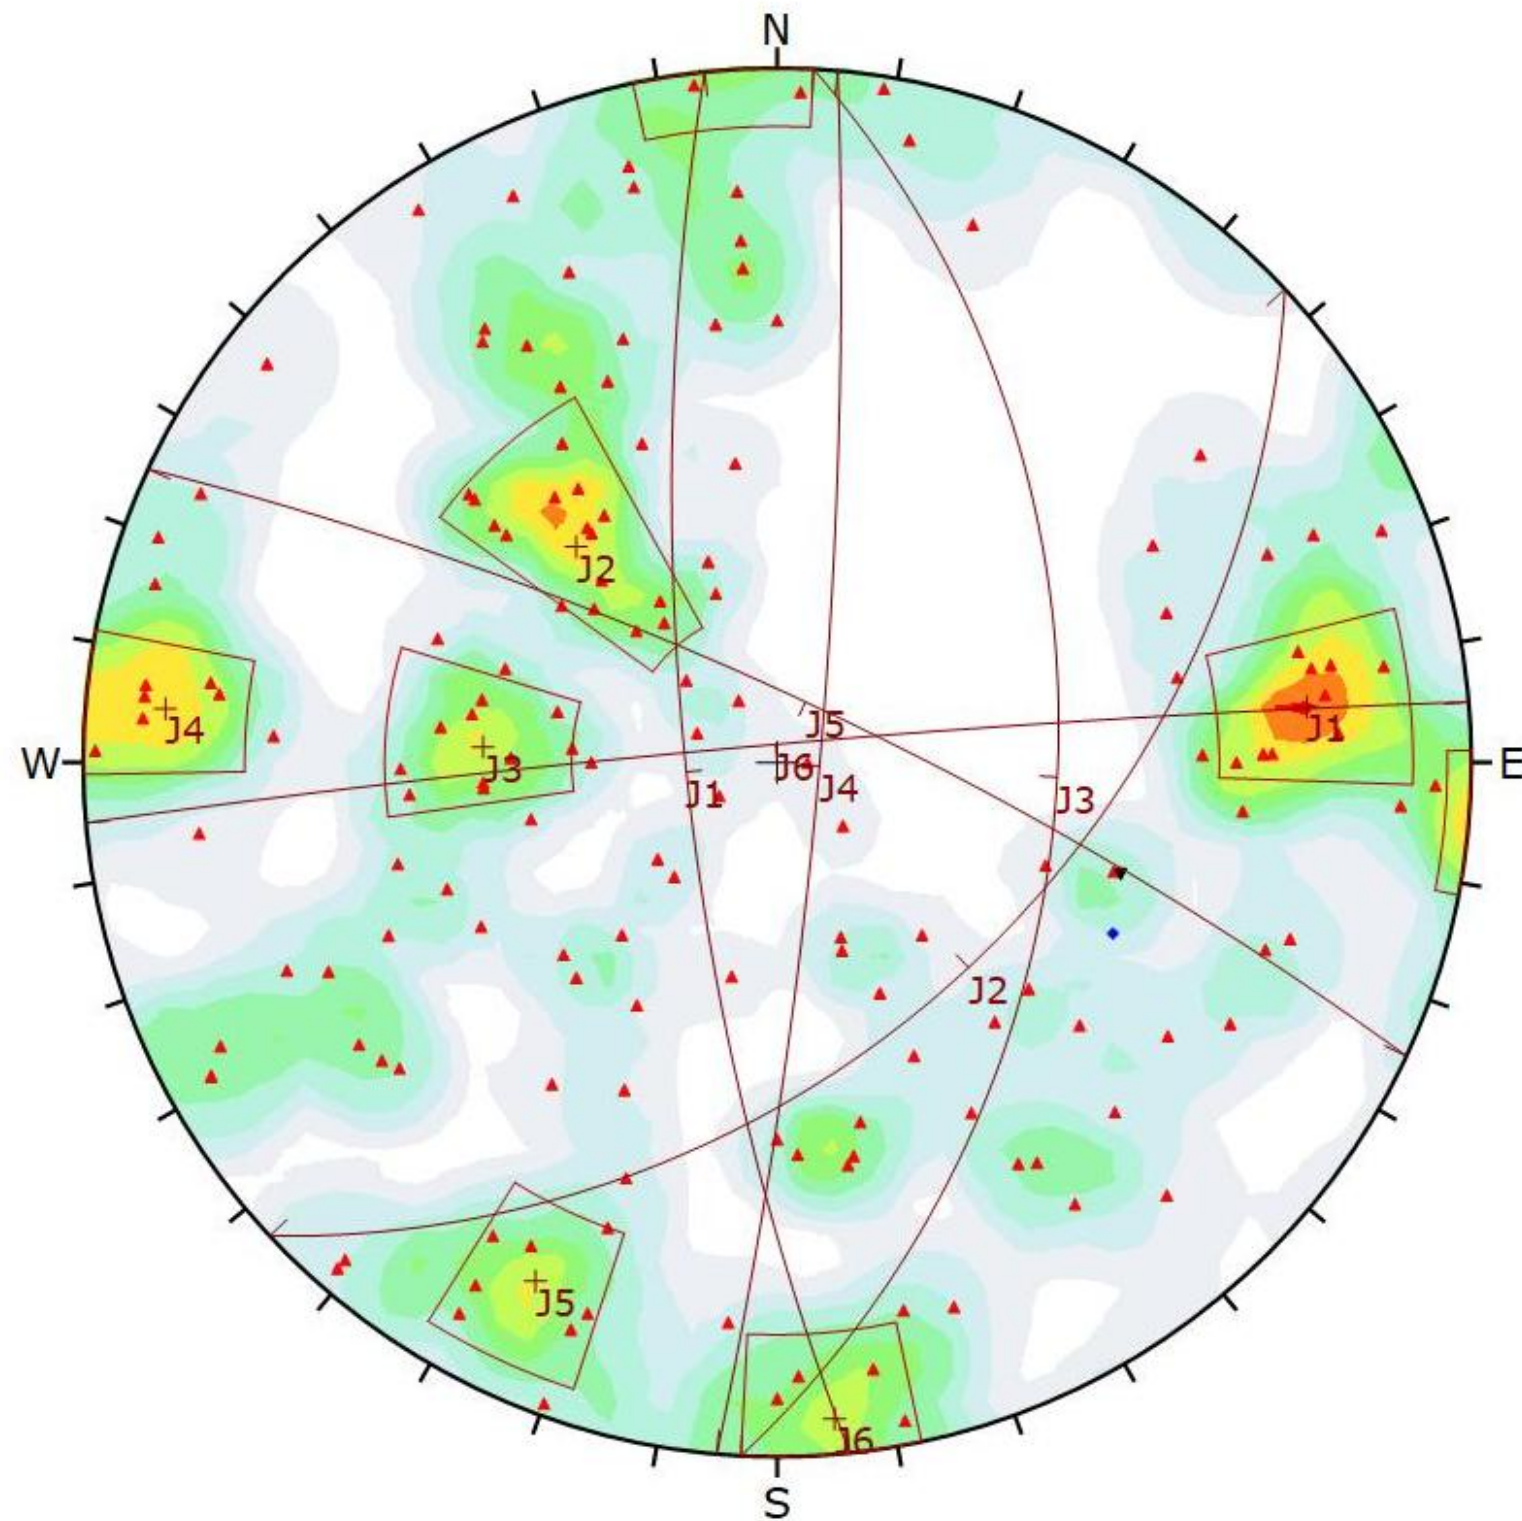
DISCONTINUITY STEREONET

A key aspect of rock slope mitigation design is a three-dimensional understanding of rock mass discontinuities. During our site visits in July, August and October 2024, we collected geologic and geotechnical information for 159 discontinuities (joints, faults and mineral veins). The data included location (either stationing or GPS outcrop locations), discontinuity type, dip angle, dip angle direction, persistence, aperture, infilling, shear strength, surface roughness, shape, water, spacing and pertinent notes/comments. These data are plotted on the lower hemisphere stereographic projection (“stereonet”) presented in Figure 1 (Attachment No. 1). Our field discontinuity data are summarized in Table 1 (Attachment No. 2). The discontinuities were further assigned to six (6) joint sets based on a minimum concentration density of 2.7%. The orientation of these joint sets aided in evaluating and designing mitigation elements and measures, as described below.

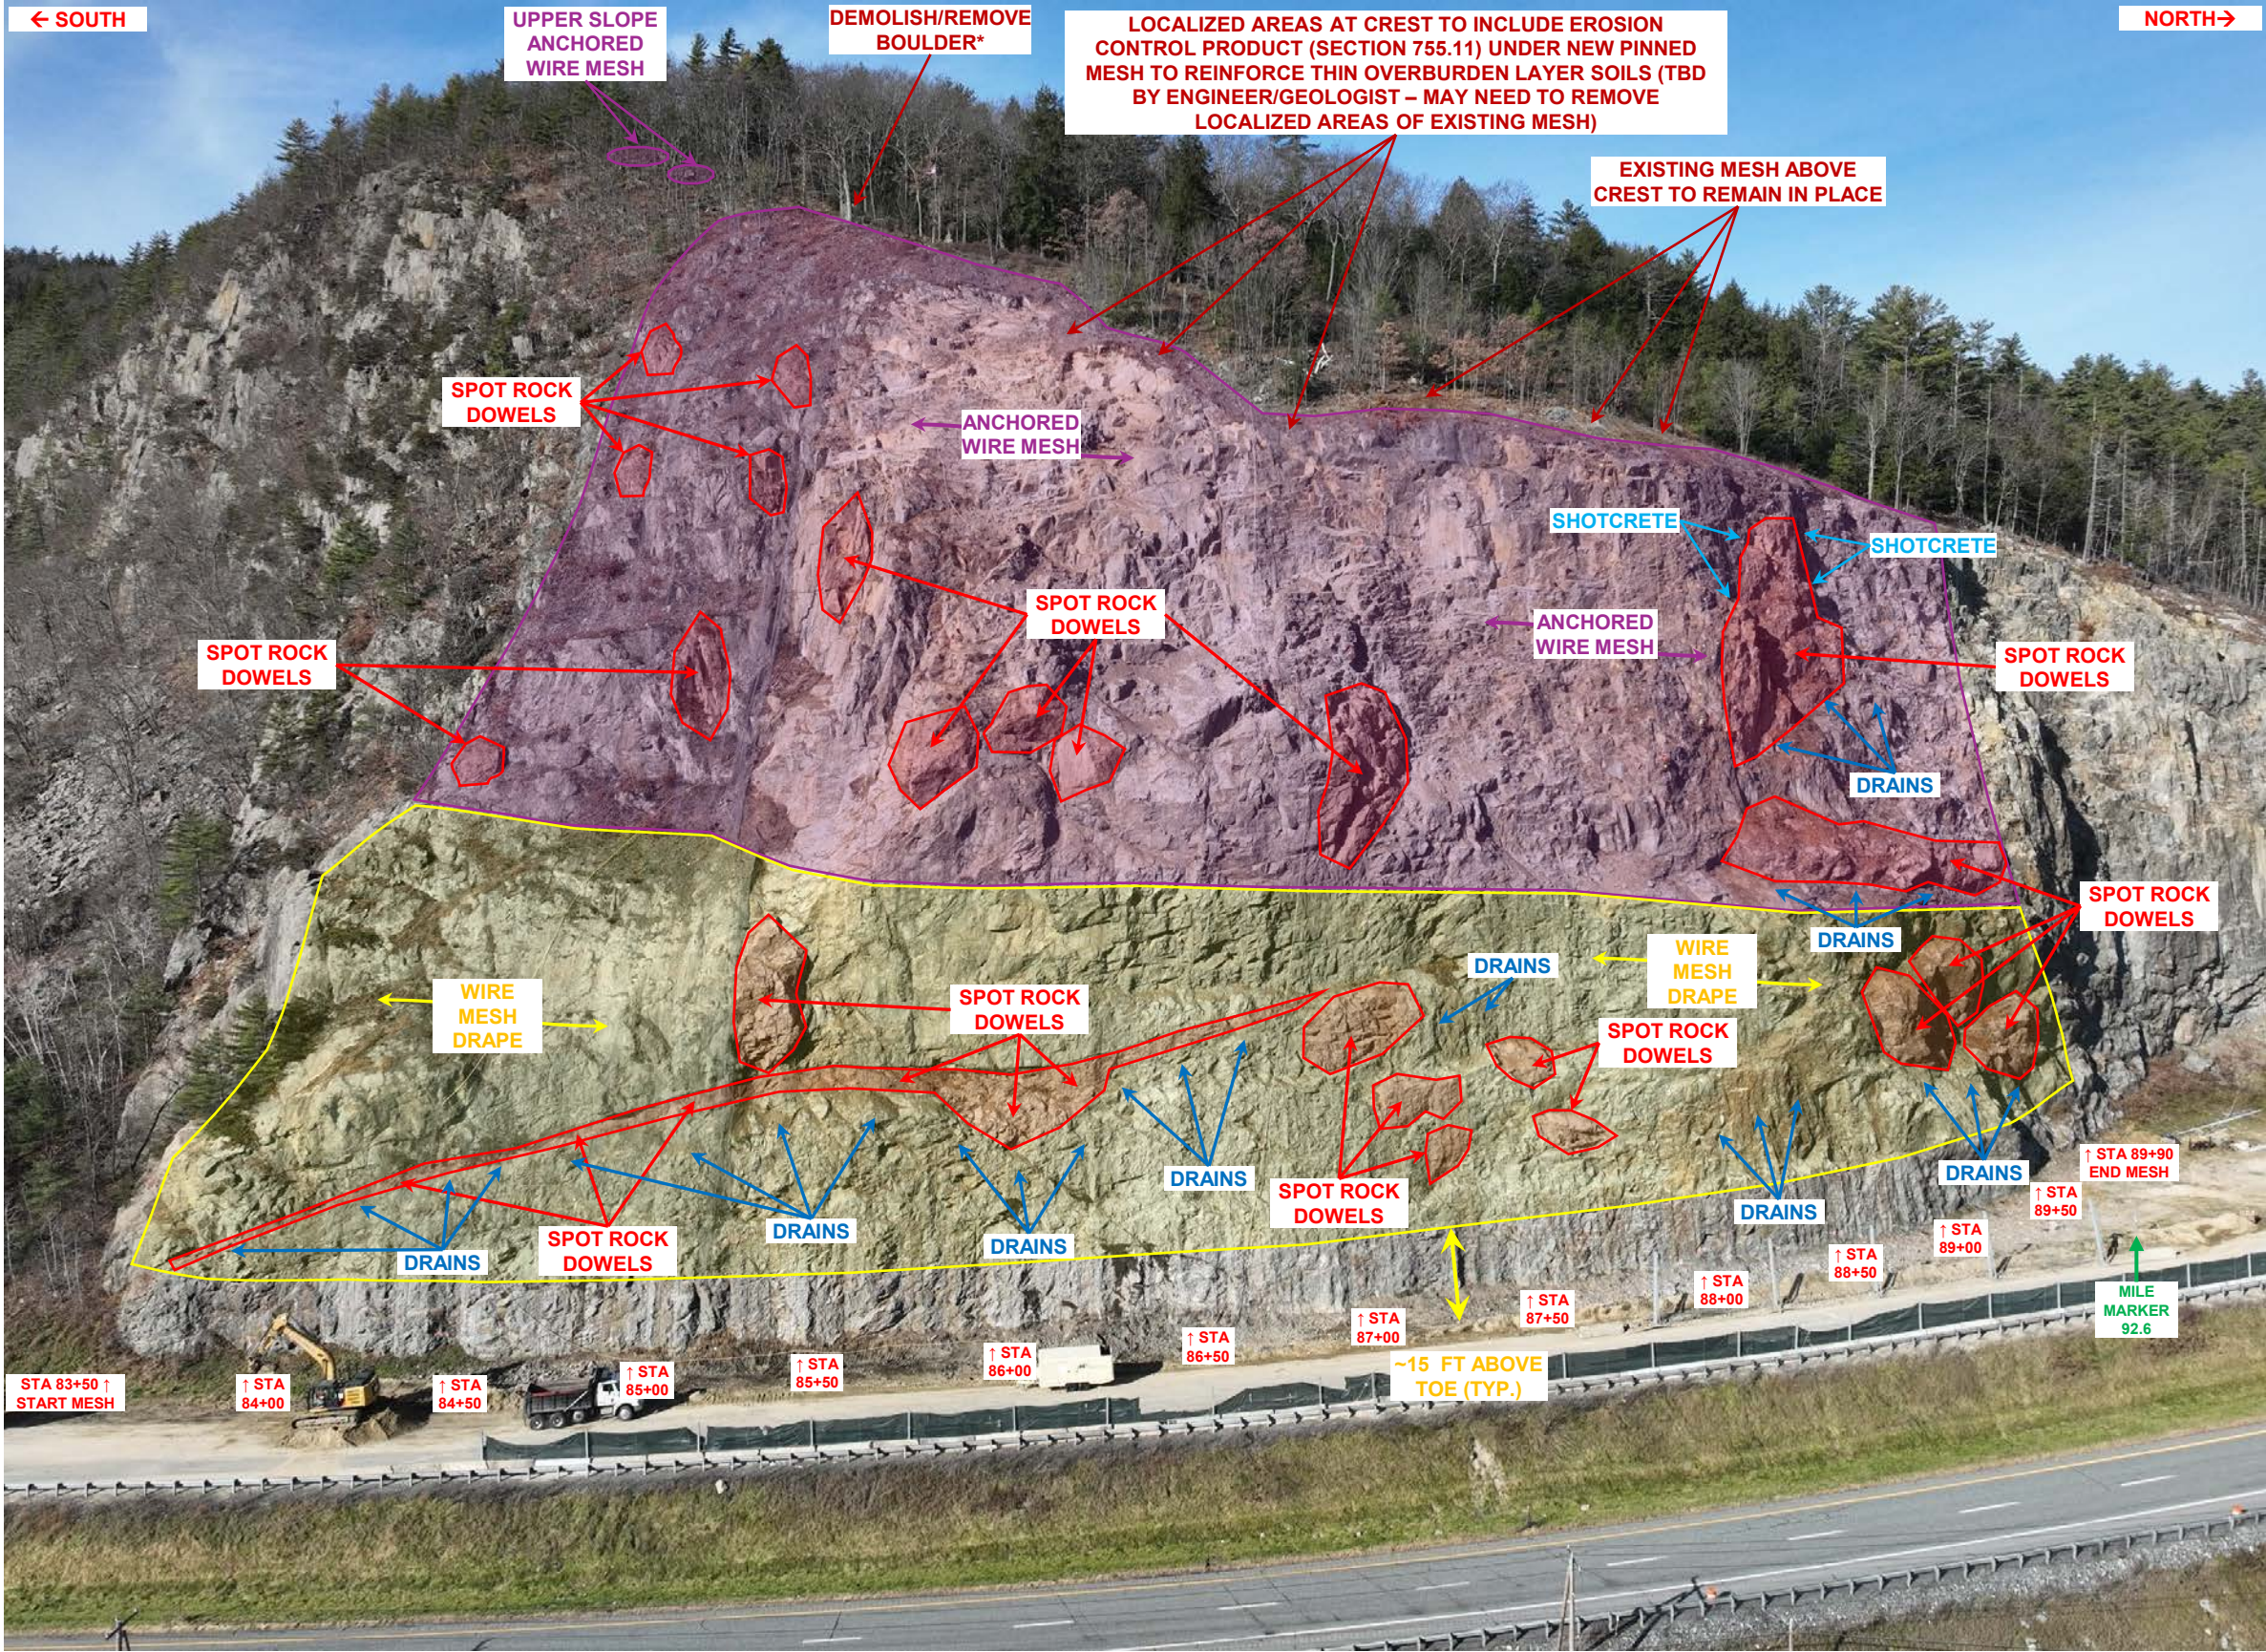
FIGURE TITLE	FIGURE NUMBER
ROCK SLOPE MITIGATION	3
	3 OF 4

The extent of the mitigation of the upper portion of the rock slope is shown in Figure 3. The pinned mesh consists of Geobrigg's Tecco® G65/4mm mesh anchored to #10 (1.25-in. dia.) Grade 75, galvanized threadbar anchors 15 ft. long (typical) placed on a staggered pattern ranging from 8 ft. X 8 ft. to 12 ft. X 12 ft., depending on slope steepness. These anchorage elements are referred to as "Wire Mesh Dowels" in the referenced contract drawing set. This mesh is constructed of high tensile strength (>256 ksi) steel wire with a zinc-aluminum corrosion protection coating, as compared with the Maccaferri double-twist mesh, which is composed of steel wire with a tensile strength of 70 ksi. The anchors will be installed in drill holes with a

The extent of the mitigation of the lower portion of the rock slope is shown in Figure 3. The draped mesh also consists of Geobrugg's Tecco® G65/4mm mesh, but it is anchored to a horizontal ¾ (0.75)-in. dia. wire rope cable, which is anchored to double-leg, ¾-in. dia. galvanized WRAs, also placed in 10 ft. long drill holes of 3.5-in. dia., placed at approximately 15-ft. spacings along the top. Supporting WRA's should be drilled 3- to 6-ft. above the bottom of the pinned mesh system so that no gap in mesh coverage exists. The draped mesh also contains vertical 5/8-in. cables at approximately 45-ft. spacings placed from the top horizontal cable to a bottom 5/8-in. dia. horizontal wire rope cable placed approximately 15 ft. above the slope toe. The mesh at the bottom will be hemmed around the bottom horizontal cable. The vertical 5/8-in. cables will be extended below the horizontal cable to form "pig tails" for periodic cleanout to remove accumulated debris using an excavator bucket attached to the pig tail.

Due to the presence of large rock blocks that either cannot be scaled safely or that could form rockfall hazards that could overload the mesh, rock dowels will be needed in select areas, as shown in Figure 3. These spot rock dowels occur in both the upper and lower portions of the mesh systems. The dowels will comprise #10 (1.25-in. dia.) Grade 75, galvanized threadbar that is nearly identical in construction elements as the mesh anchors used for the pinned mesh but have a square bearing plate and may be longer depending on drilling conditions (est. to be 20 ft. on average). These rock reinforcement elements are referred to as "Rock Dowels" in the construction drawings. Rock dowels in the pinned mesh areas may receive spike plates and be used to help tie the mesh to the slope. Rock dowels within draped mesh areas will receive bearing plates with the mesh over the dowel.

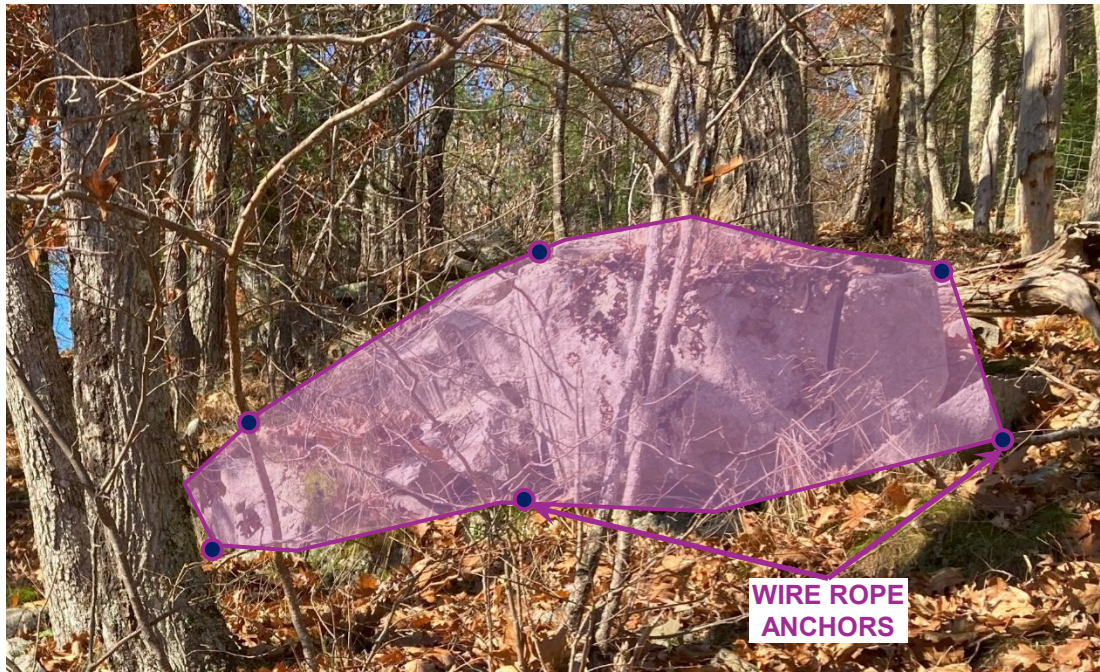
OUTCROP OC-8

During our evaluations to support temporary mitigation at the southern end of the slope, we noted a rock block exceeding 100 lbs. that had been retained by small trees on top of the mesh, just below the crest of the mesh (Rock Block 7).¹⁰ The source area for this rock block was determined to be further up slope where the slope angle was as great as 30 degrees. Subsequent observations indicate the presence of two low outcrops above this area with loose, dilated rock blocks. Due to the elevation of these outcrops (exceeding 450 ft. vertically above the roadway), rolling rocks emanating from these outcrops could attain enough energy to reach the roadway. To mitigate these areas, we include two additional pinned mesh areas as shown in Figure 4. These areas will contain the same elements as the pinned mesh, but as they are relatively small in area and do not require Wire Mesh Dowels within the mesh limits but just WRAs on the perimeter wire rope around the outcrops.

- SCALING/TREE REMOVAL AS NECESSARY
- PLACE ANCHORED WIRE MESH, EST. AREA = 300 FT²
- SIX (6) WIRE ROPE ANCHORS, 5 FT (MIN.) EMBEDDED IN BEDROCK

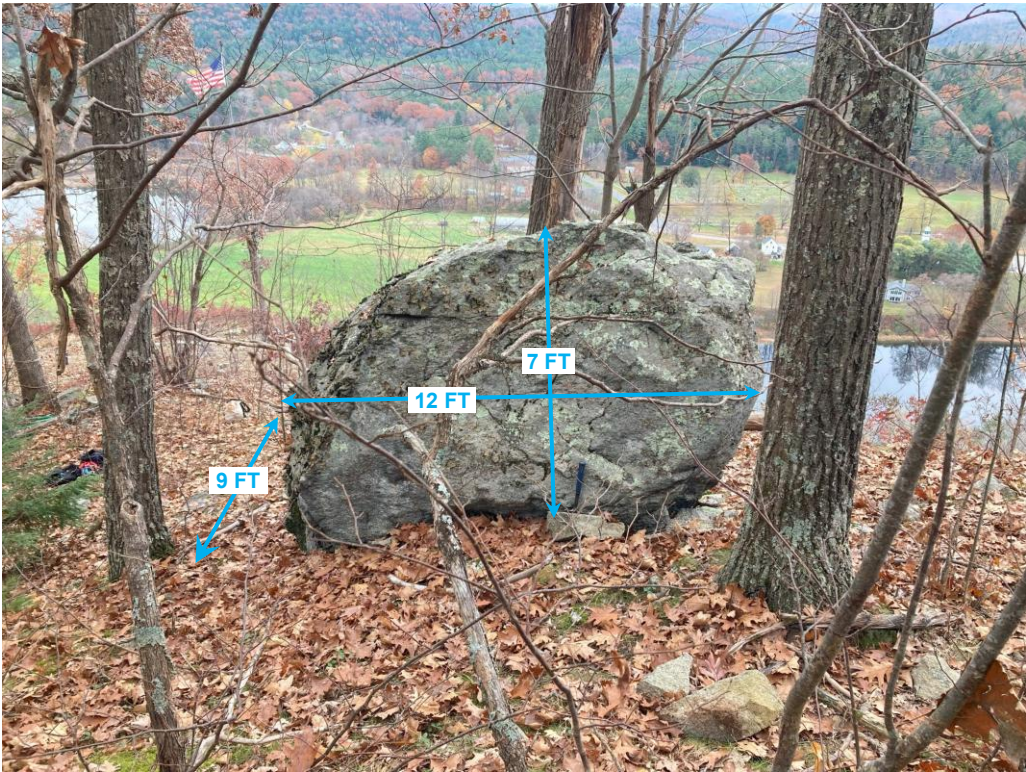
During our evaluations to support temporary mitigation at the southern end of the slope, we noted a glacial erratic boulder approximately 20 to 30 ft. above the slope crest. The boulder is estimated to have a mass exceeding 15 tons and is visibly depressing the shallow overburden. While not deemed a potential source of major rockfall, slope wash, freeze/thaw and root jacking effects could move the boulder down slope towards the crest over time. As mitigation work will be conducted adjacent to the boulder, we recommend that VTrans demolish/break up the boulder and remove the debris, as shown in Figure 4.

- DEMOLISH BOULDER IN PLACE USING NON-EXPLOSIVE METHODS, DISPOSE OF DEBRIS AWAY FROM CREST OF SLOPE TO AREA APPROVED BY ENGINEER
- EST. VOLUME = 28 YD³
