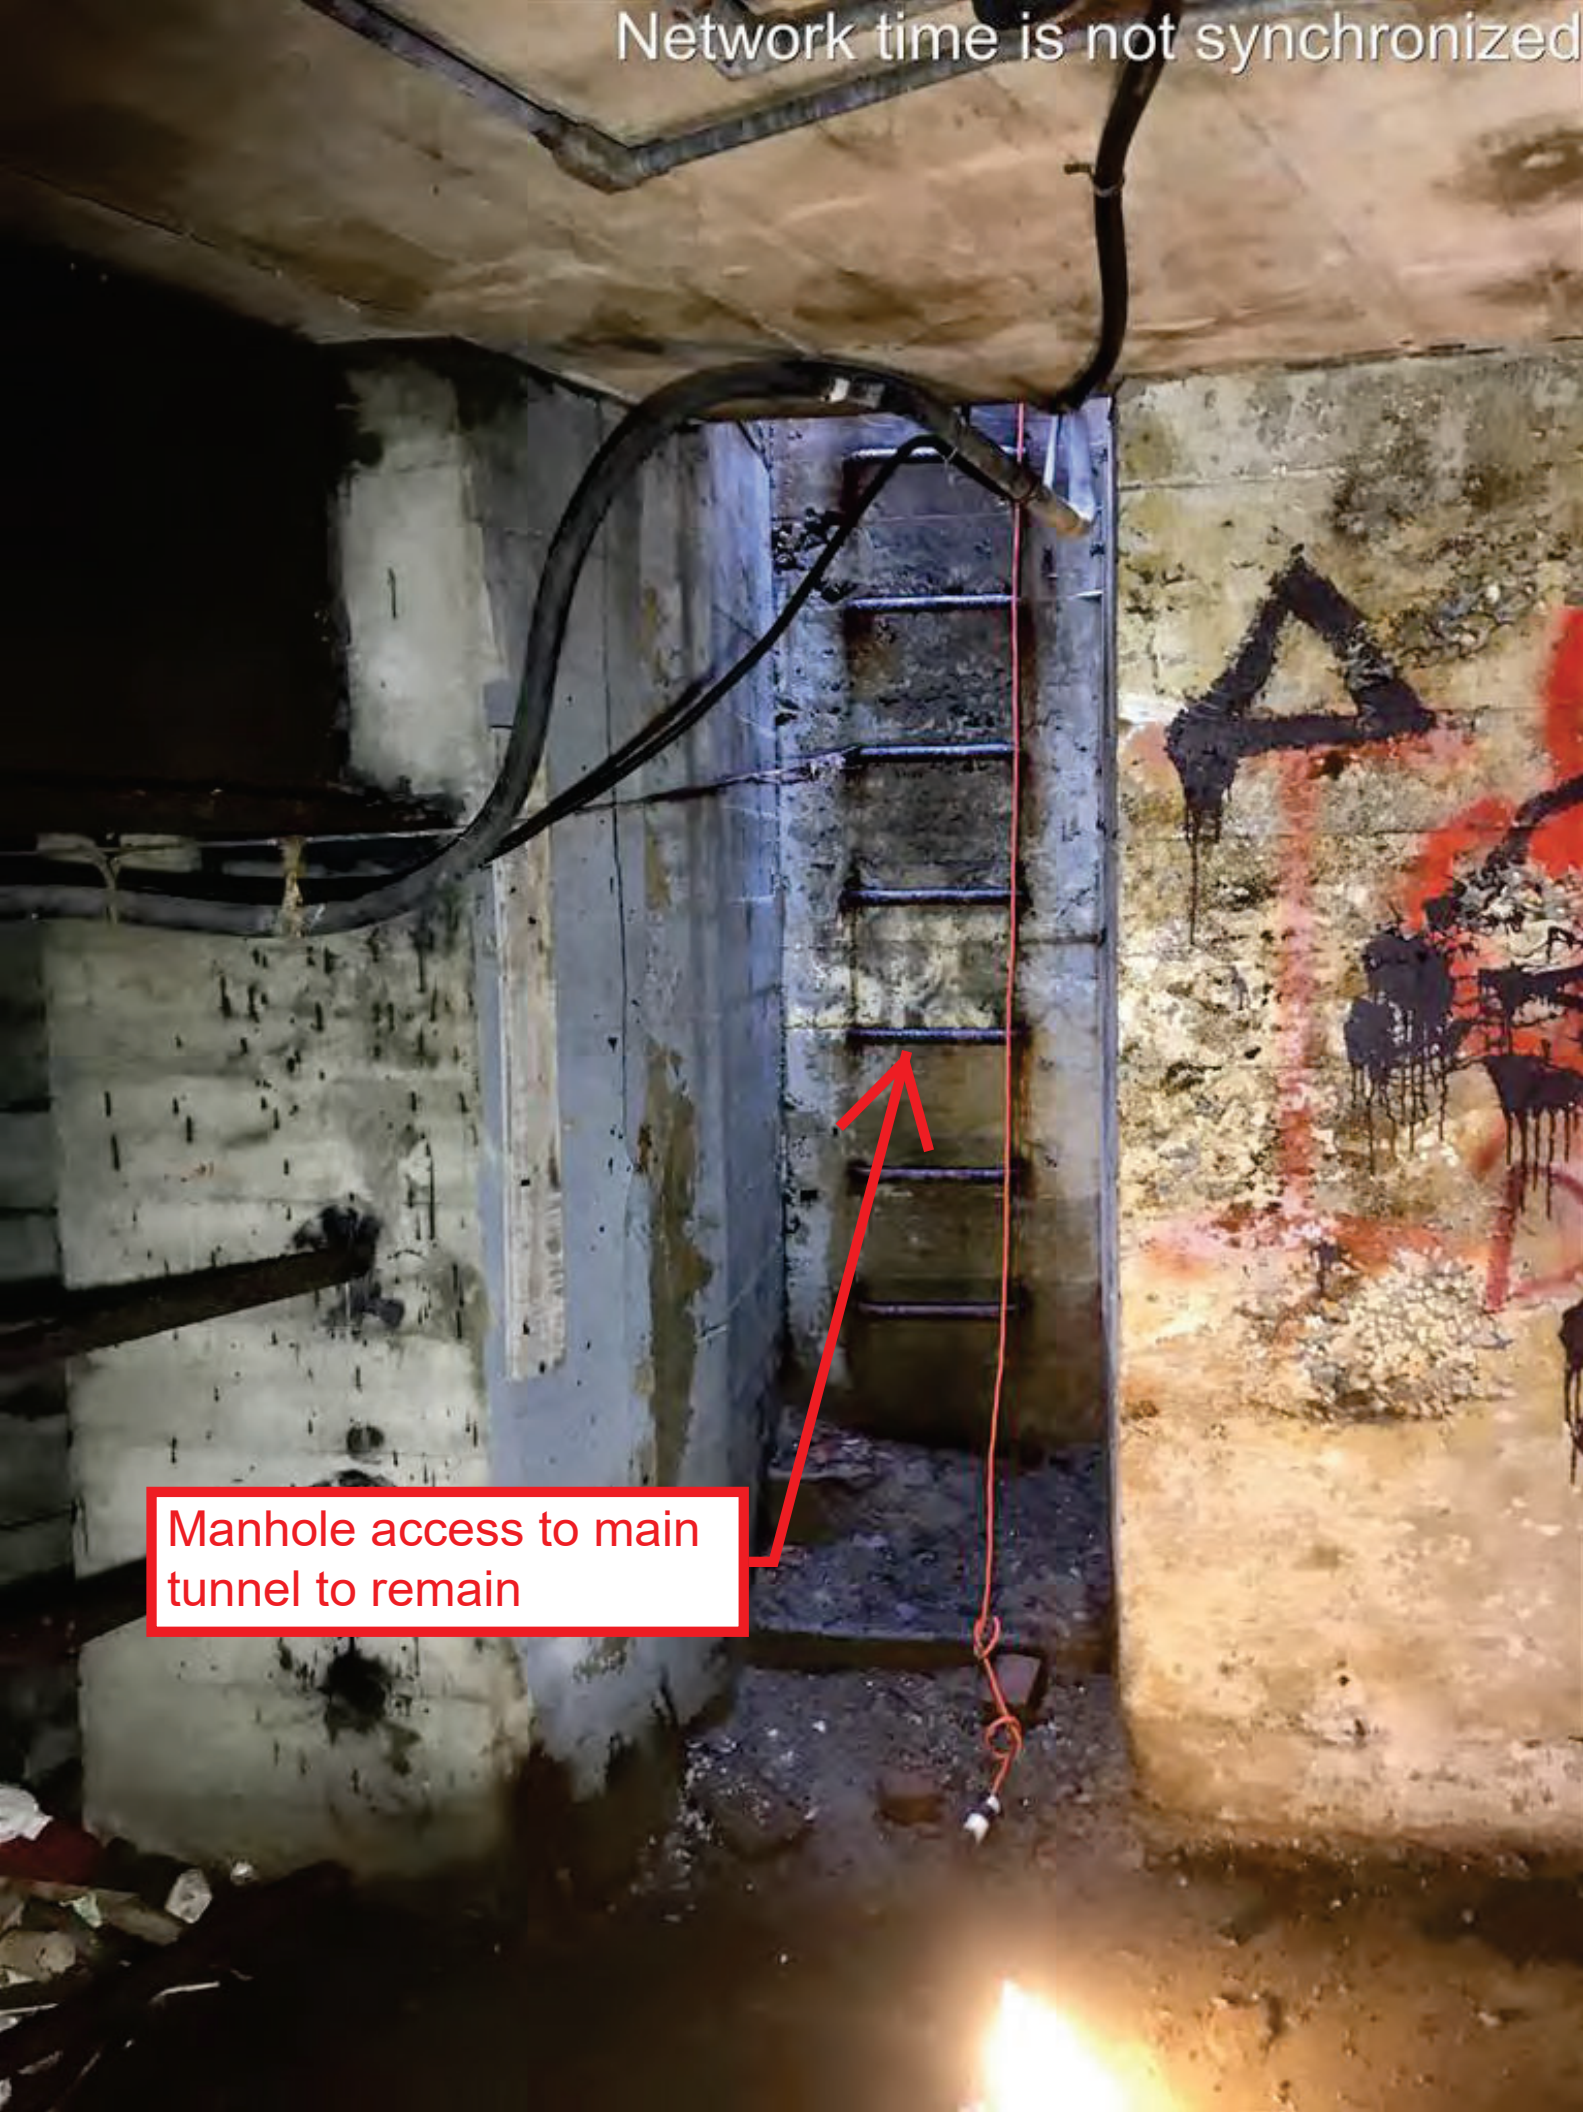
Tunnel under railroad  
tracks to remain

Stairway access to be filled in

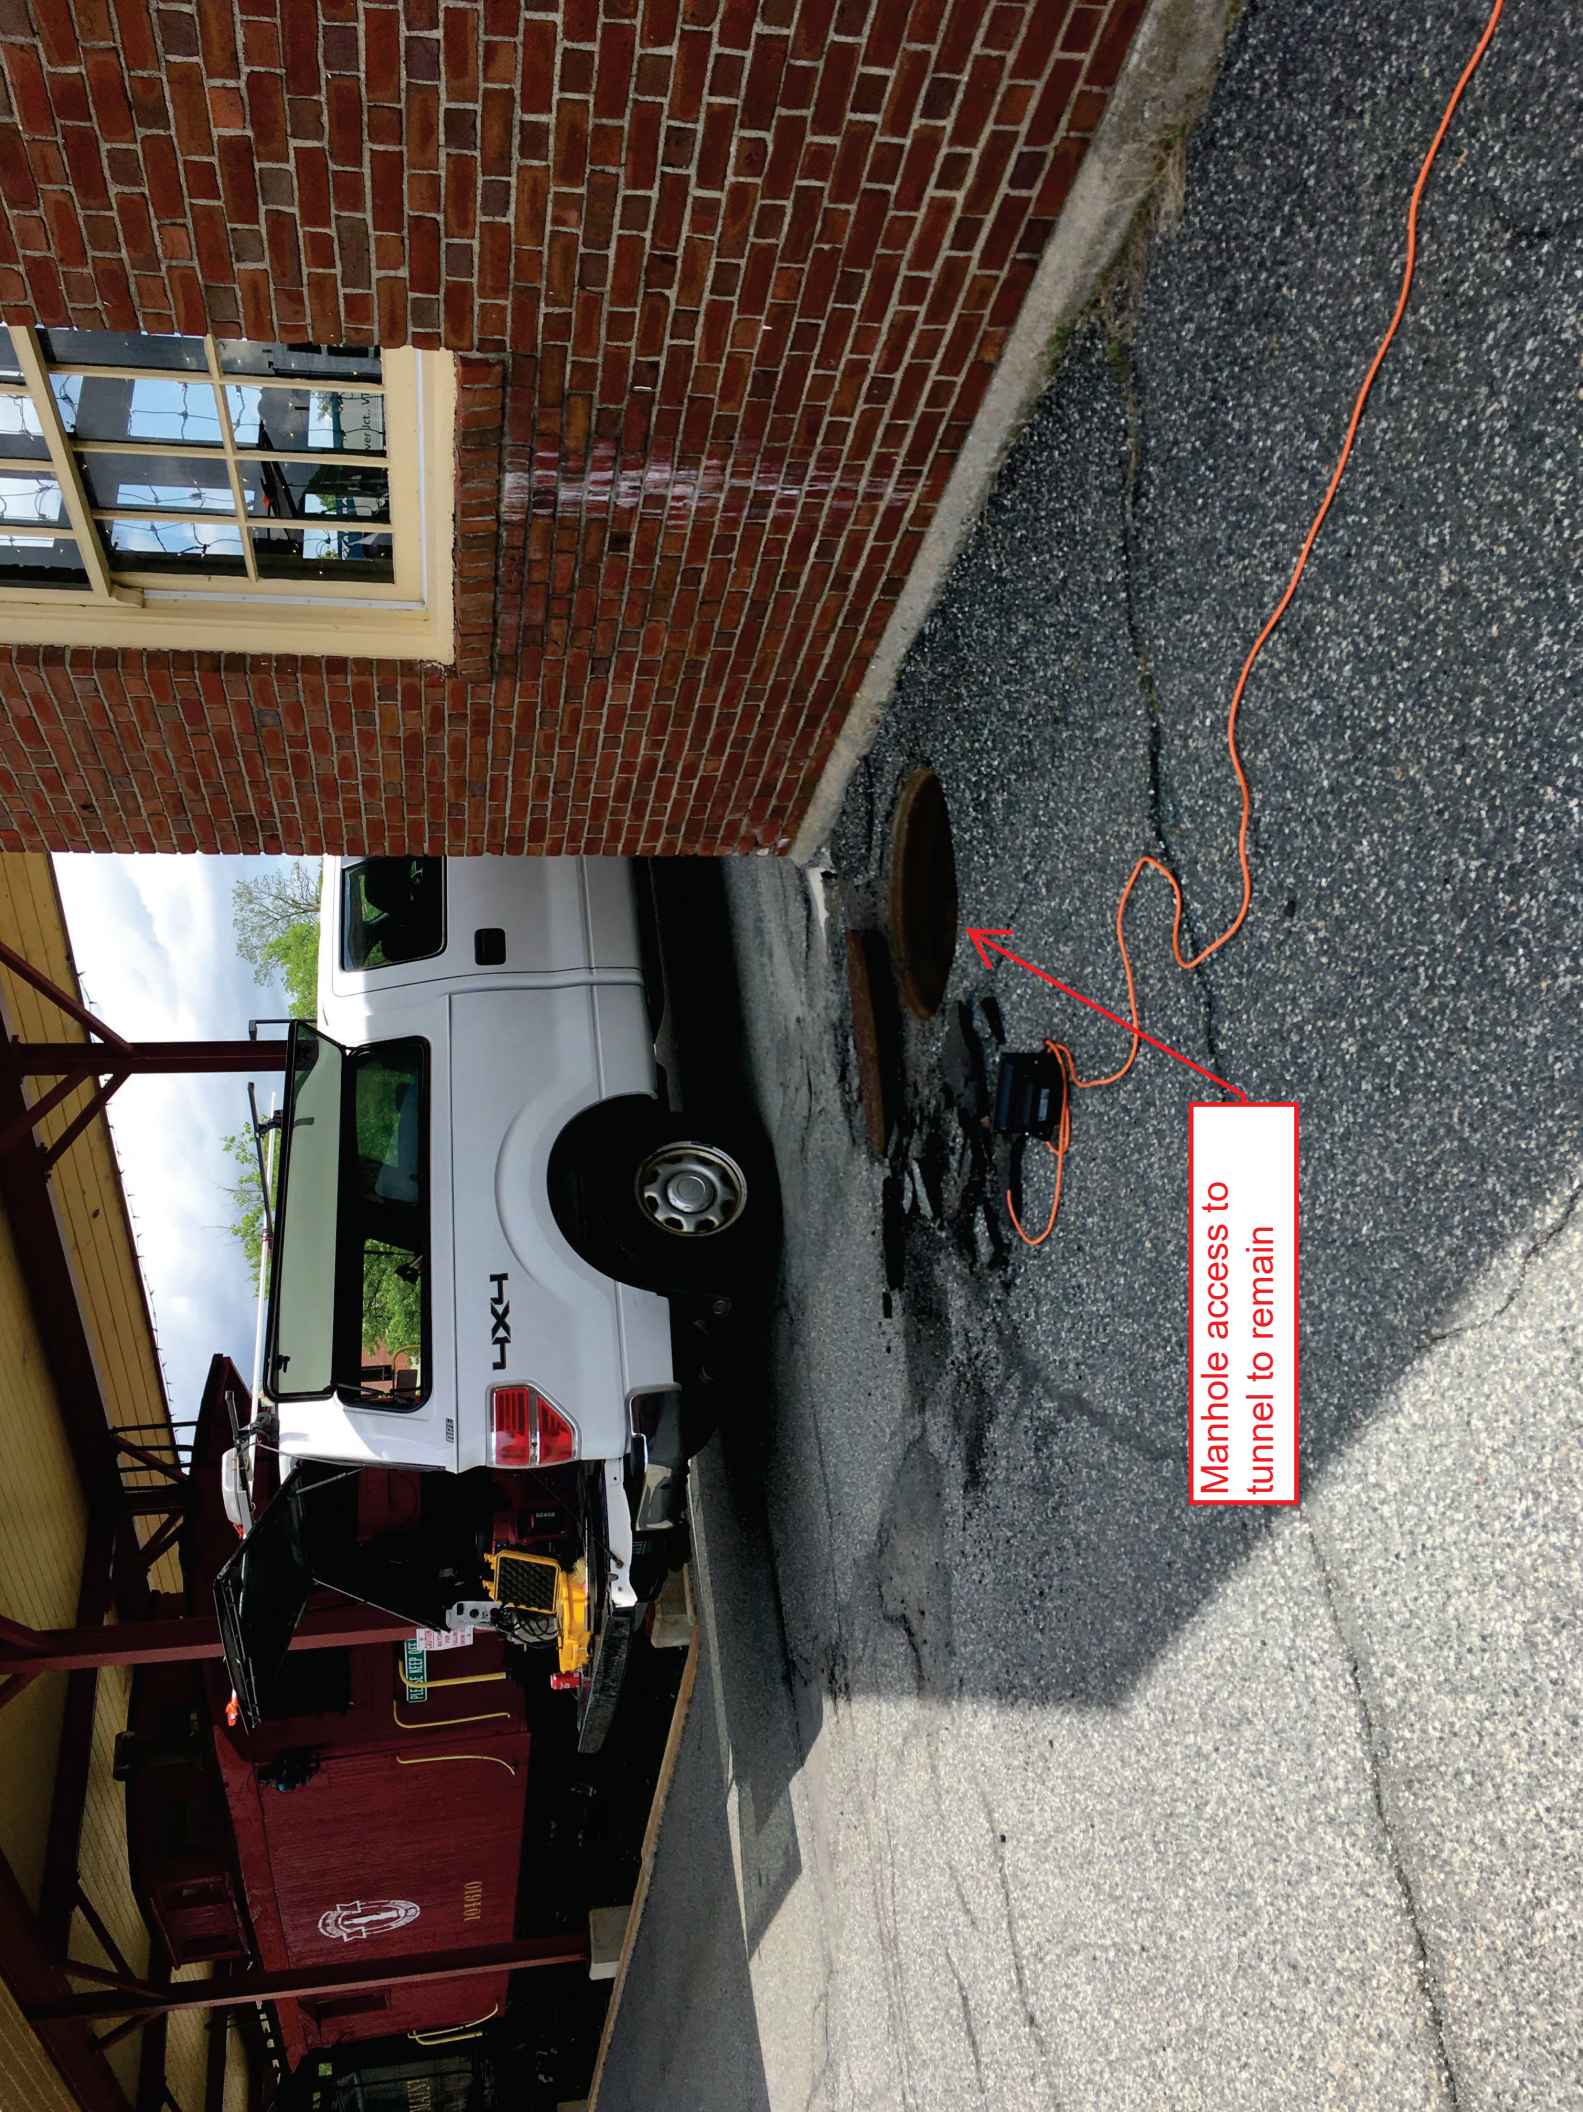
Manhole access to main  
tunnel to remain
