Geotechnical Engineering Report

Bennington BF 1000(20) VT Rt 9, Bridge 6 Over Walloomsac Bennington, Vermont

November 30, 2020

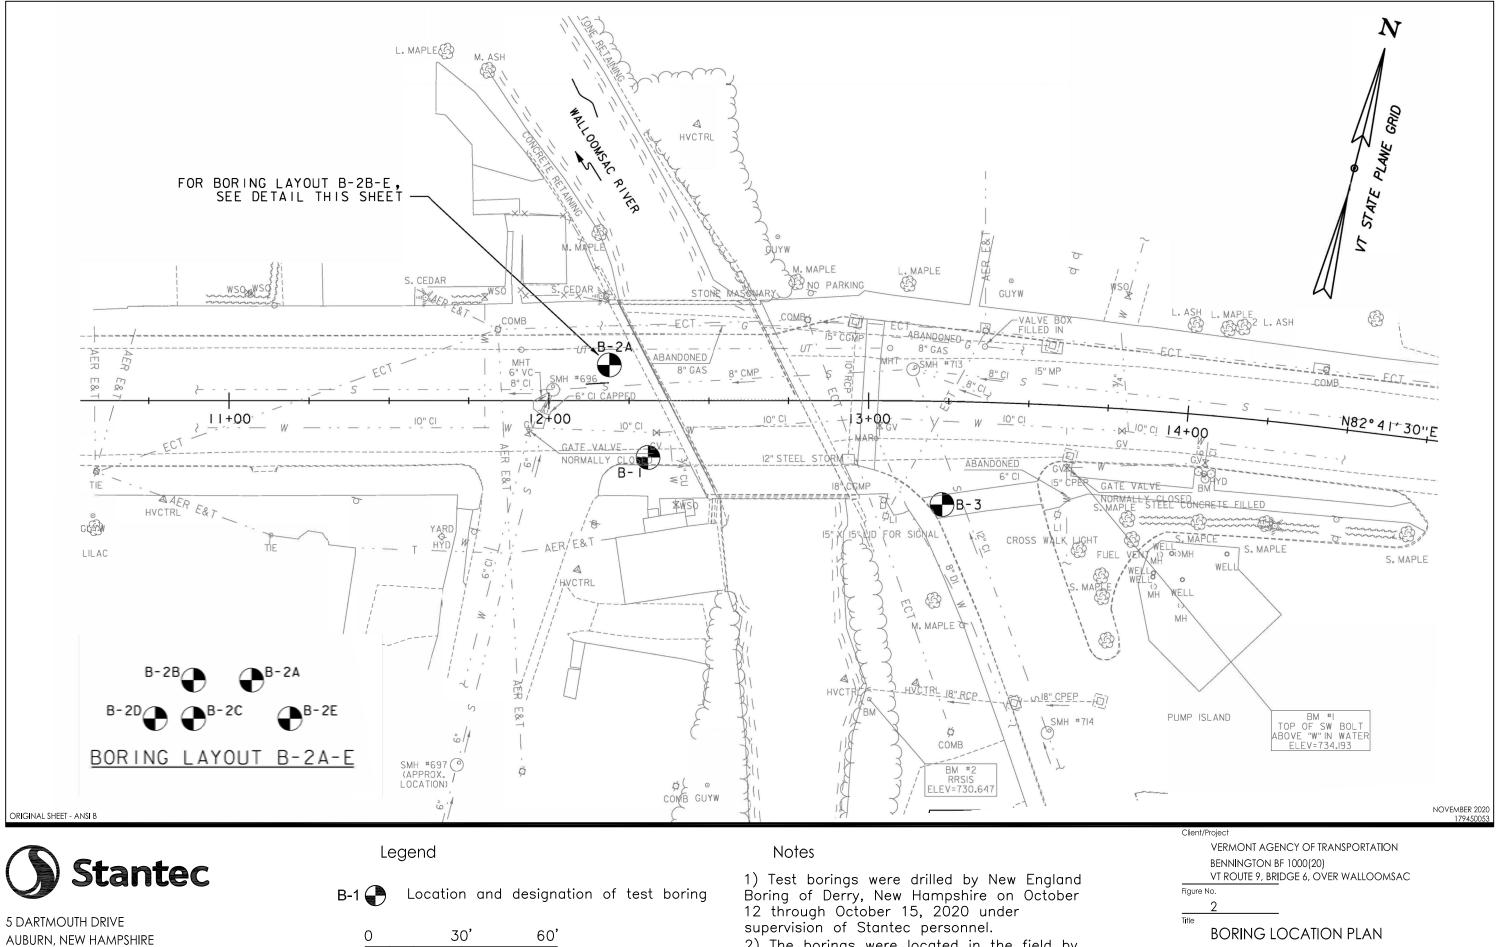
The exploration program consisted of three test borings drilled from October 12 to 15, 2020. The tests borings are designated as B-1 through B-3. Borings B-1 and B-2 were drilled in the area of the proposed Abutment No. 1 (west abutment). Boring B-3 was drilled in the area of the proposed Abutment No. 2 (east abutment). Boring B-2 encountered refusal a shallow depth and five attempts were made to advance the boring. The attempts where designated B-2A through B-2E. The locations of the test borings are shown on the attached Figure 2, entitled "Boring Location Plan."

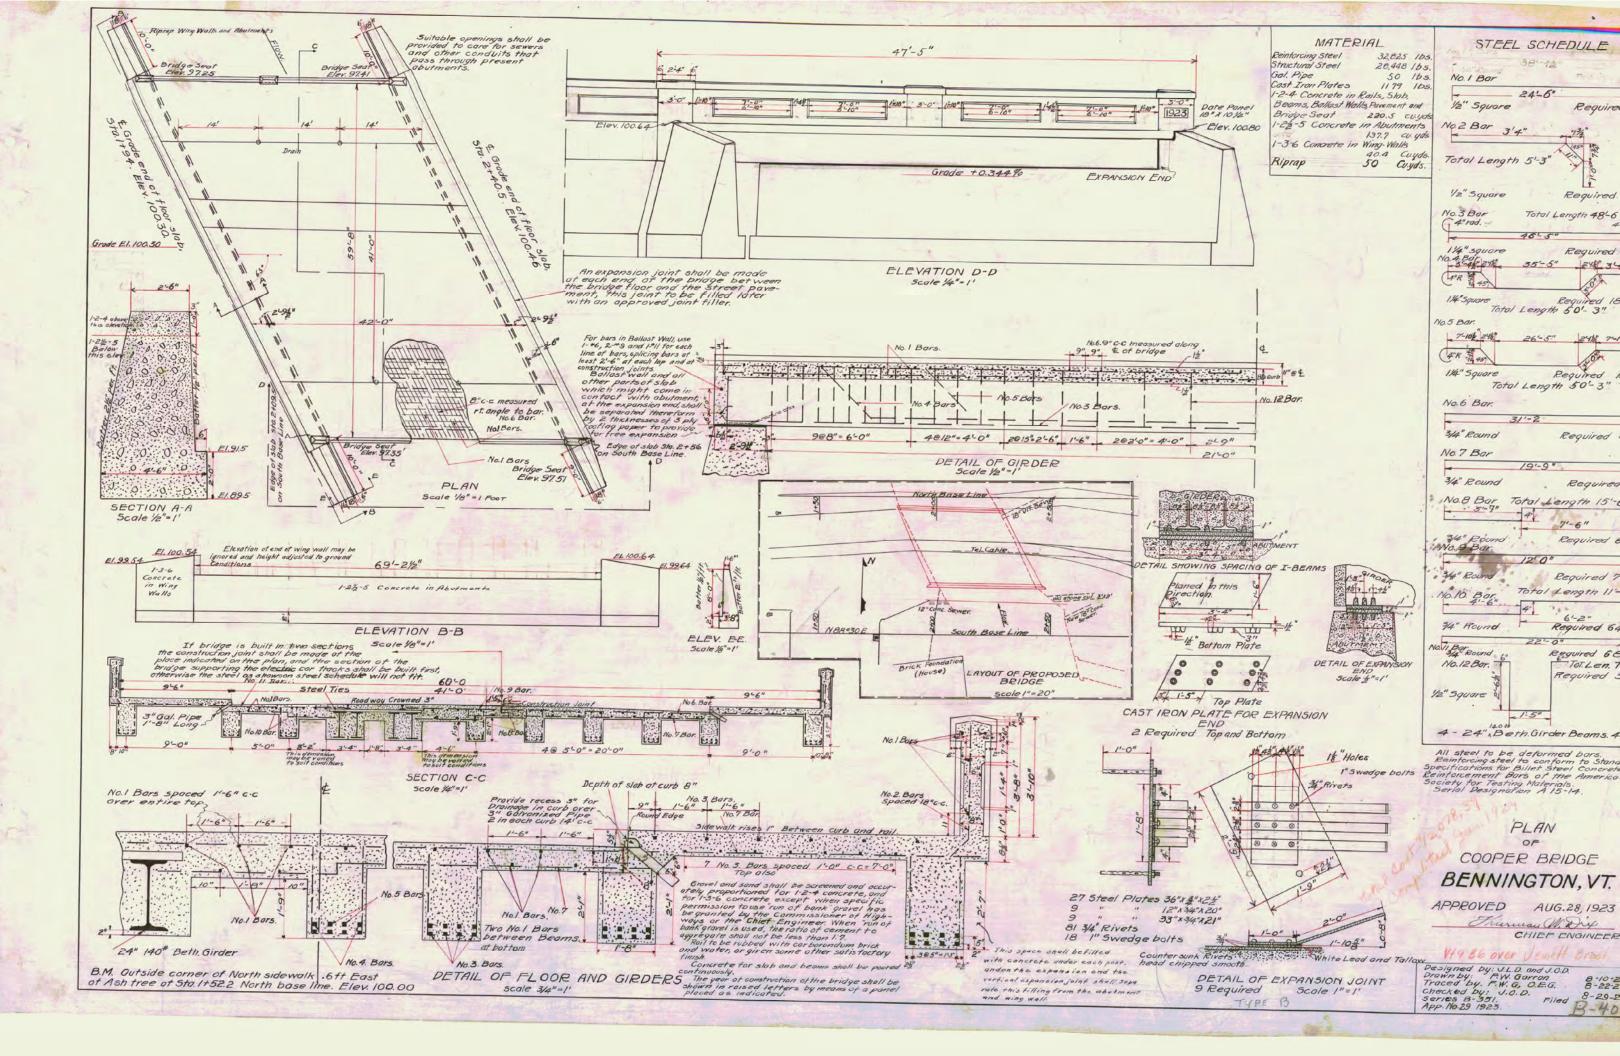
The existing bridge is a single-span structure located on VT Route 9 approximately 0.5 miles east of the intersection with VT Route 7. The existing bridge carries VT Route 9 over the Walloomsac River. The river flows from north to south and the bridge spans the river in an east to west direction. In the area of the bridge, the bottom of the river channel ranges from approximately El. 721 to El 722. The existing bridge consists of the reinforced concrete deck supported by concrete abutments. The 1923 Bridge Plans indicate the abutments bear at El. 89.5 based on the datum used for the project. Based on the current datum (NAVD88) the existing abutments have been estimated to bear at El. 720. Based on the recently drilled test borings the existing abutments are soil supported. The clear span of the bridge is 42 feet. The width of the bridge is 59.67 feet. The bridge supports a two-lane roadway and a sidewalk on both sides. Wingwalls ranging from 9 to 10 feet long are located at each bridge corner and run parallel to the river. The northern side of the bridge supported trolley car tracks. A water line, sewer line and a telecommunication line are supported under the existing bridge deck. The 1923 Bridge Plans are provided in Appendix A.

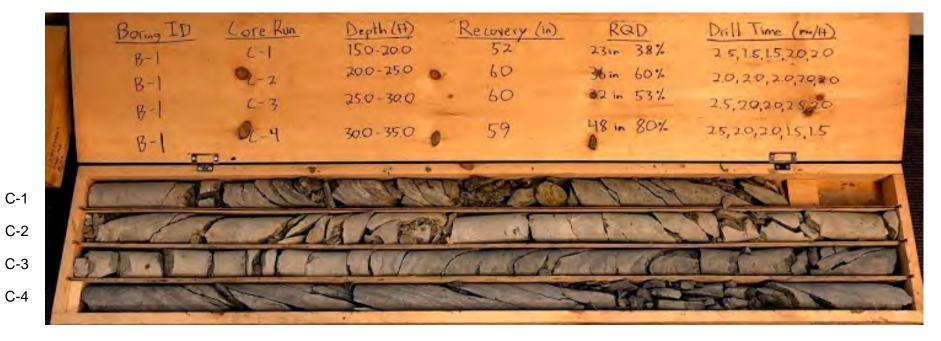
Rock Core Photo B-1

15.0 15.0 ft - 20.0 ft, Light gray, Dolomite, Moderately hard, Slightly weathered, Poor rock, NQDC, Joints are moderately dipping, rough, slightly discolored, partly open. Highly fractured zone from 17 to 18															- - - 12.5 - -
is.0 ft - 20.0 ft, Light gray, Dolomite, Moderately nard, Slightly 1 84 2.5 weathered, Poor rock, NQDC, Joints are moderately dipping, rough, (45) (38) slightly discolored, partly open. Highly fractured zone from 17 to 18	ock @ 14.0	drock	of Bec	Тор							Ū				- - 15 0
)			lipping, rough,	erately di	C, Joints are mod	athered, Poor rock, NQDO	weather slightly

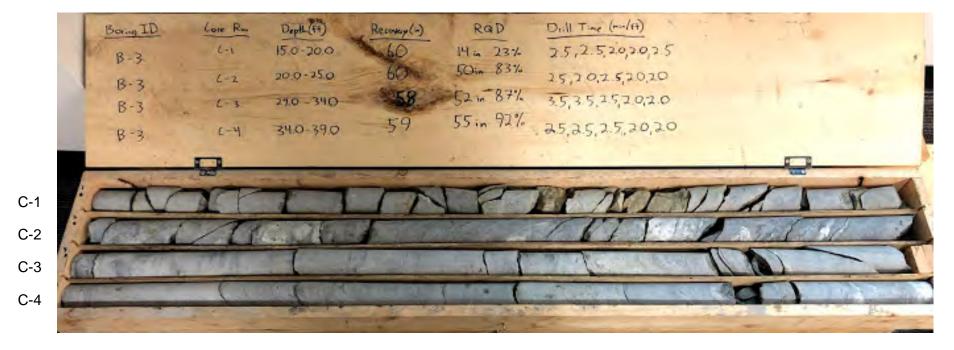
Rock Core Photo B-3

35.0-		34.0 ft - 39.0 ft, Light gray, Dolomite, Moderat rock, NQDC, Joints are low angle to moderate tight. RMR = 46	ely dippin		4 (15)	98 (92)	2.5 2.5 2.5 2 2								
		Hole stopped @ 39.0	ft				· · · ·								
·	1 Stratificati	ion lines represent approximate boundary between material type	as Transitia	n may be gradual											
Notes	2. N Values 3. Water lev	ion lines represent approximate boundary between material type have not been corrected for hammer energy. $C_{\rm E}$ is the hammer el readings have been made at times and under conditions state nents were made.	r energy cor	rection factor.	occur due to	o other f	actors thar	those pre	esent at	t the time	e
