GEOTECHNICAL INVESTIGATION REPORT

TAXIWAY AND APRON EXPANSIONS

Morrisville-Stowe State Airport
Morrisville, Vermont 05661

July 12, 2023

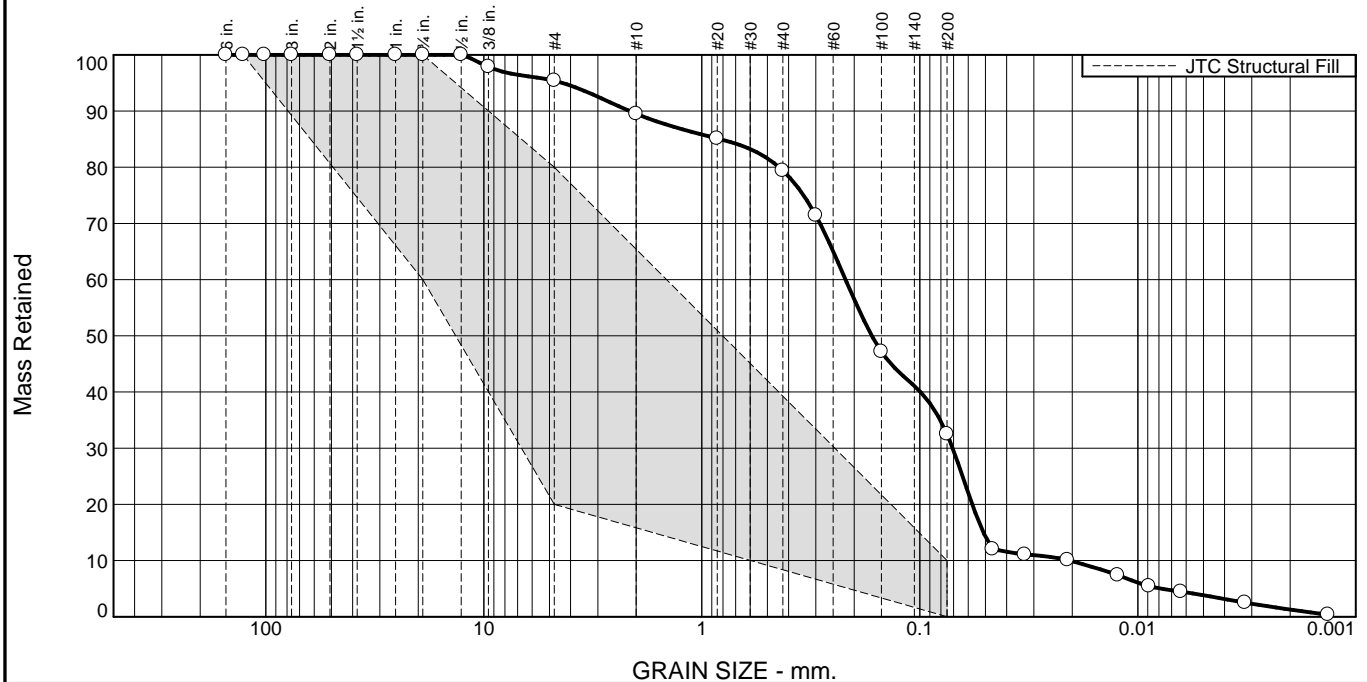
Particle Size Distribution Report

% +3"	% Gravel		% Sand			% Fines	
	Coarse	Fine	Coarse	Medium	Fine	Silt	Clay
0.0	0.0	4.6	5.9	10.1	46.9	28.7	3.8

Test Results (ASTM D 6913 & ASTM C 117)			
Opening Size	Percent Finer	Spec.* (Percent)	Pass? (X=Fail)
6	100.0	100.0	
5	100.0		
4	100.0		
3	100.0	60.0 - 100.0	
2	100.0		
1.5	100.0		
1	100.0	20.0 - 80.0	X
3/4	100.0		
1/2	100.0		
3/8	97.9	0.0 - 10.0	X
#4	95.4		
#10	89.5		
#20	85.1	0.0 - 10.0	
#40	79.4		
#50	71.4		
#100	47.2		
#200	32.5		
0.0463 mm.	12.0		
0.0330 mm.	11.1		
0.0210 mm.	10.1		
0.0124 mm.	7.4		
0.0089 mm.	5.5		
0.0063 mm.	4.5		
0.0032 mm.	2.5		
0.0013 mm.	0.4

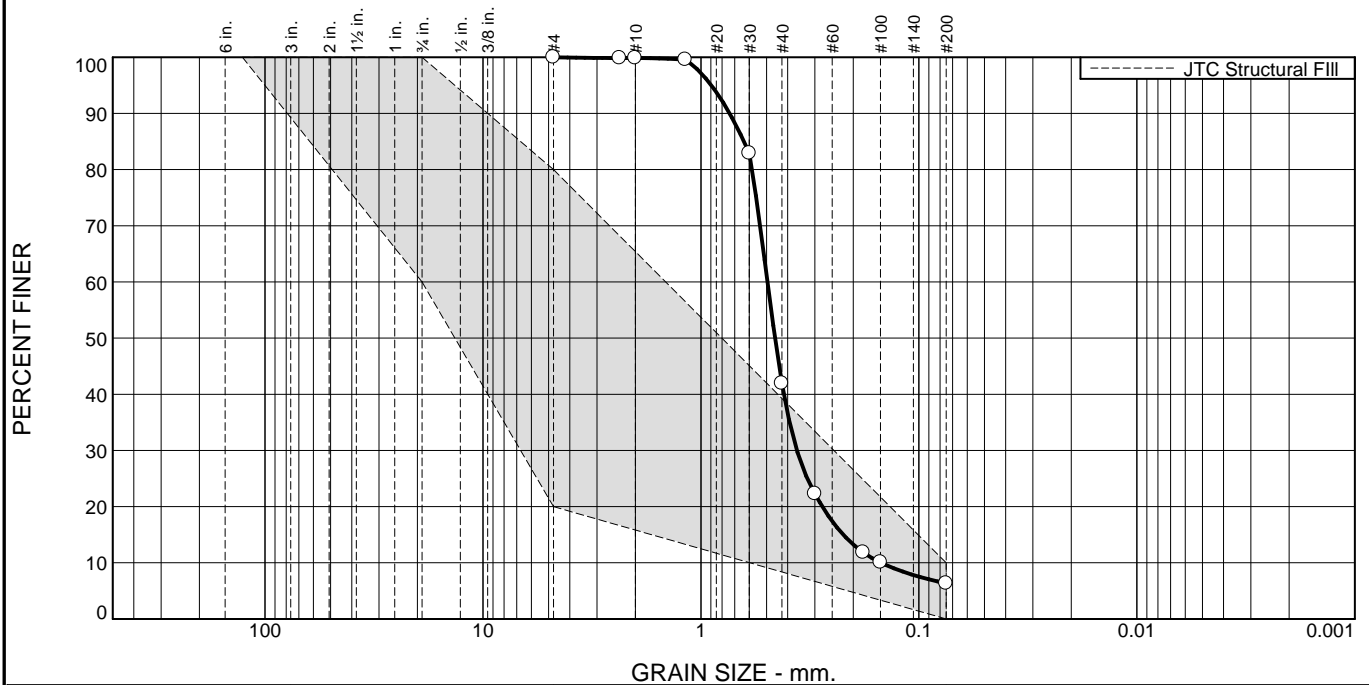
Particle Size Distribution Report

% +3"	% Gravel		% Sand			% Fines	
	Coarse	Fine	Coarse	Medium	Fine	Silt	Clay
0.0	0.0	0.0	0.1	58.0	35.6	6.3

Test Results (ASTM C 136 & ASTM C 117)			
Opening Size	Percent Finer	Spec.* (Percent)	Pass? (X=Fail)
#4	100.0	20.0 - 80.0	X
#8	99.9		
#10	99.9		
#16	99.6		
#30	82.9		
#40	41.9	0.0 - 10.0	
#50	22.3		
#80	11.8		
#100	10.1		
#200	6.3

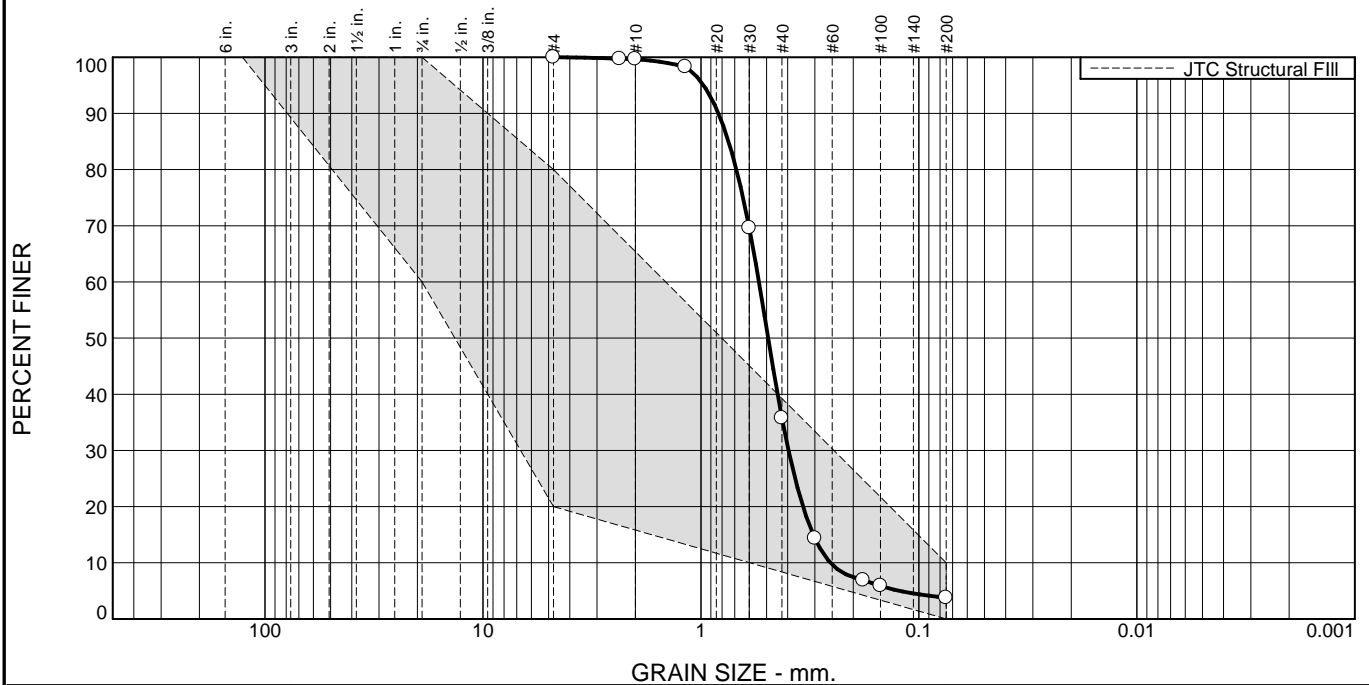
Particle Size Distribution Report

% +3"	% Gravel		% Sand			% Fines	
	Coarse	Fine	Coarse	Medium	Fine	Silt	Clay
0.0	0.0	0.0	0.4	63.9	31.9	3.8

Test Results (ASTM C 136 & ASTM C 117)			
Opening Size	Percent Finer	Spec.* (Percent)	Pass? (X=Fail)
#4	100.0	20.0 - 80.0	X
#8	99.7		
#10	99.6		
#16	98.3		
#30	69.6		
#40	35.7	0.0 - 10.0	
#50	14.3		
#80	6.9		
#100	5.9		
#200	3.8

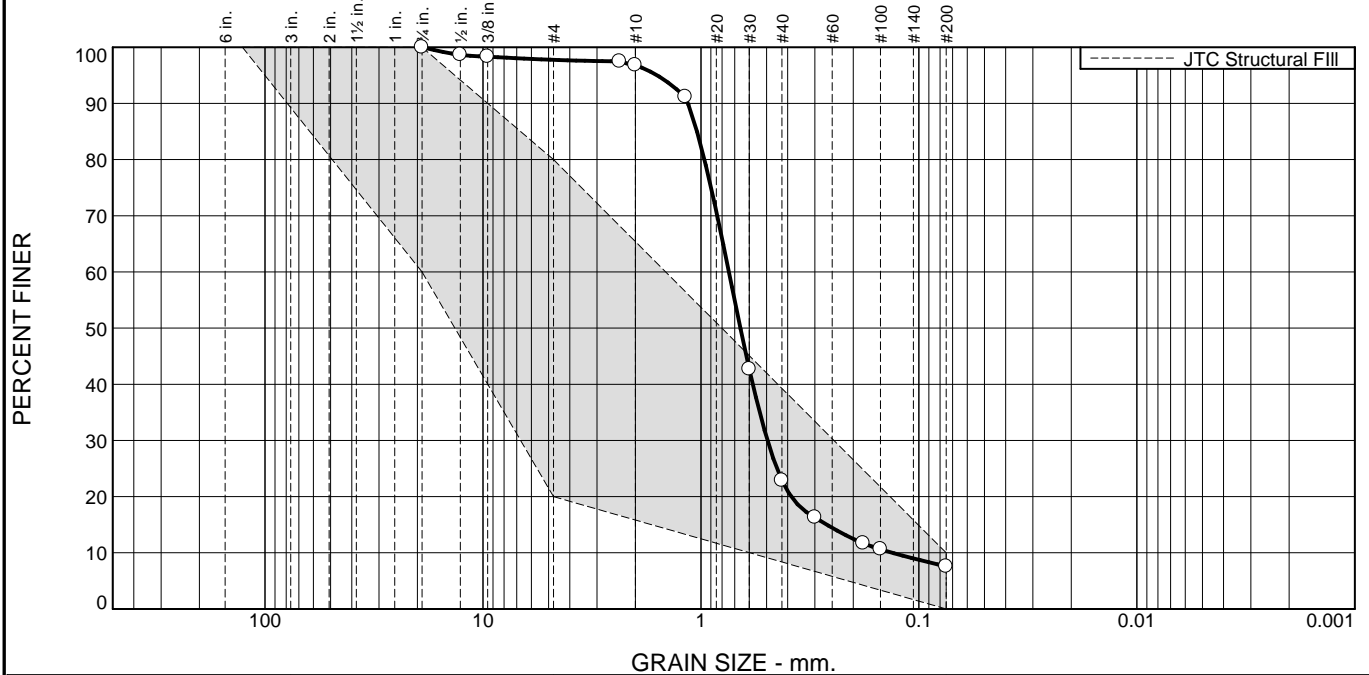
Particle Size Distribution Report

% +3"	% Gravel		% Sand			% Fines	
	Coarse	Fine	Coarse	Medium	Fine	Silt	Clay
0.0	0.0	2.2	1.0	73.9	15.3	7.6

Test Results (ASTM C 136 & ASTM C 117)			
Opening Size	Percent Finer	Spec.* (Percent)	Pass? (X=Fail)
3/4"	100.0	60.0 - 100.0	
1/2"	98.7		
3/8"	98.3		
#8	97.5		
#10	96.8		
#16	91.1		
#30	42.7		
#40	22.9		
#50	16.3		
#80	11.7		
#100	10.6	0.0 - 10.0	
#200	7.6

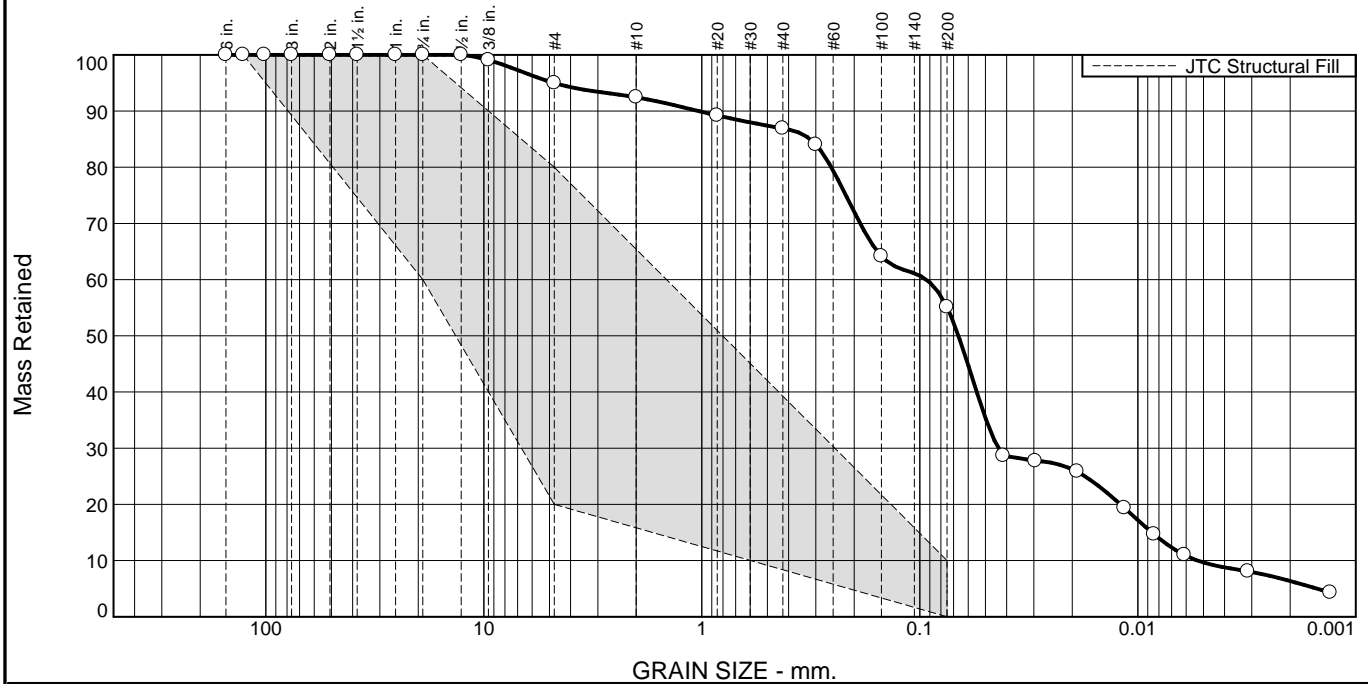
Particle Size Distribution Report

% +3"	% Gravel		% Sand			% Fines	
	Coarse	Fine	Coarse	Medium	Fine	Silt	Clay
0.0	0.0	5.0	2.5	5.6	31.8	45.5	9.6

Test Results (ASTM C 136 & ASTM C 117)			
Opening Size	Percent Finer	Spec.* (Percent)	Pass? (X=Fail)
6	100.0	100.0	
5	100.0		
4	100.0		
3	100.0	60.0 - 100.0	
2	100.0		
1.5	100.0		
1	100.0		
3/4	100.0		
1/2	100.0	20.0 - 80.0	X
3/8	99.1		
#4	95.0		
#10	92.5		
#20	89.2		
#40	86.9	0.0 - 10.0	X
#50	84.0		
#100	64.2		
#200	55.1		
0.0414 mm.	28.7		
0.0296 mm.	27.7		
0.0190 mm.	25.8		
0.0115 mm.	19.4		
0.0084 mm.	14.7		
0.0061 mm.	11.0		
0.0031 mm.	8.1		
0.0013 mm.	4.3

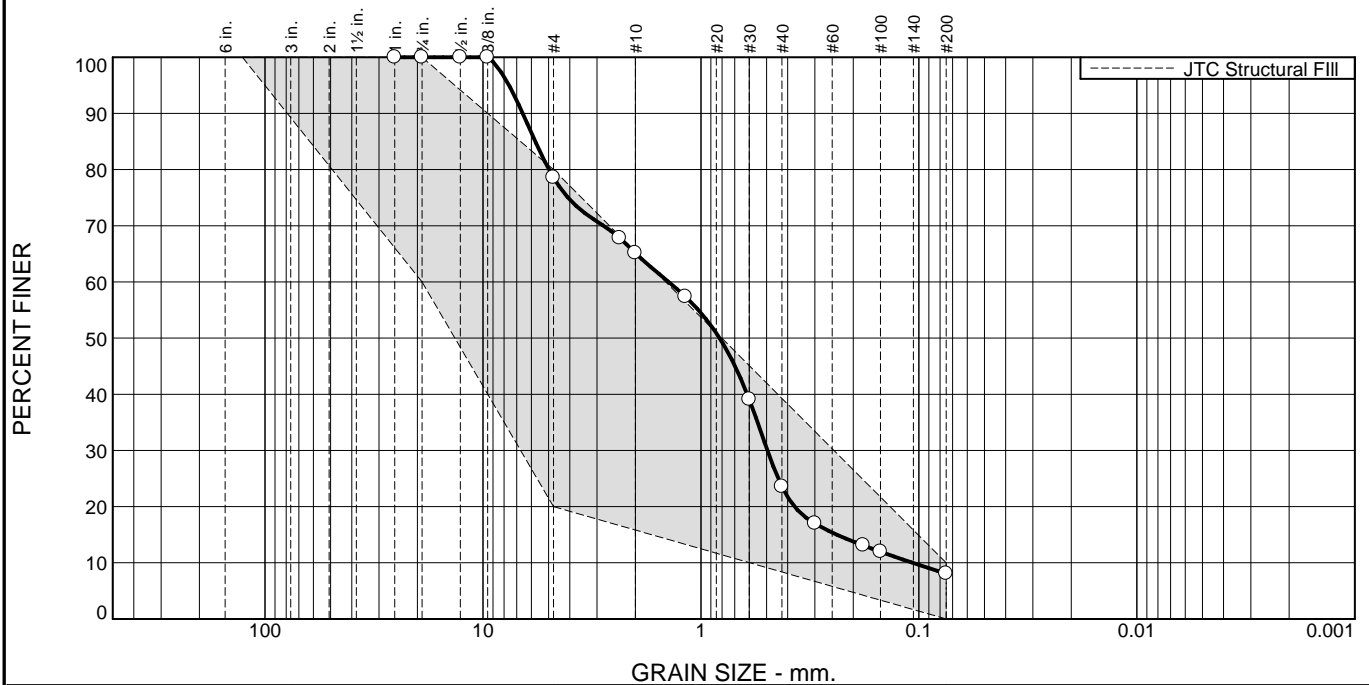
Particle Size Distribution Report

% +3"	% Gravel		% Sand			% Fines	
	Coarse	Fine	Coarse	Medium	Fine	Silt	Clay
0.0	0.0	21.4	13.5	41.5	15.5	8.1

Test Results (ASTM C 136 & ASTM C 117)			
Opening Size	Percent Finer	Spec.* (Percent)	Pass? (X=Fail)
1"	100.0	60.0 - 100.0	
3/4"	100.0		
1/2"	100.0		
3/8"	100.0		
#4	78.6		
#8	67.8	20.0 - 80.0	
#10	65.1		
#16	57.4		
#30	39.1		
#40	23.6		
#50	17.0	0.0 - 10.0	
#80	13.1		
#100	12.0		
#200	8.1

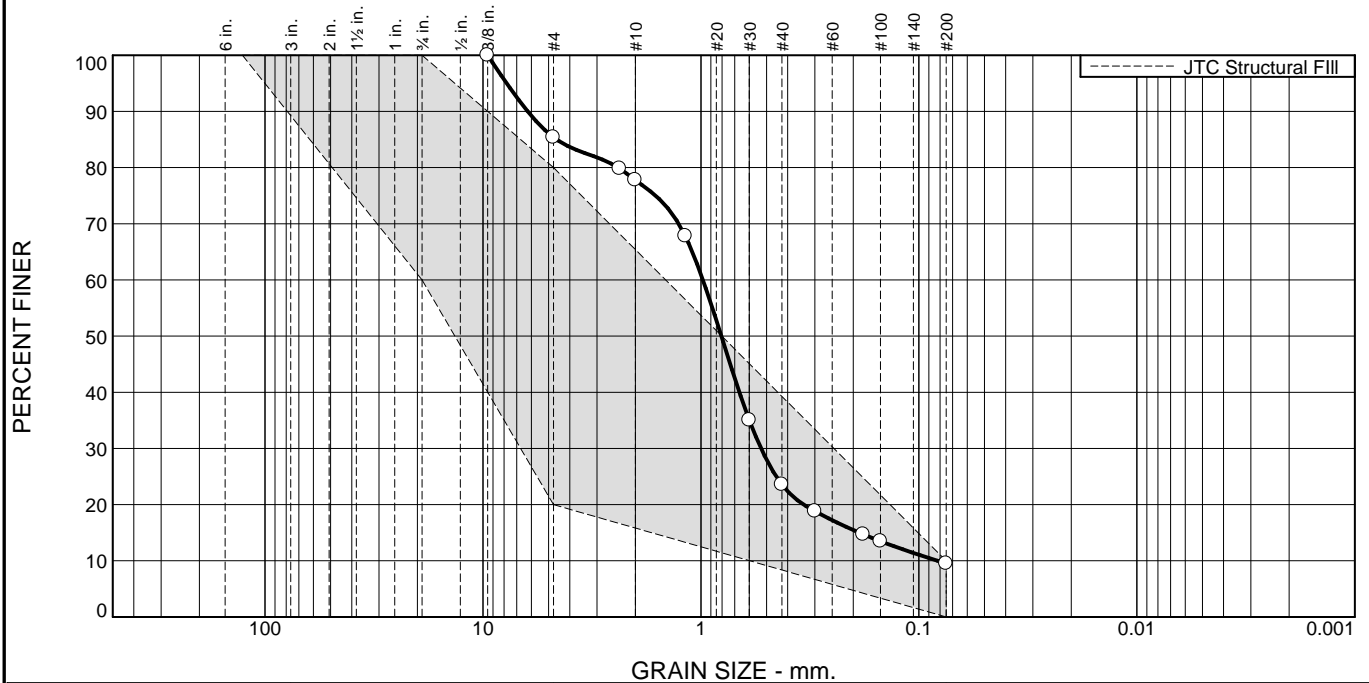
Particle Size Distribution Report

% +3"	% Gravel		% Sand			% Fines	
	Coarse	Fine	Coarse	Medium	Fine	Silt	Clay
0.0	0.0	14.6	7.6	54.2	14.1	9.5

Test Results (ASTM C 136 & ASTM C 117)			
Opening Size	Percent Finer	Spec.* (Percent)	Pass? (X=Fail)
3/8"	100.0	20.0 - 80.0	X
#4	85.4		
#8	79.8		
#10	77.8		
#16	67.8		
#30	35.0		
#40	23.6	0.0 - 10.0	
#50	18.8		
#80	14.7		
#100	13.5		
#200	9.5

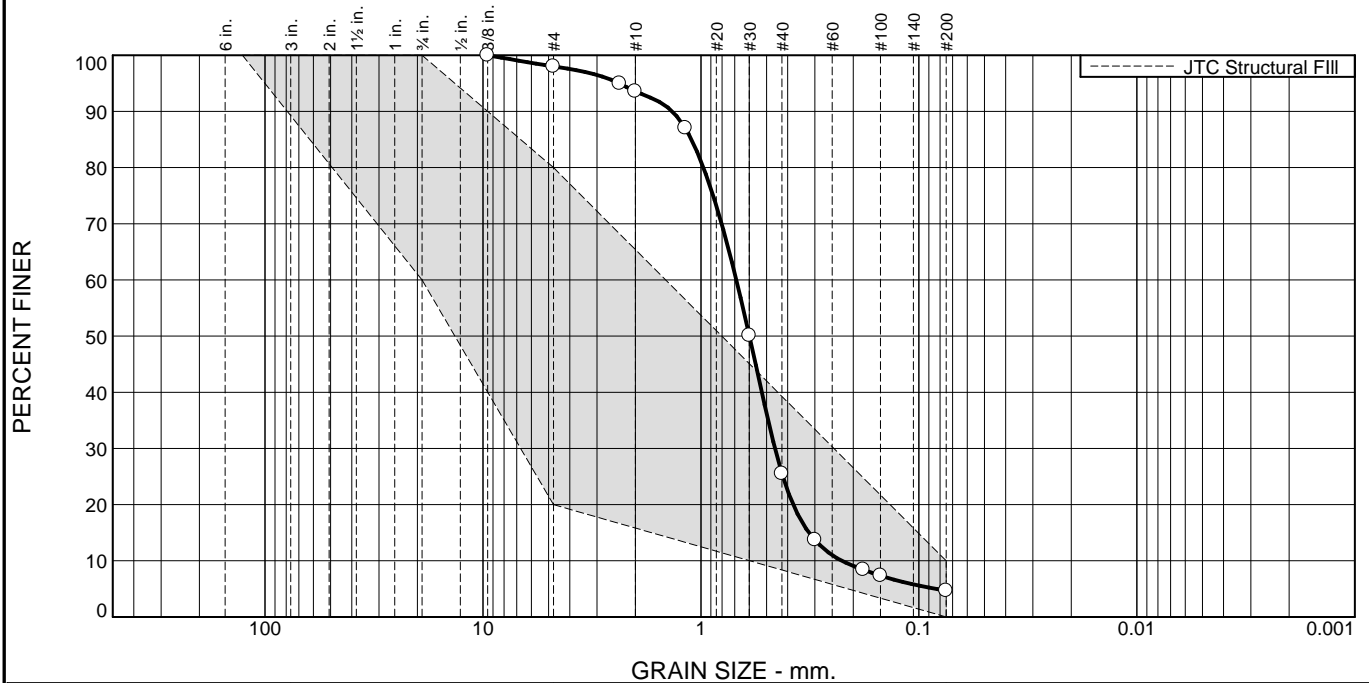
Particle Size Distribution Report

% +3"	% Gravel		% Sand			% Fines	
	Coarse	Fine	Coarse	Medium	Fine	Silt	Clay
0.0	0.0	2.0	4.4	68.1	20.8	4.7

Test Results (ASTM C 136 & ASTM C 117)			
Opening Size	Percent Finer	Spec.* (Percent)	Pass? (X=Fail)
3/8"	100.0	20.0 - 80.0	X
#4	98.0		
#8	95.0		
#10	93.6		
#16	87.0		
#30	50.1	0.0 - 10.0	
#40	25.5		
#50	13.7		
#80	8.4		
#100	7.4		
#200	4.7

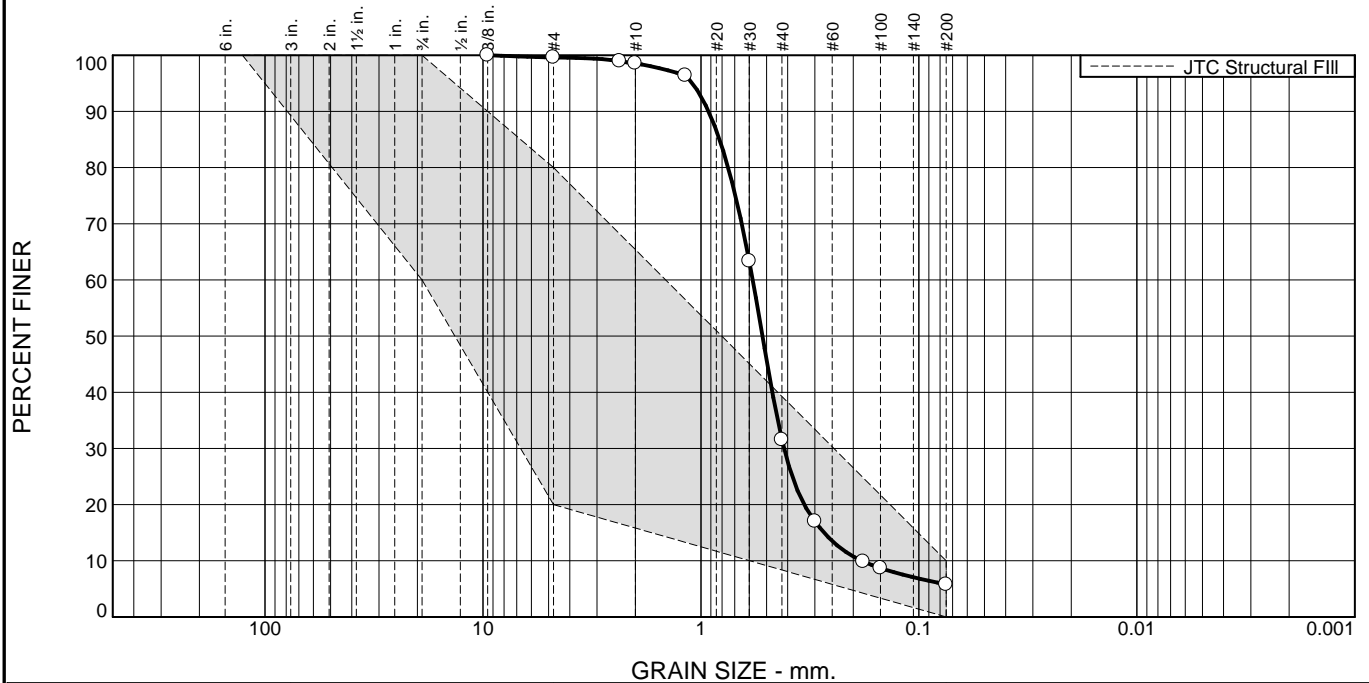
Particle Size Distribution Report

% +3"	% Gravel		% Sand			% Fines	
	Coarse	Fine	Coarse	Medium	Fine	Silt	Clay
0.0	0.0	0.4	1.0	67.0	25.8	5.8

Test Results (ASTM C 136 & ASTM C 117)			
Opening Size	Percent Finer	Spec.* (Percent)	Pass? (X=Fail)
3/8"	100.0	20.0 - 80.0	X
#4	99.6		
#8	98.9		
#10	98.6		
#16	96.4		
#30	63.3		
#40	31.6	0.0 - 10.0	
#50	17.0		
#80	9.9		
#100	8.7		
#200	5.8

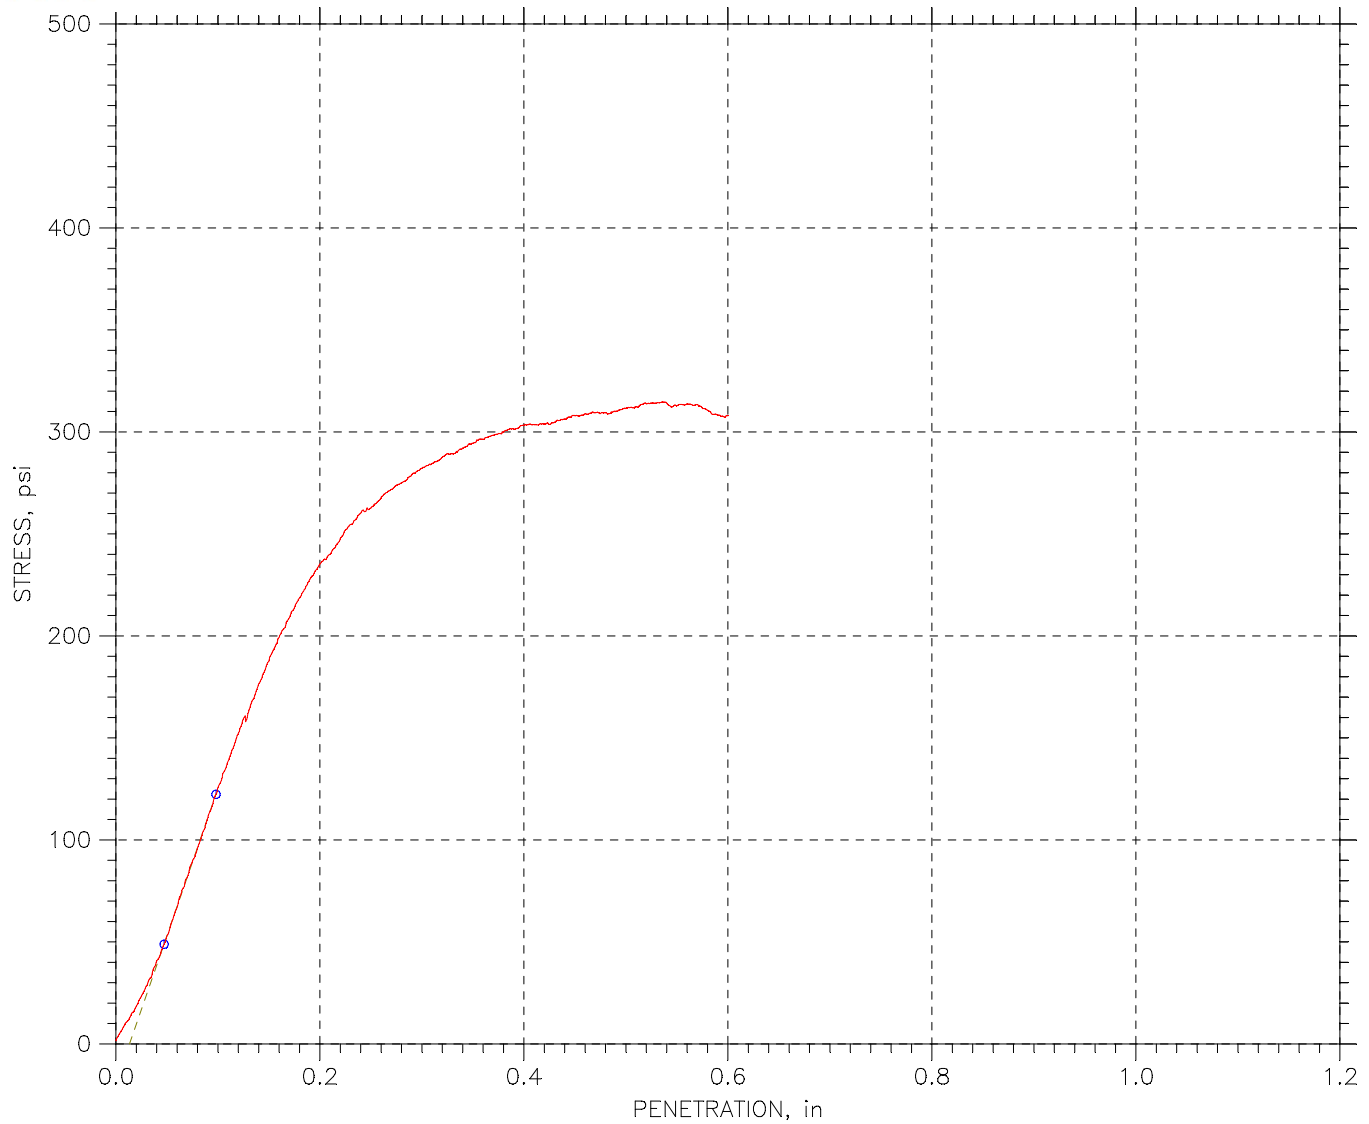
CALIFORNIA BEARING RATIO TEST REPORT

Sample Height: 4.58 in	California Bearing Ratio			
Sample Area: 28.274 in^2	at 0.1 in: 14	at 0.3 in: 15	at 0.5 in: 12	
Sample Volume: 0.07494 ft^3	at 0.2 in: 16	at 0.4 in: 13		
Sample Mass: 4311 gm				
Sample Condition: Soaked	Water Content	Before	Top	Average
Swell: 0.01 %	Tare ID	E1168	E4411	E4558
Surcharge: 4540 gm	Tare Mass, gm	8.21	8.21	8.26
Void Ratio: 0.40	Mass Tare + Wet Soil, gm	223.07	312.8	404.94
Wet Unit Weight: 126.82 pcf	Mass Tare + Dry Soil, gm	207.73	281.68	363.22
Dry Unit Weight: 117.77 pcf	Water Content, %	7.69	11.38	11.75

Project: Morrisville-Stowe AP	Location: Stowe, VT	Project No.: GTX-317320
Boring No.: B-2	Tested By: cwd	Checked By: ank
Sample No.: ---	Test Date: 6/23/23	Depth: 2-4'
Test No.: cbr-1	Sample Type: remolded	Elevation: ---
Description: Moist, dark olive brown sand with gravel		
Remarks: 92% of 127.9 pcf @ 7.7% moisture content

Table 1 – California Bearing Ratio					
Sample/ Location #	USCS Soil Type	Laboratory CBR Values & Test Conditions			
		Depth of Lab Sample (feet bgs)	Laboratory CBR Value (Corrected)	Soaked Moisture Content (%)	In-Situ Moisture Content (%)
CBR-1 (B-2)	SP	2 - 4	14	11.4	5.3
CBR-2 (B-9)	SP	2 - 4	5	17.6	2.7
CBR-3 (B-6)	SP	2 - 4	10	13.9	4.5
CBR-4 (B-5)	SM	2 - 4	20	15.1	-

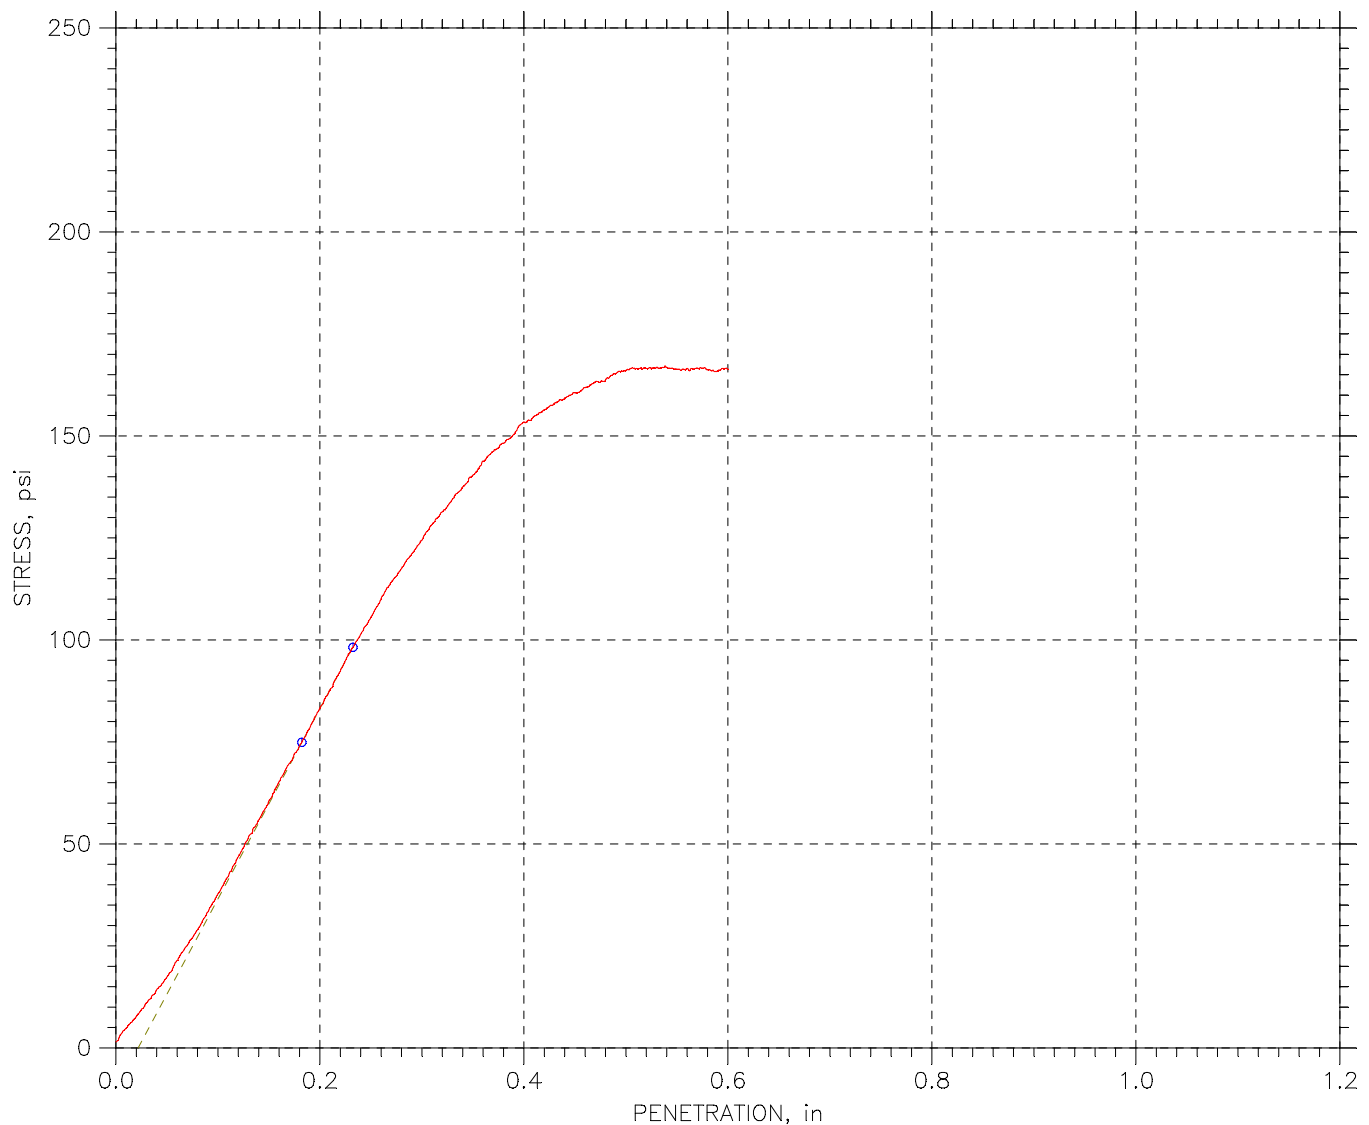
CALIFORNIA BEARING RATIO TEST REPORT

Sample Height: 4.58 in	California Bearing Ratio			
Sample Area: 28.274 in^2	at 0.1 in: 5	at 0.3 in: 7	at 0.5 in: 6	
Sample Volume: 0.07494 ft^3	at 0.2 in: 6	at 0.4 in: 7		
Sample Mass: 3760 gm				
Sample Condition: Soaked	Water Content	Before	Top	Average
Swell: -0.01 %	Tare ID	E2227	E4832	E4853
Surcharge: 4540 gm	Tare Mass, gm	24.94	8.17	8.14
Void Ratio: 0.71	Mass Tare + Wet Soil, gm	965.33	179.85	207.72
Wet Unit Weight: 110.61 pcf	Mass Tare + Dry Soil, gm	849.71	154.14	173.47
Dry Unit Weight: 97.014 pcf	Water Content, %	14.02	17.61	20.72

Project: Morrisville-Stowe AP	Location: Stowe, VT	Project No.: GTX-317320
Boring No.: B-9	Tested By: cwd	Checked By: ank
Sample No.: ---	Test Date: 6/23/23	Depth: 2-4'
Test No.: cbr-4	Sample Type: remolded	Elevation: ---
Description: Moist, very dark grayish brown sand		
Remarks: 92% of 105.2 pcf @ OMC 14.0% moisture content

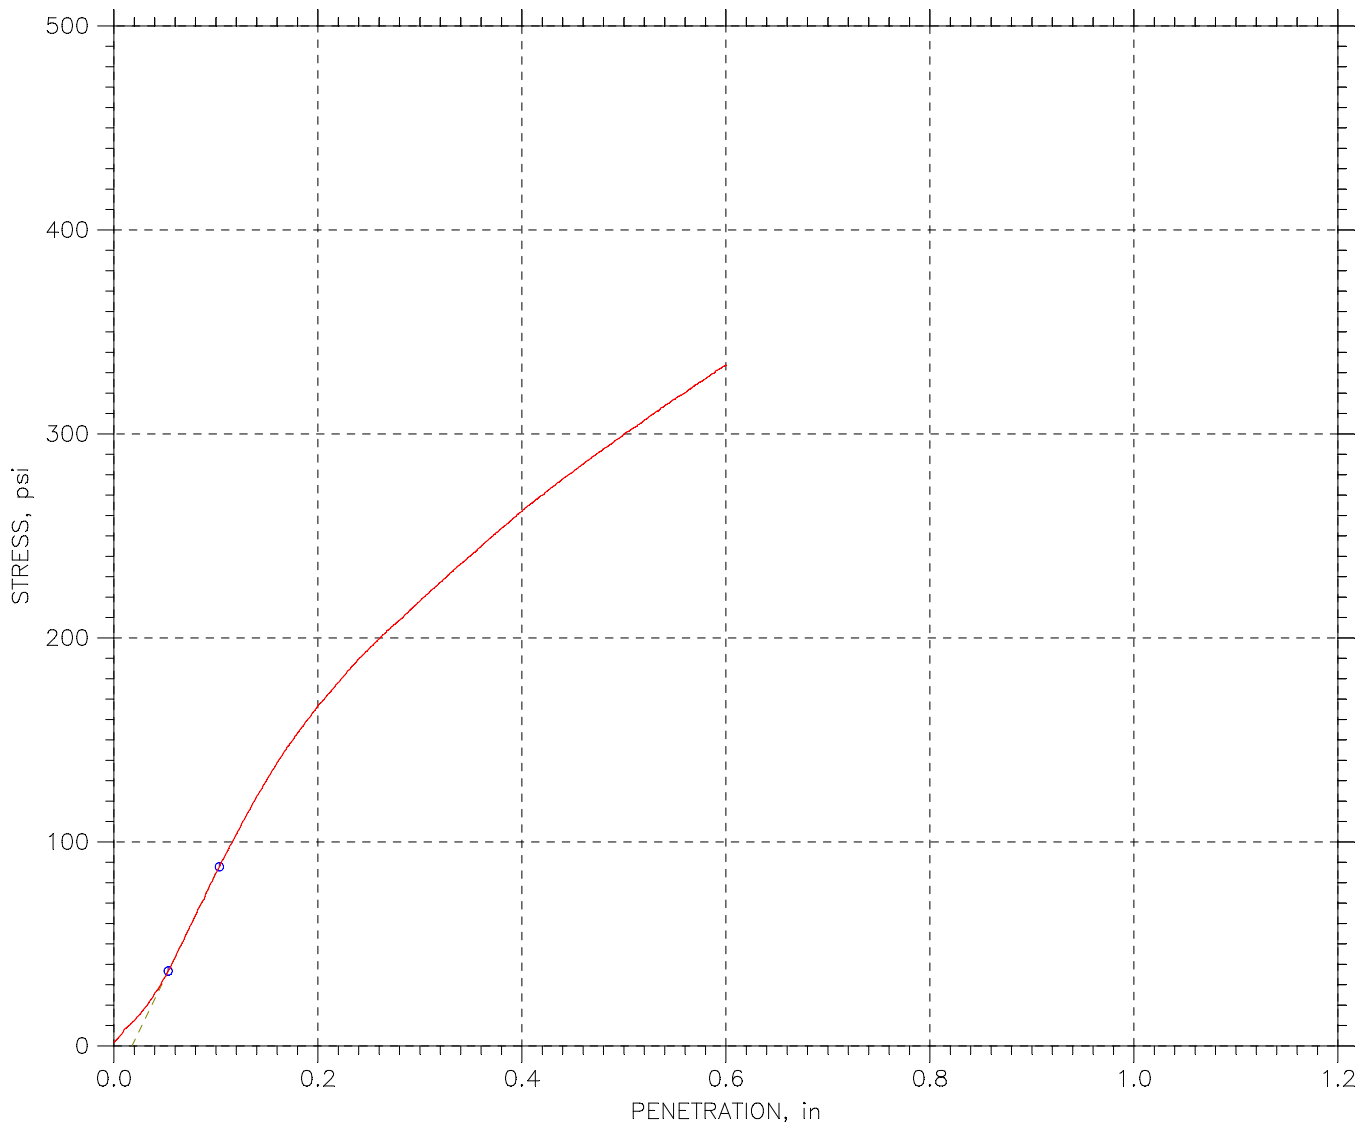
CALIFORNIA BEARING RATIO TEST REPORT

Sample Height: 4.58 in	California Bearing Ratio			
Sample Area: 28.274 in^2	at 0.1 in: 10	at 0.3 in: 12	at 0.5 in: 12	
Sample Volume: 0.07494 ft^3	at 0.2 in: 12	at 0.4 in: 12		
Sample Mass: 4027 gm				
Sample Condition: Soaked	Water Content	Before	Top	Average
Swell: 0.04 %	Tare ID	E6580	E3320	E3837
Surcharge: 4540 gm	Tare Mass, gm	24.52	8.21	8.53
Void Ratio: 0.53	Mass Tare + Wet Soil, gm	697.35	391.87	398.37
Wet Unit Weight: 118.47 pcf	Mass Tare + Dry Soil, gm	640.12	345.04	346.17
Dry Unit Weight: 108.39 pcf	Water Content, %	9.30	13.90	15.46

Project: Morrisville-Stowe AP	Location: Stowe, VT	Project No.: GTX-317320
Boring No.: B-6	Tested By: cwd	Checked By: ank
Sample No.: ---	Test Date: 6/29/23	Depth: 2-4'
Test No.: cbr-3	Sample Type: remolded	Elevation: ---
Description: Moist, dark yellowish brown silty sand		
Remarks: Compacted to 92% of 117.7 pcf at 9.2% moisture content

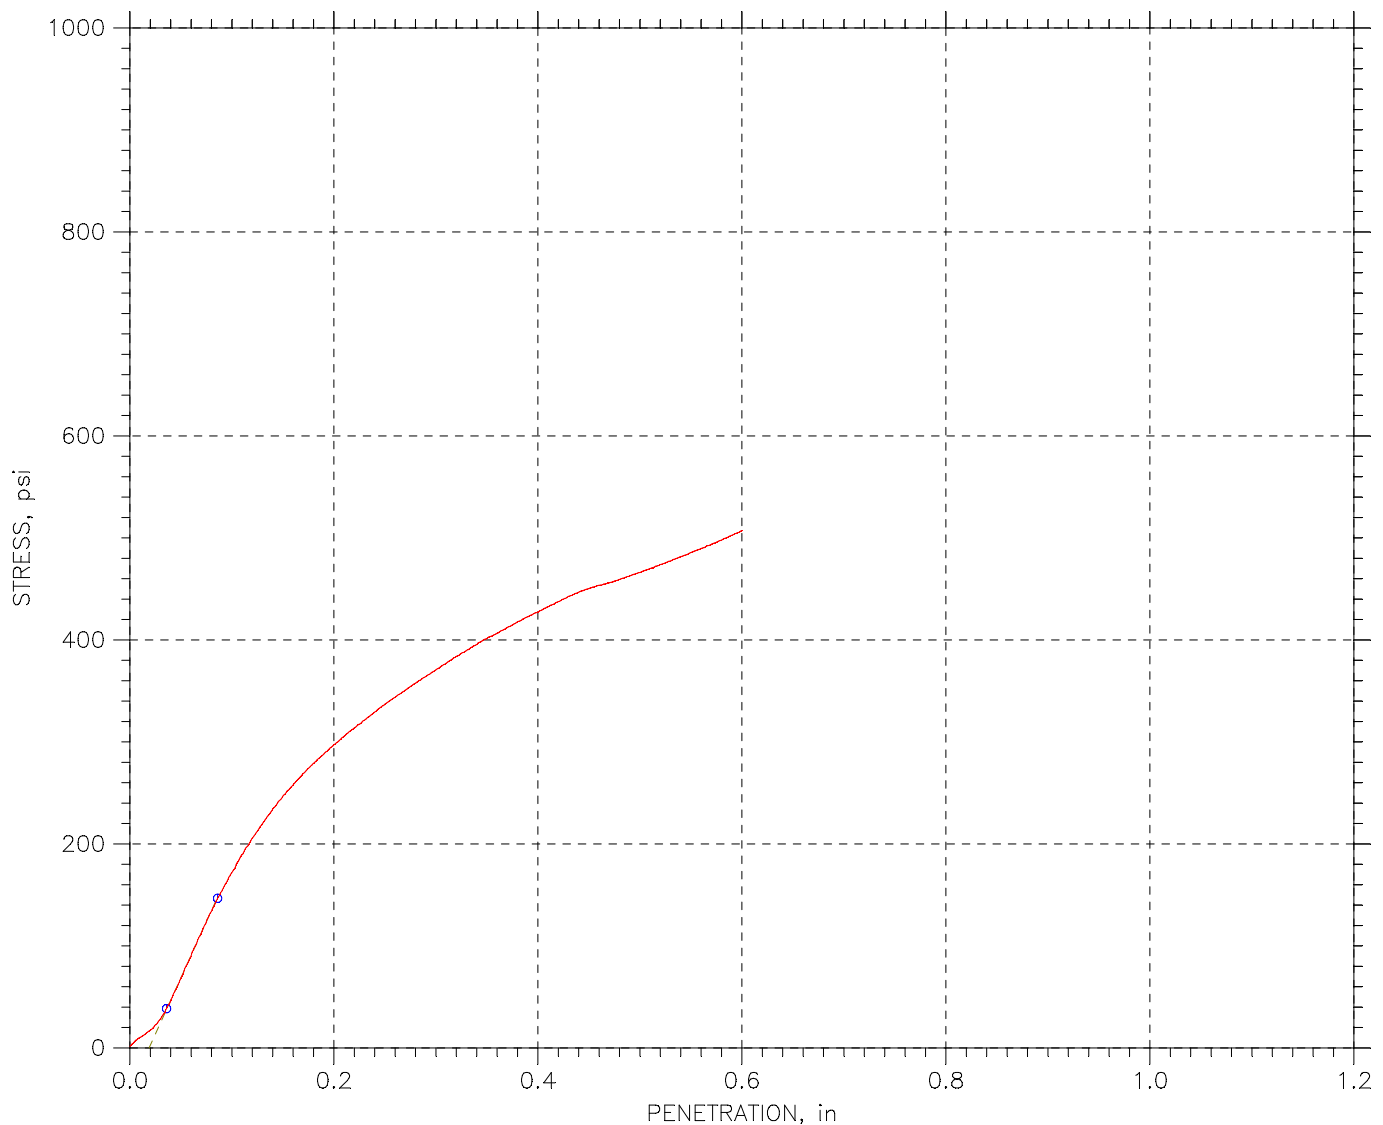
CALIFORNIA BEARING RATIO TEST REPORT

Sample Height: 4.58 in	California Bearing Ratio			
Sample Area: 28.274 in^2	at 0.1 in: 20	at 0.3 in: 20	at 0.5 in: 18	
Sample Volume: 0.07494 ft^3	at 0.2 in: 21	at 0.4 in: 19		
Sample Mass: 4289 gm				
Sample Condition: Soaked	Water Content	Before	Top	Average
Swell: 0.26 %	Tare ID	E6537	E6204	E7214
Surcharge: 4540 gm	Tare Mass, gm	24.44	7.64	8.55
Void Ratio: 0.46	Mass Tare + Wet Soil, gm	595.67	363.38	410.11
Wet Unit Weight: 126.18 pcf	Mass Tare + Dry Soil, gm	537.95	316.71	359.37
Dry Unit Weight: 113.43 pcf	Water Content, %	11.24	15.10	14.46

Project: Morrisville-Stowe AP	Location: Stowe, VT	Project No.: GTX-317320
Boring No.: B-5	Tested By: cwd	Checked By: ank
Sample No.: ---	Test Date: 6/29/23	Depth: 2-4'
Test No.: cbr-2redo	Sample Type: remolded	Elevation: ---
Description: Moist, dark olive brown silty sand with gravel		
Remarks: Compacted to 92% of 123.1 pcf at 11.1% moisture content

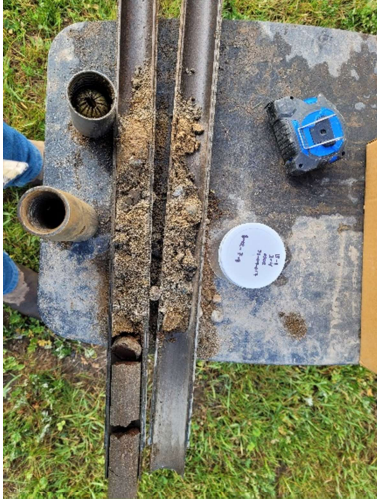
<p>Description: Example of Silty Sand (SM)</p>

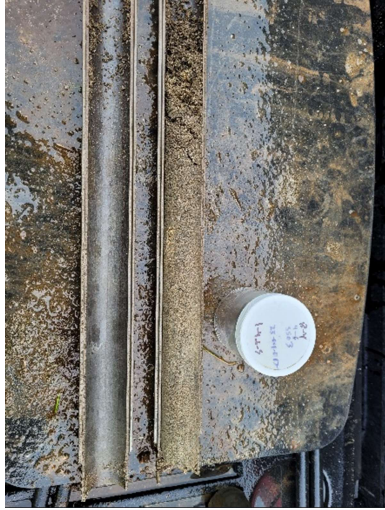
<p>Description: Example of Poorly Graded Sand with Silt (SP)</p>
