June 26, 2018

Project No. 1895029

**RE: VT ROUTE 12 SLOPE STABILITY – STABILIZATION ALTERNATIVES AND FINAL DESIGN  
BETHEL, VERMONT**

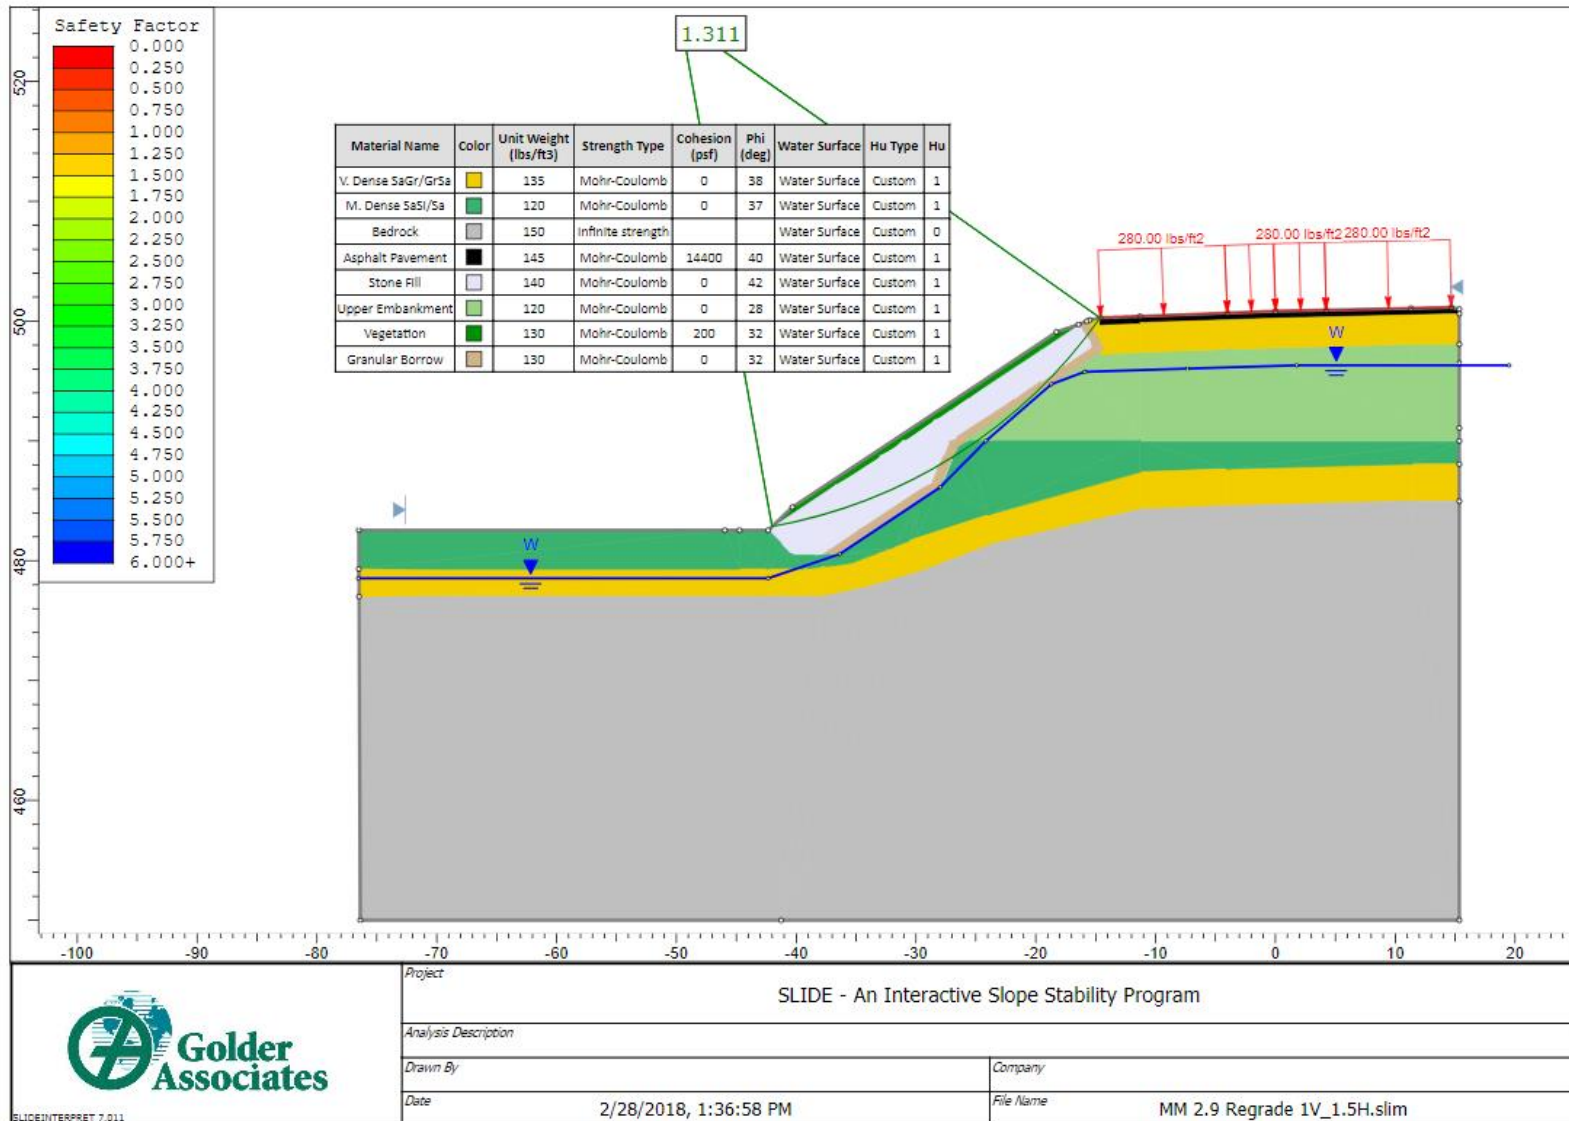
Figure 6: MM 2.9 Initial Conditions

For the existing condition models, the global factor of safety (FS) of close to 1.0 was targeted in order to model imminent failure conditions and refine the soil and groundwater properties used in the analyses (see Figures 6, 11, 16, and 21). A water filled tension crack was modelled at the observed head scarps at MM 2.9, 6.0, and 6.35 to account for the influx of rainwater from the July 2017 storm event and the field conditions observed. Results for the existing conditions models are summarized in Table 1 below.
